To: Jerald Schnabel  
Continental Materials Corp.  
File: July 2022 Monitoring Summary

From: Paul Kos  
Denver, CO 80222  
Date: August 26, 2022

**Reference: July 2022 Geotechnical Monitoring Summary Pikeview Quarry**

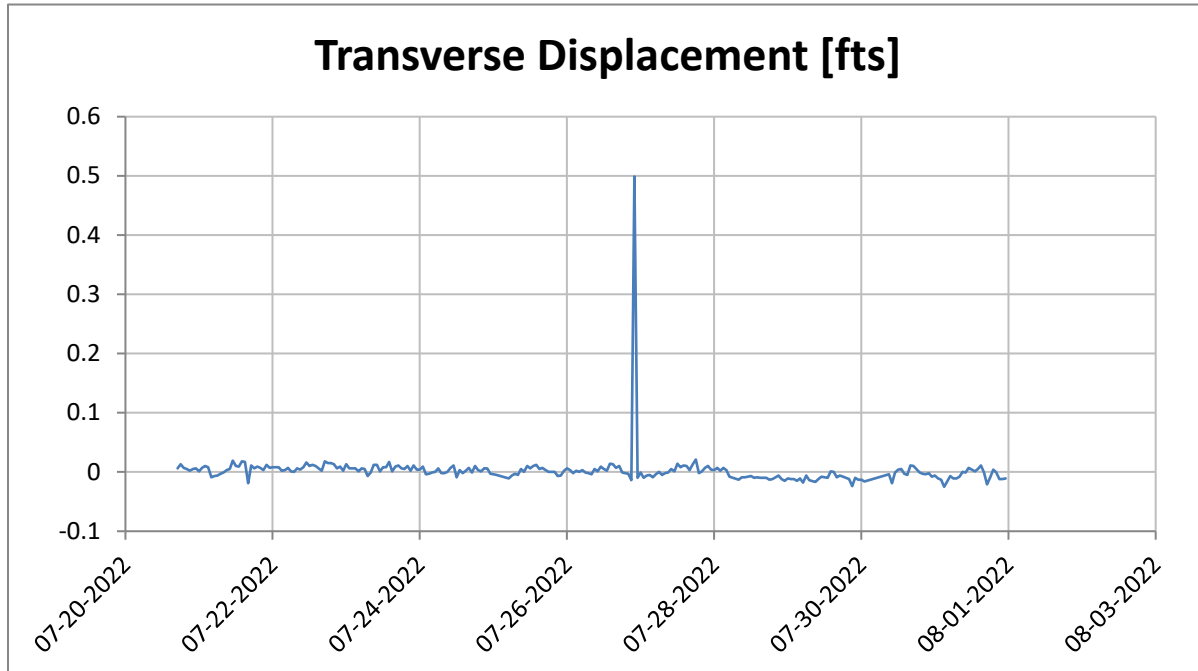
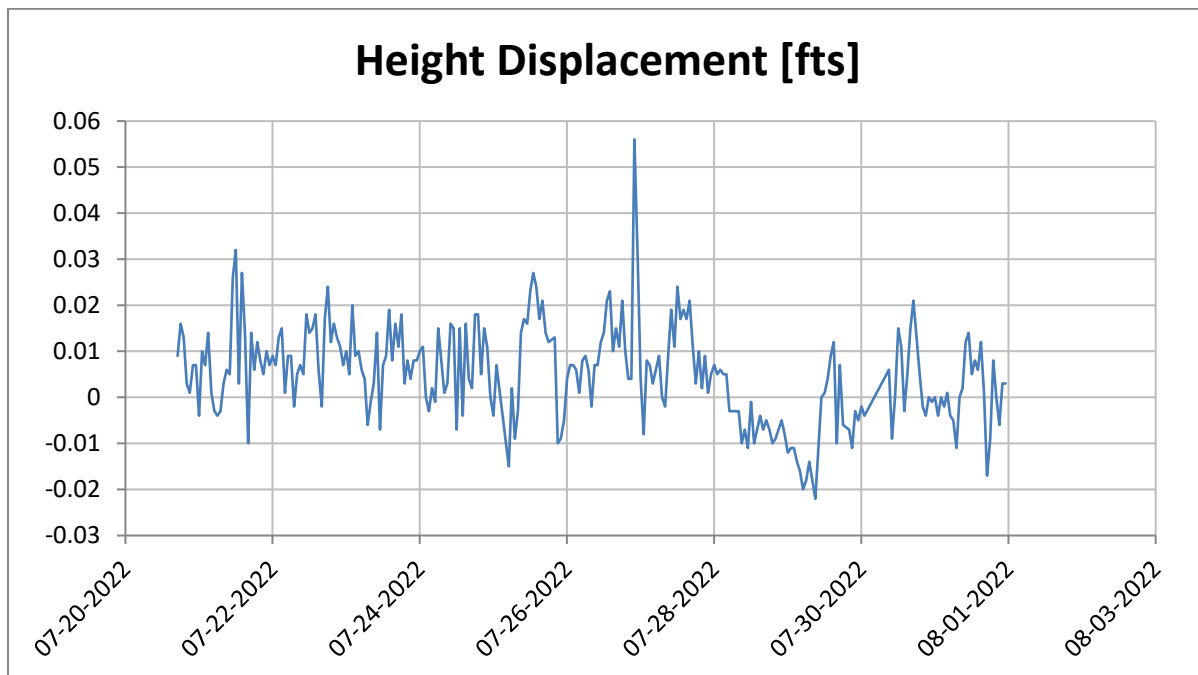
## Prism P32

1. Survey accuracy is +/-0.016 feet.
2. Alarm threshold is +/-0.35 feet.
3. Transverse displacement is in the horizontal direction. Positive direction means closer to the robotic station.
4. Height displacement is in the vertical direction. Positive direction means higher in elevation.
5. Exceedance alerts received on 7/1, 7/2, 7/3, 7/4, 7/12, 7/26, 7/27.
6. Prism reading for 7/20/22 through 7/30/22.

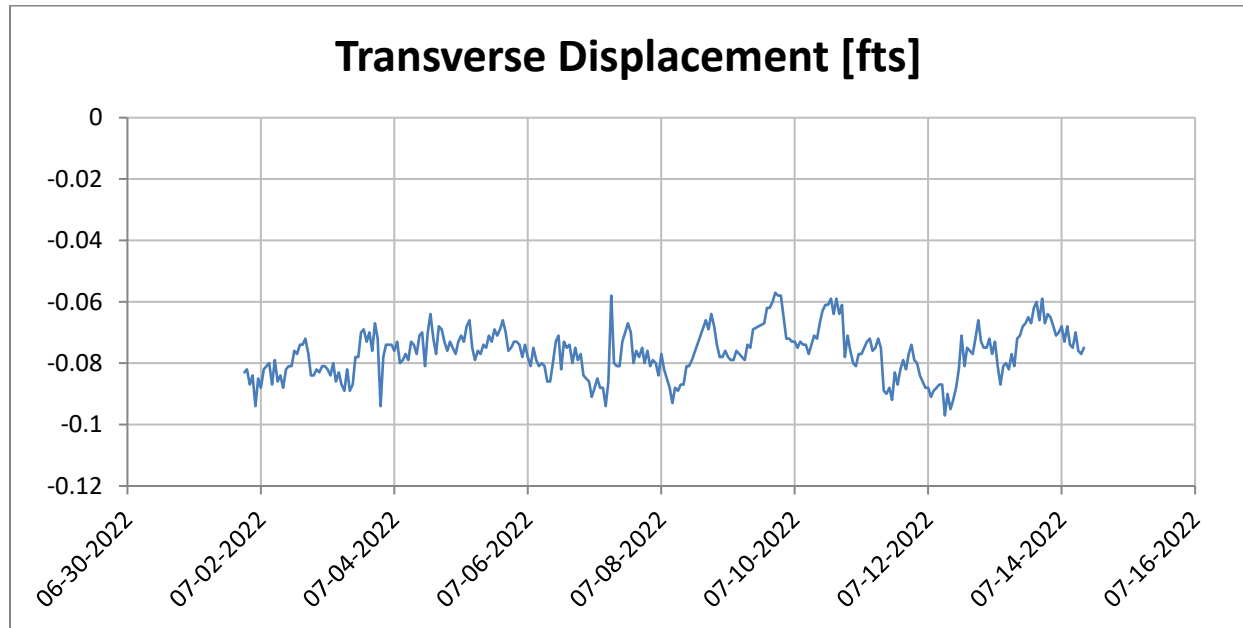
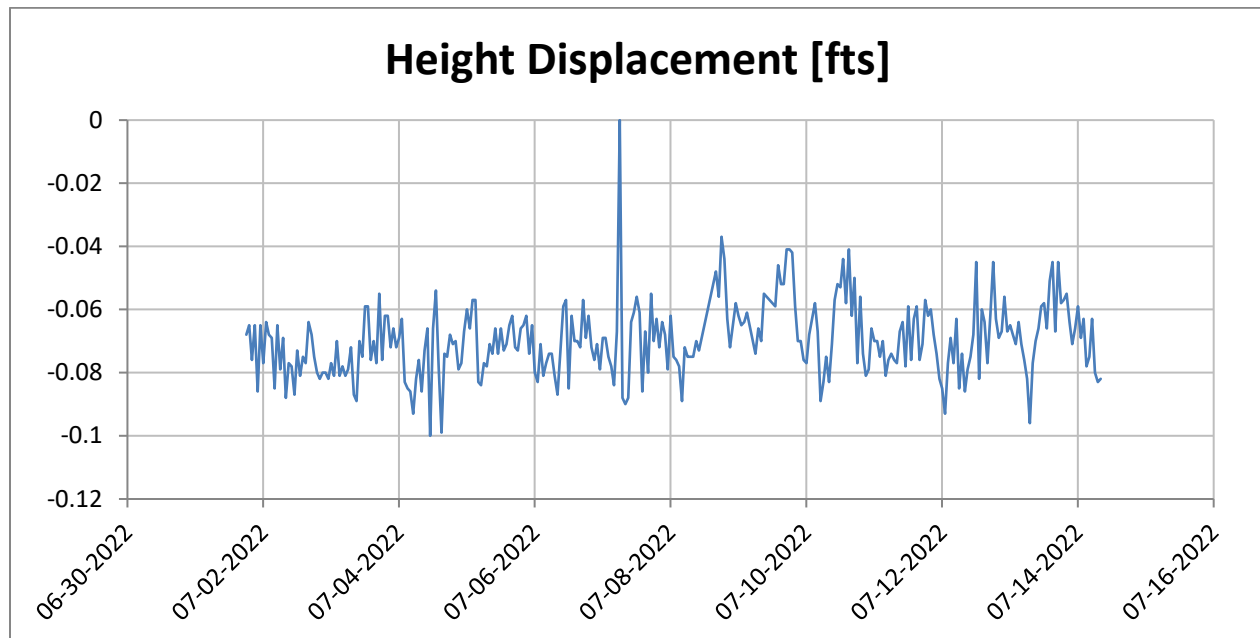
## Prism P33

1. Survey accuracy is +/-0.016 feet.
2. Alarm threshold is +/-0.35 feet.
3. Transverse displacement is in the horizontal direction. Positive direction means closer to the robotic station.
4. Height displacement is in the vertical direction. Positive direction means higher in elevation.
5. Exceedance alerts received on 7/3, 7/4, 7/25, 7/26, 7/27.
6. Prism reading for 7/1/22 through 7/14/22.

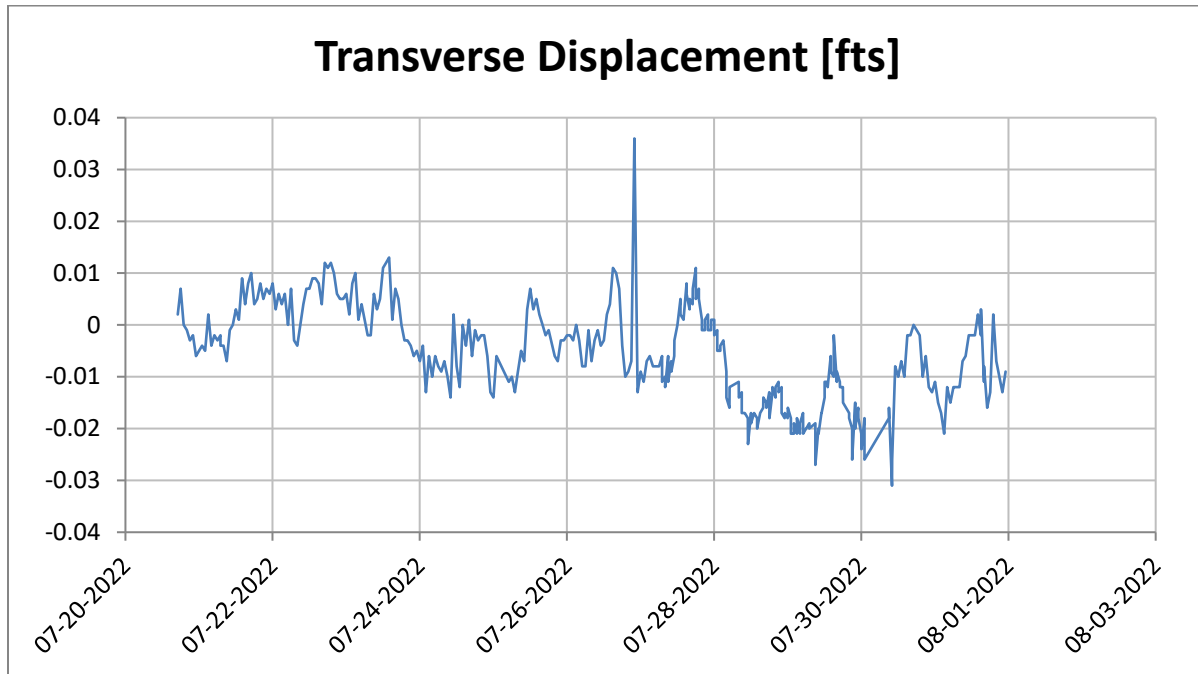
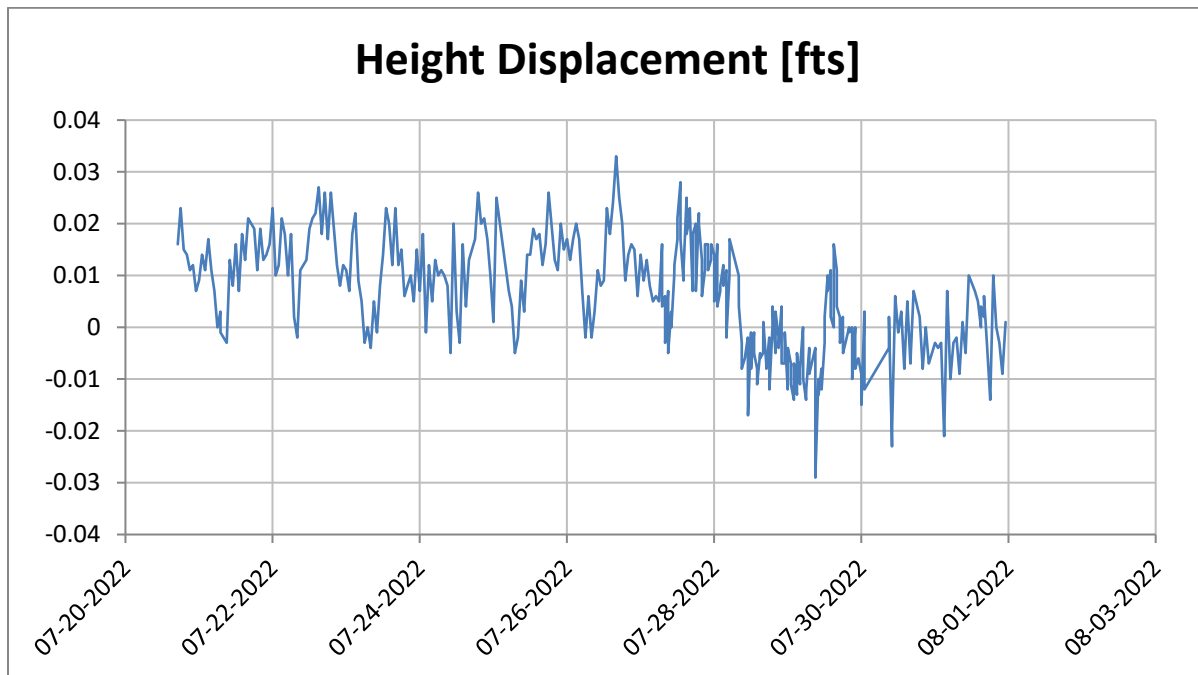
## Prism P33

1. Survey accuracy is  $\pm 0.016$  feet.
2. Alarm threshold is  $\pm 0.35$  feet.
3. Transverse displacement is in the horizontal direction. Positive direction means closer to the robotic station.
4. Height displacement is in the vertical direction. Positive direction means higher in elevation.
5. Exceedance alerts received on 7/3, 7/4, 7/25, 7/26, 7/27.
6. Prism reading for 7/20/22 through 7/30/22.

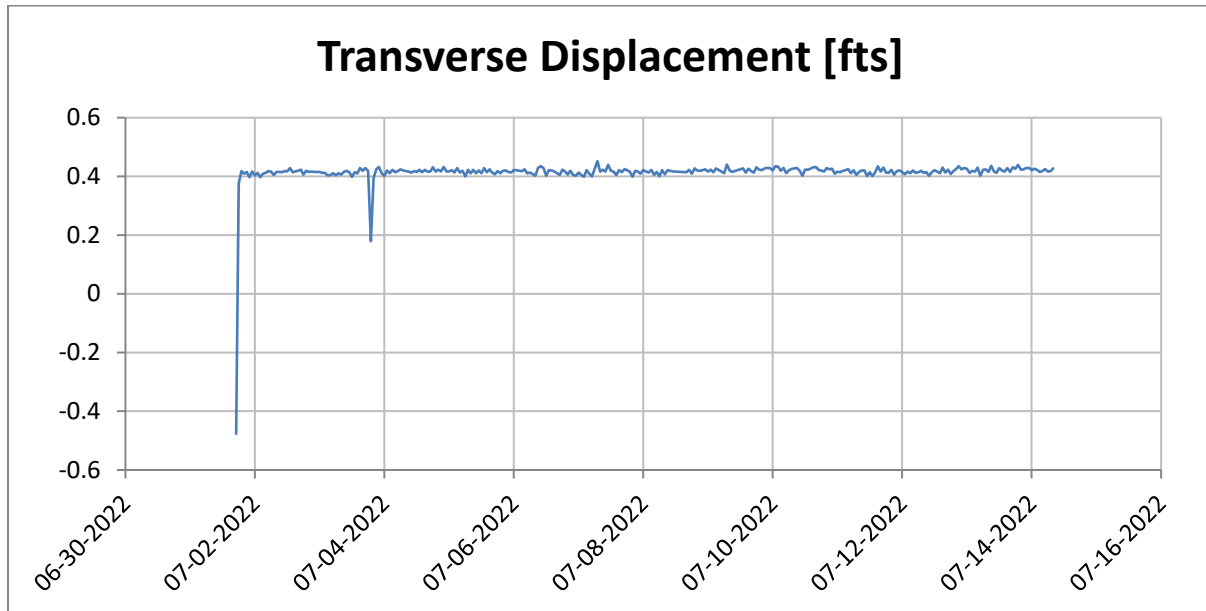
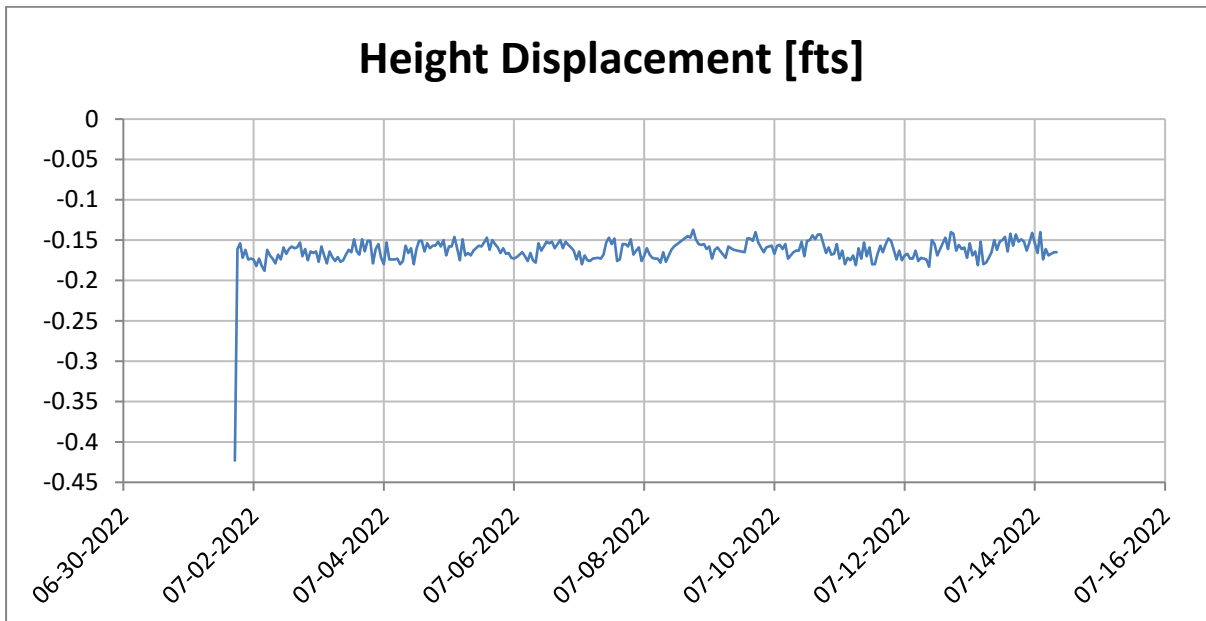
## Prism P5

1. Survey accuracy is +/-0.016 feet.
2. Alarm threshold is +/-0.35 feet.
3. Transverse displacement is in the horizontal direction. Positive direction means closer to the robotic station.
4. Height displacement is in the vertical direction. Positive direction means higher in elevation.
5. Exceedance alerts received on 7/1, 7/2, 7/3, 7/4
6. Prism reading for 7/1/22 through 7/14/22.

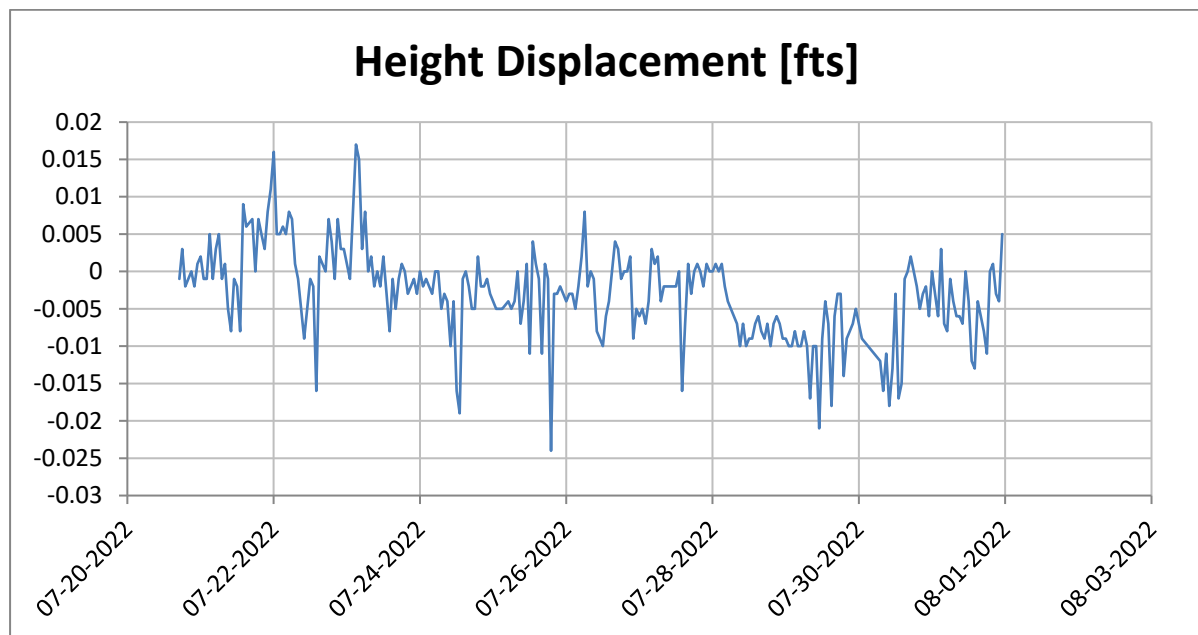
## Prism P63

1. Survey accuracy is  $\pm 0.016$  feet.
2. Alarm threshold is  $\pm 0.35$  feet.
3. Transverse displacement is in the horizontal direction. Positive direction means closer to the robotic station.
4. Height displacement is in the vertical direction. Positive direction means higher in elevation.
5. Prism records slope creep movements with slow velocity.
6. Exceedance alerts received on 7/26.
7. Prism reading for 7/20/22 through 7/30/22.

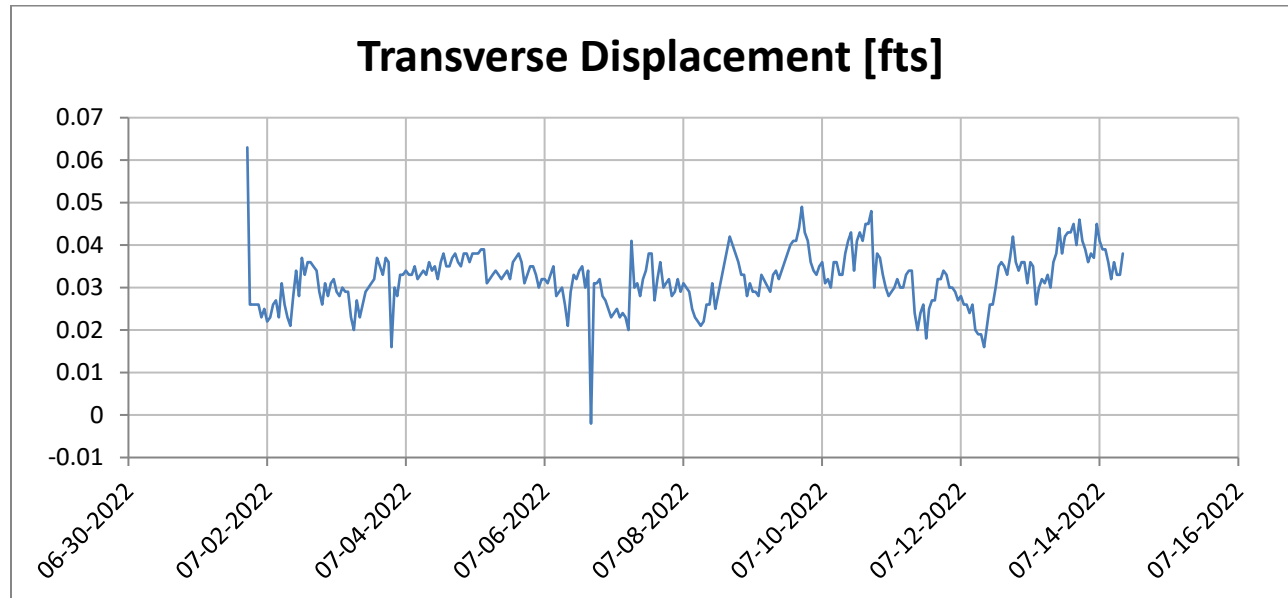
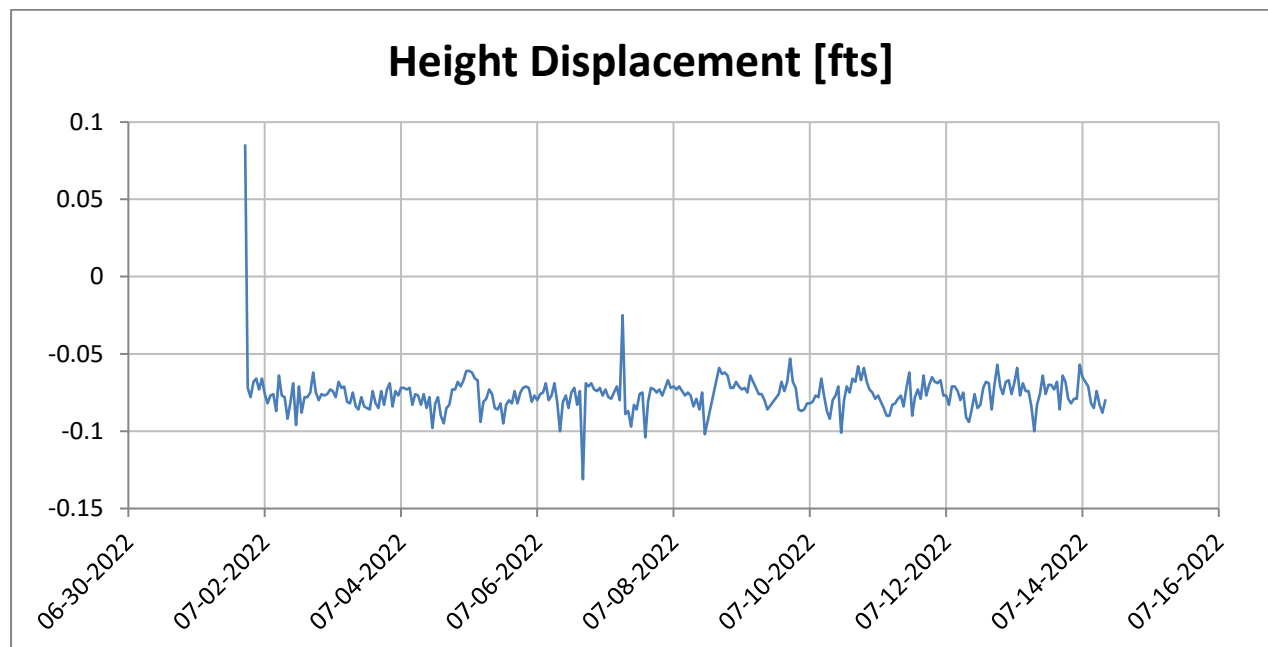
## Prism P69

1. Survey accuracy is +/-0.016 feet.
2. Alarm threshold is +/-0.35 feet.
3. Transverse displacement is in the horizontal direction. Positive direction means closer to the robotic station.
4. Height displacement is in the vertical direction. Positive direction means higher in elevation.
5. Prism records slope creep movements with slow velocity.
6. Prism previously identified as P69.
7. Exceedance alerts received on 7/26, 7/27.
8. Prism reading for 7/1/22 through 7/14/22.

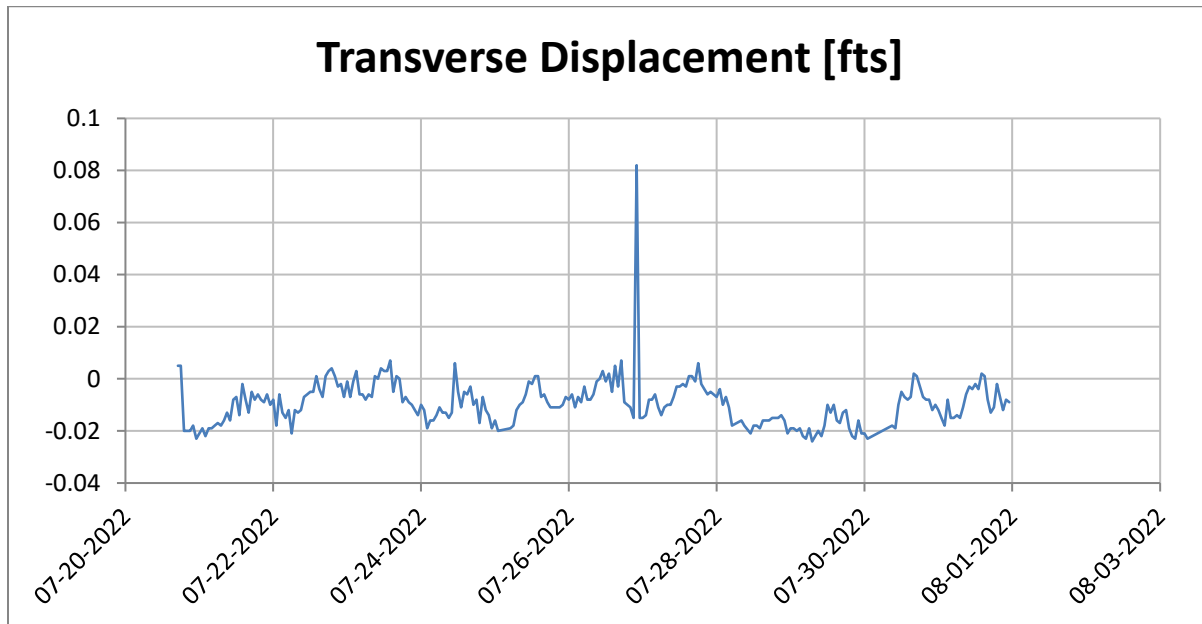
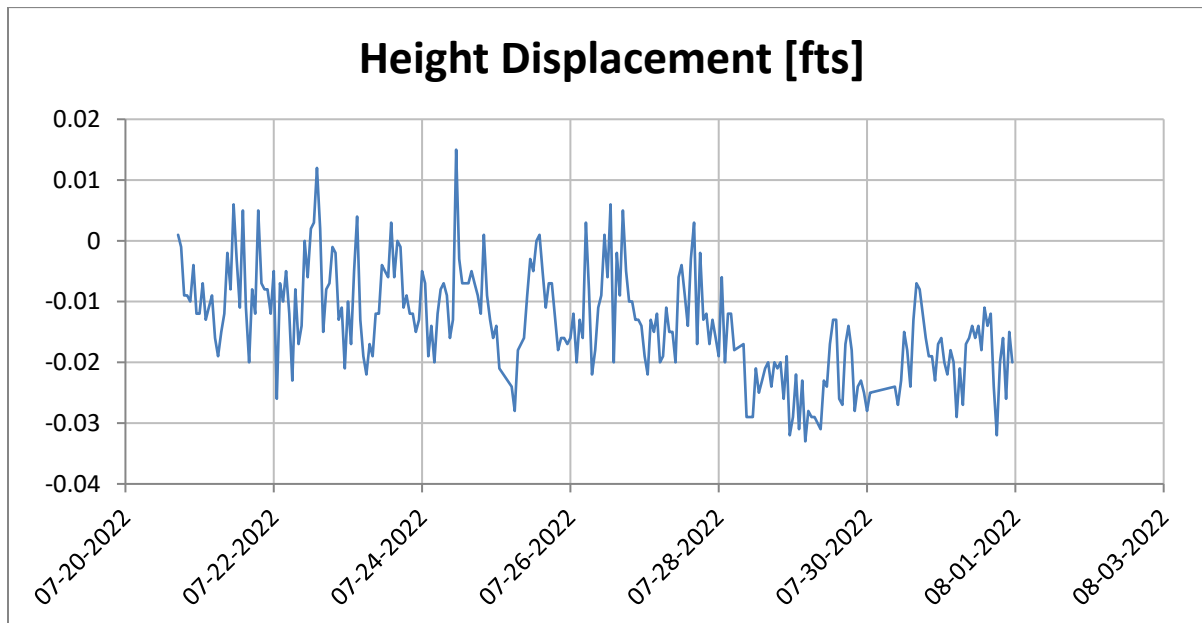
## Prism P69A

1. Survey accuracy is +/-0.016 feet.
2. Alarm threshold is +/-0.35 feet.
3. Transverse displacement is in the horizontal direction. Positive direction means closer to the robotic station.
4. Height displacement is in the vertical direction. Positive direction means higher in elevation.
5. Prism records slope creep movements with slow velocity.
6. Prism previously identified as P69.
7. Exceedance alerts received on 7/26, 7/27.
8. Prism reading for 7/20/22 through 7/30/22.

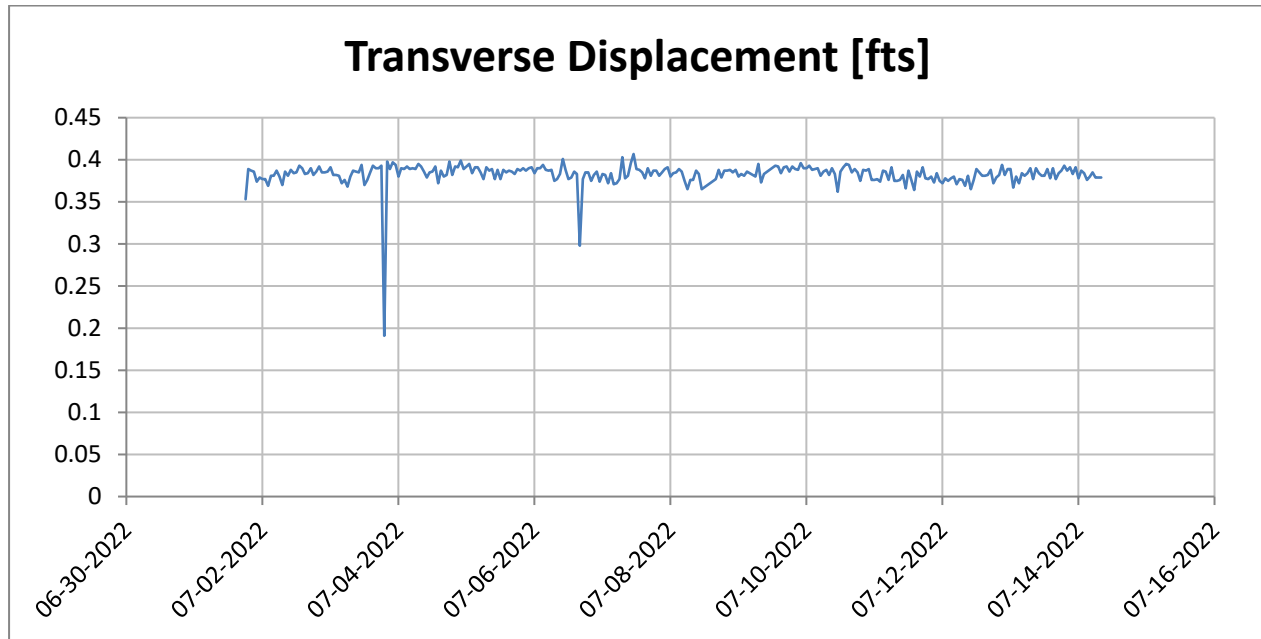
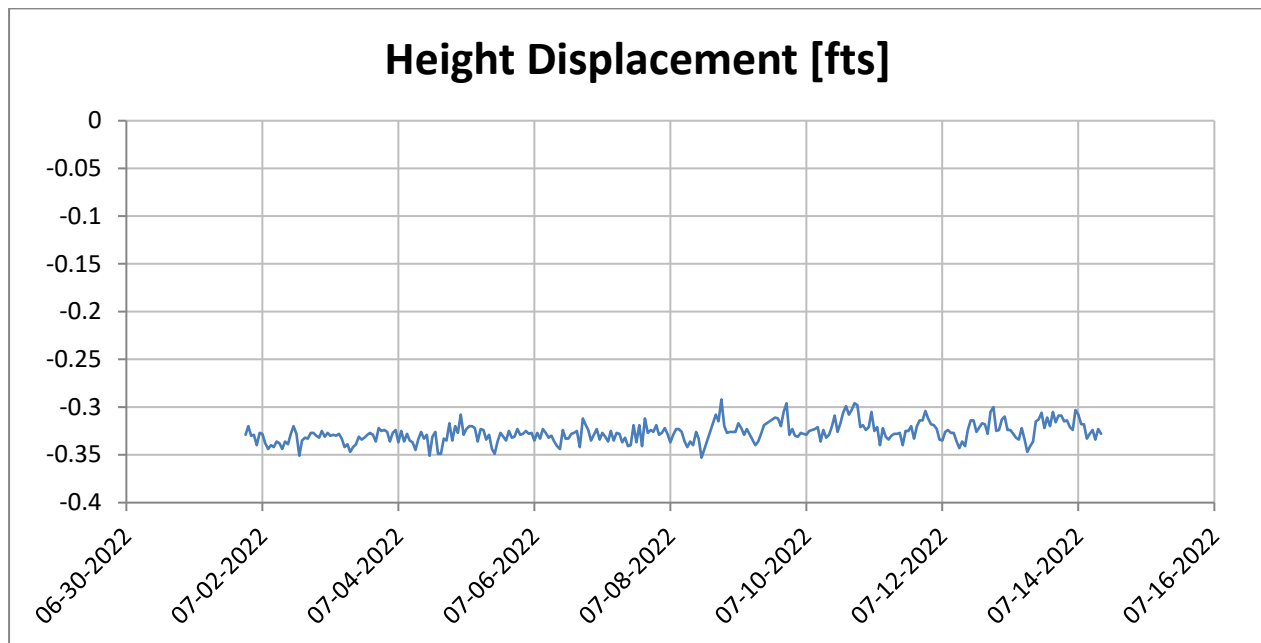
## Prism P70

1. Survey accuracy is +/-0.016 feet.
2. Alarm threshold is +/-0.35 feet.
3. Transverse displacement is in the horizontal direction. Positive direction means closer to the robotic station.
4. Height displacement is in the vertical direction. Positive direction means higher in elevation.
5. Exceedance alerts received on 7/3, 7/4, 7/26, 7/27.
6. Prism reading for 7/1/22 through 7/14/22.

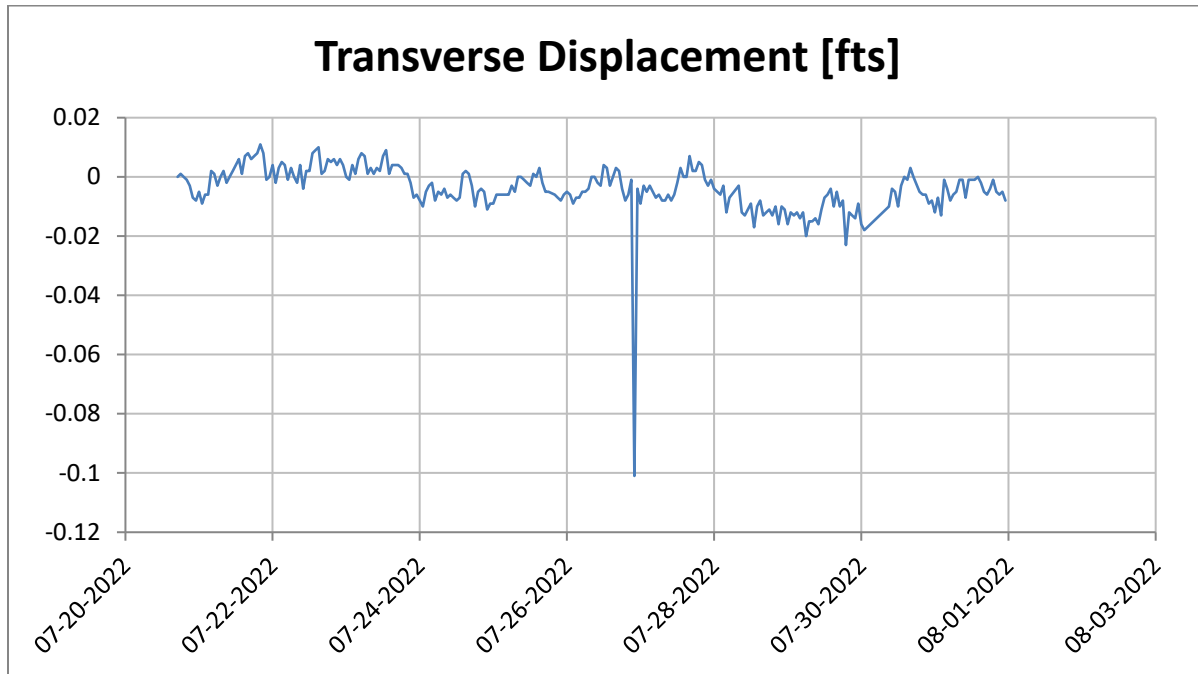
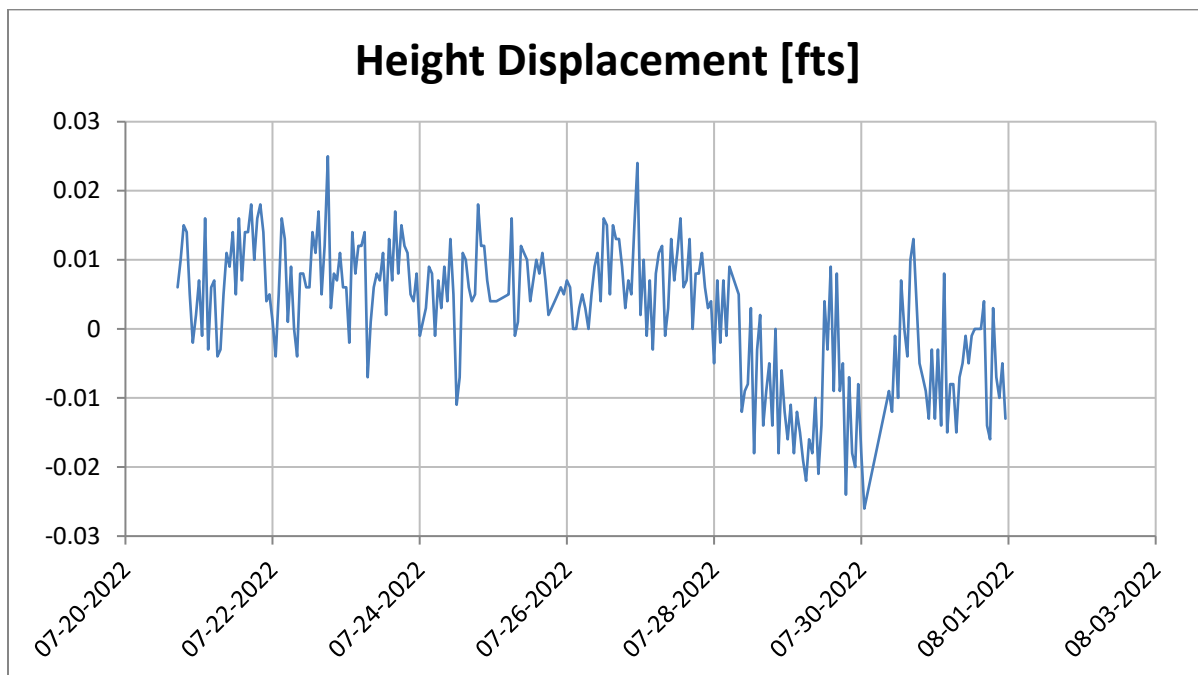
## Prism P70

1. Survey accuracy is +/-0.016 feet.
2. Alarm threshold is +/-0.35 feet.
3. Transverse displacement is in the horizontal direction. Positive direction means closer to the robotic station.
4. Height displacement is in the vertical direction. Positive direction means higher in elevation.
5. Exceedance alerts received on 7/3, 7/4, 7/26, 7/27.
6. Prism reading for 7/20/22 through 7/30/22.
