MINERALS PROGRAM INSPECTION REPORT
PHONE: (303) 866-3567

MINE NAME: Turnpike Mining Resource	MINE/PROSPECTING ID#: M-2004-009	MINERAL: Sand and gravel	COUNTY: Weld
INSPECTION TYPE: Monitoring	INSPECTOR(S): Eric Scott	INSP. DATE: August 24, 2022	INSP. TIME: 11:30
OPERATOR: Asphalt Specialties Co., Inc.	OPERATOR REPRESENTATIVE: Greg Geras/David King	TYPE OF OPERATION: 112c - Construction Regular Operation

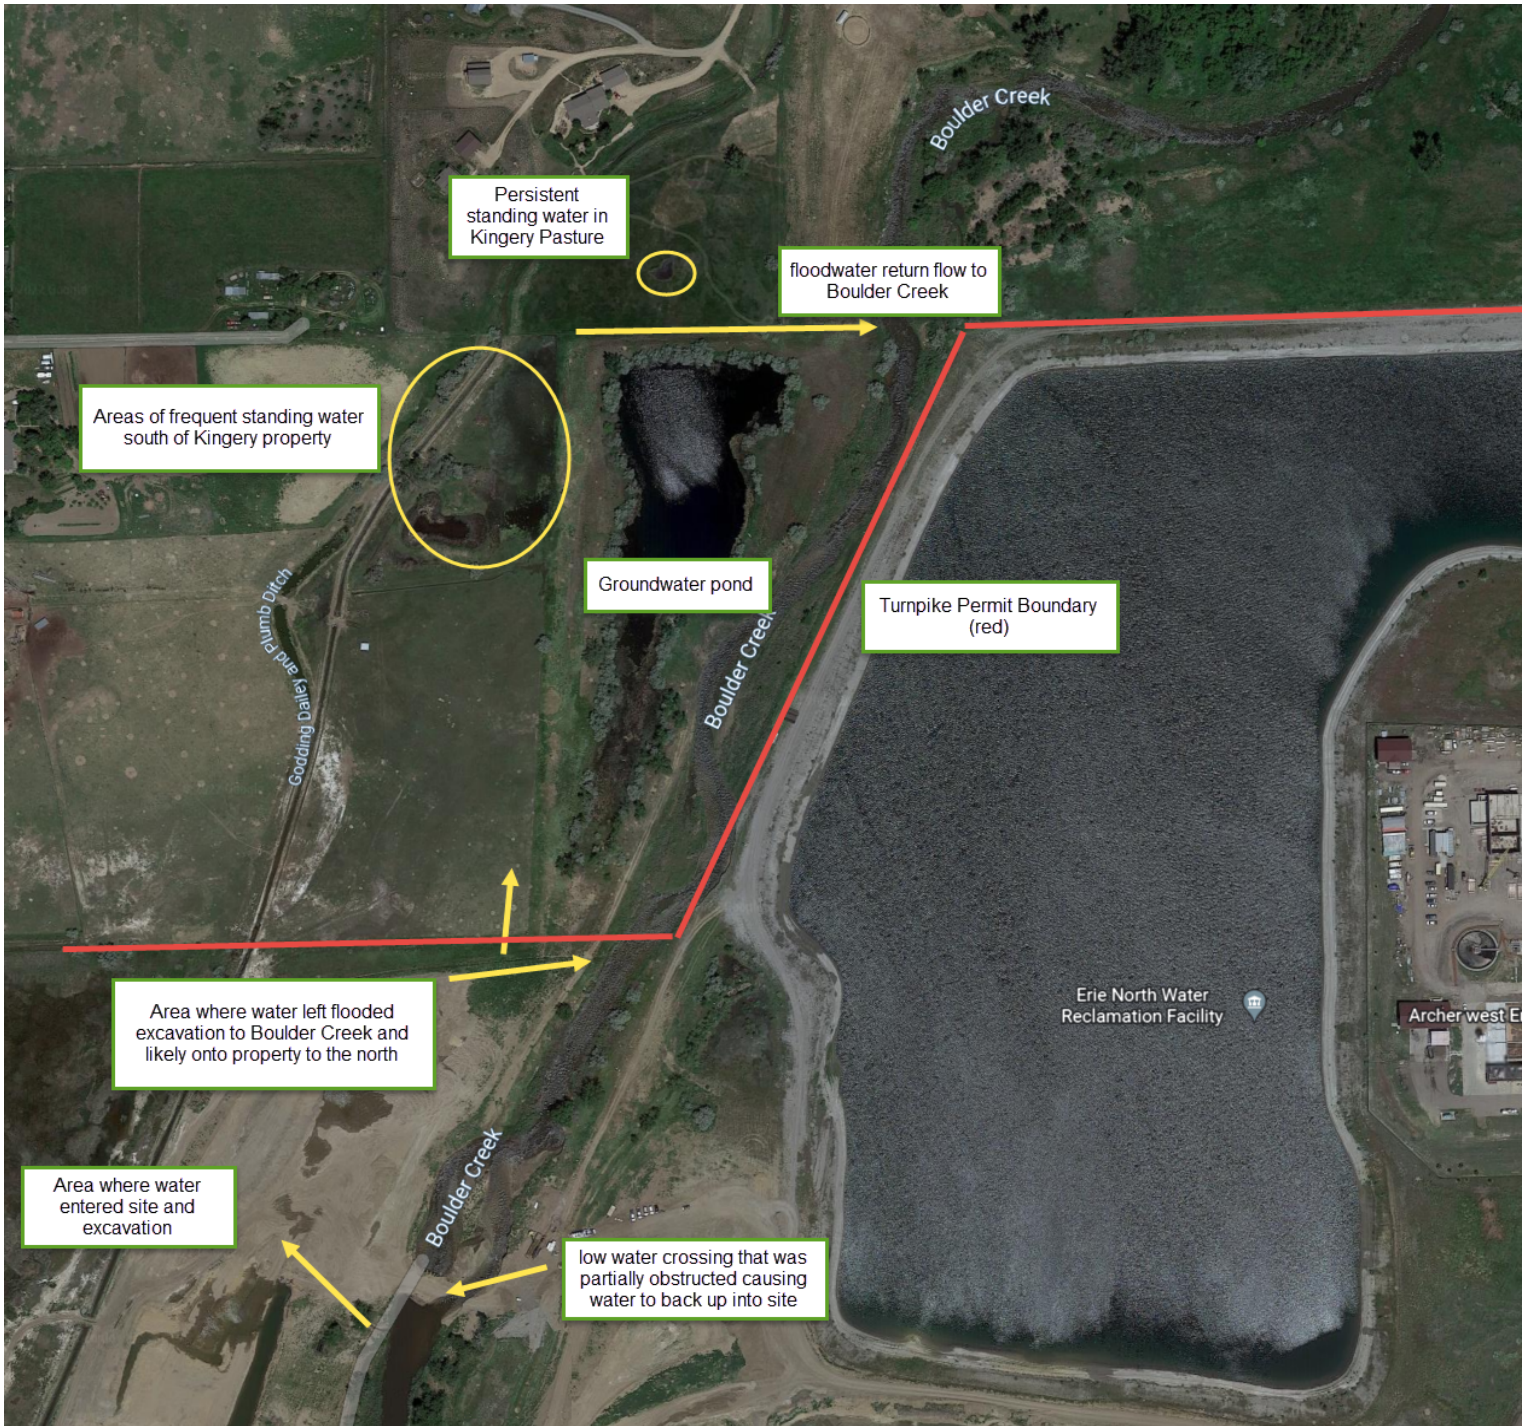
From the permittee's property, DRMS observed the condition of the adjacent Kingery pasture. Vegetation was left behind on the lower strand of the property fencing in the SE corner of the pasture. This appeared to be the lowest point of the property, where surface water would have left the pasture flowing back to Boulder Creek. This indicates that water had reached a depth of approximately 12 inches at some point, although no standing water was present at the time of the inspection. DRMS also noted that the pasture area of the Kingery property has a small area of persistent standing water within it which was also observed in historic air photos (photo 5), and that the ground surface of the pasture area is very near in elevation to the groundwater pond located immediately to the south. This indicates that the normal static water levels are very near the ground surface in this area. The pasture area of the Kingery property is also within the current floodplain and the revised regulatory floodway of Boulder Creek, and lies within an area that has been classified as having a >4%-10% chance of annual flooding as shown on the <https://coloradohazardmapping.com/> website.

Photo 1 – Persistent standing water area in Kingery pasture. No other standing water at time of inspection.
