## MINERALS PROGRAM INSPECTION REPORT

<b>MINE NAME:</b> Revenue Mine	<b>MINE/PROSPECTING ID#:</b> M-2012-032	<b>MINERAL:</b> Lead, silver and gold	<b>COUNTY:</b> Ouray
<b>INSPECTION TYPE:</b> Monitoring	<b>INSPECTOR(S):</b> Lucas West	<b>INSP. DATE:</b> August 25, 2022	<b>INSP. TIME:</b> 09:00
<b>OPERATOR:</b> Ouray Silver Mines Inc.	<b>OPERATOR REPRESENTATIVE:</b> Todd Jesse, Poppy Staub	<b>TYPE OF OPERATION:</b> 112d-1 - Designated Mining Operation	
<b>REASON FOR INSPECTION:</b> Normal I&E Program	<b>BOND CALCULATION TYPE:</b> None	<b>BOND AMOUNT:</b> \$517,219.00	
<b>DATE OF COMPLAINT:</b> NA	<b>POST INSP. CONTACTS:</b> None	<b>JOINT INSP. AGENCY:</b> None	
<b>WEATHER:</b> Clear	<b>INSPECTOR'S SIGNATURE:</b>

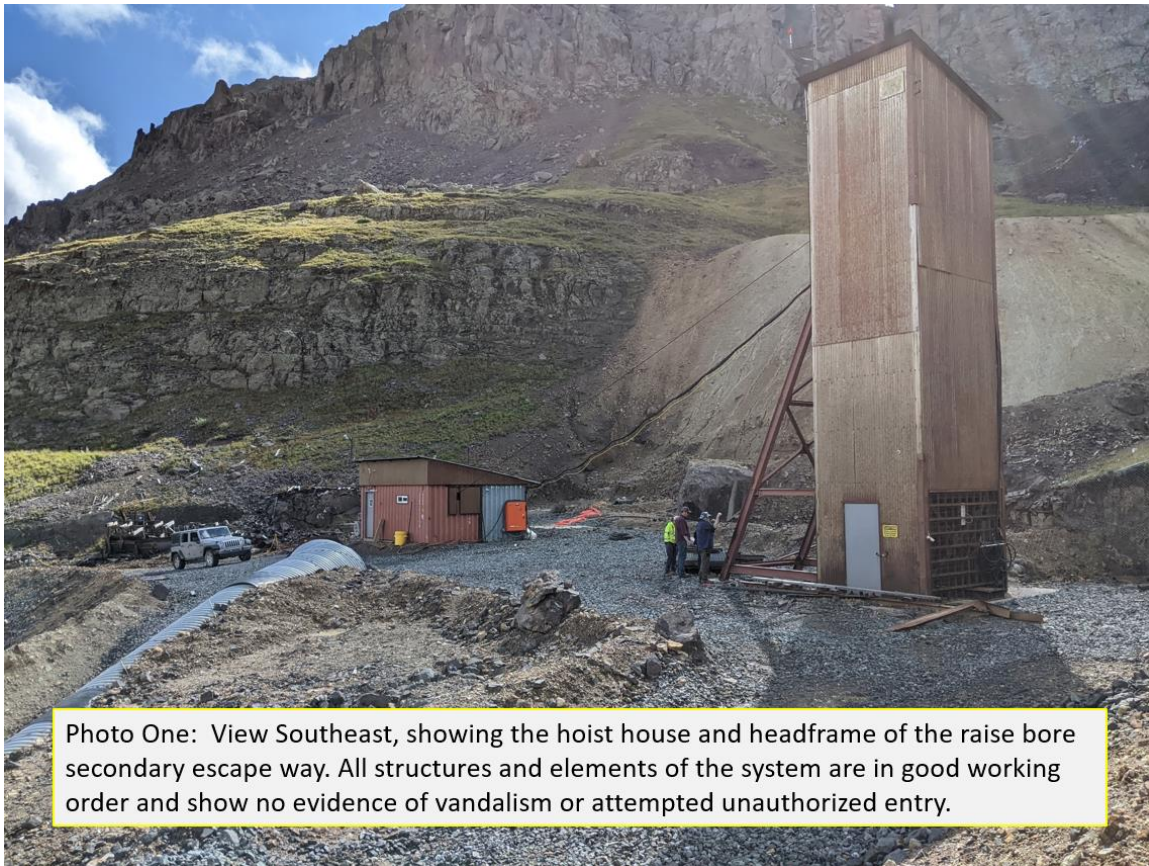
The secondary escape way located in Governor's Basin was observed during this inspection. As the site was not active during the inspection, no personnel were present in this area. The hoist house and headframe were in excellent condition, and verified secure. A locking metal grate was observed covering the raise bore for safety. The hoist house and headframe can be seen in Photo One. A small area of avalanche damage was noted on the hoist house, however it appeared to be superficial and does not compromise the structure or its related components. Similar to the secure hoist house, the refuge chamber and access tunnel was verified to be secure. The area of the tunnel and refuge chambers can be seen in Photo Two. Despite the heavy amounts of precipitation received in this area in the recent weeks all storm water control structures are in good condition and appear to be functioning as designed. No evidence of settling, slumping or erosion was noted in this area.
