## MINERALS PROGRAM INSPECTION REPORT

<b>MINE NAME:</b> Castle Gulch	<b>MINE/PROSPECTING ID#:</b> M2022-039	<b>MINERAL:</b> Unknown	<b>COUNTY:</b> Boulder
<b>INSPECTION TYPE:</b> Possible Illegal(Unpermitted Operation)	<b>INSPECTOR(S):</b> Patrick Lennberg	<b>INSP. DATE:</b> September 15, 2022	<b>INSP. TIME:</b> 08:30
<b>OPERATOR:</b> Unknown	<b>REPRESENTATIVES:</b> Eric Harms, Laura Engel	<b>TYPE OF OPERATION:</b> ILL – Illegal (Possible)

## **OBSERVATIONS**

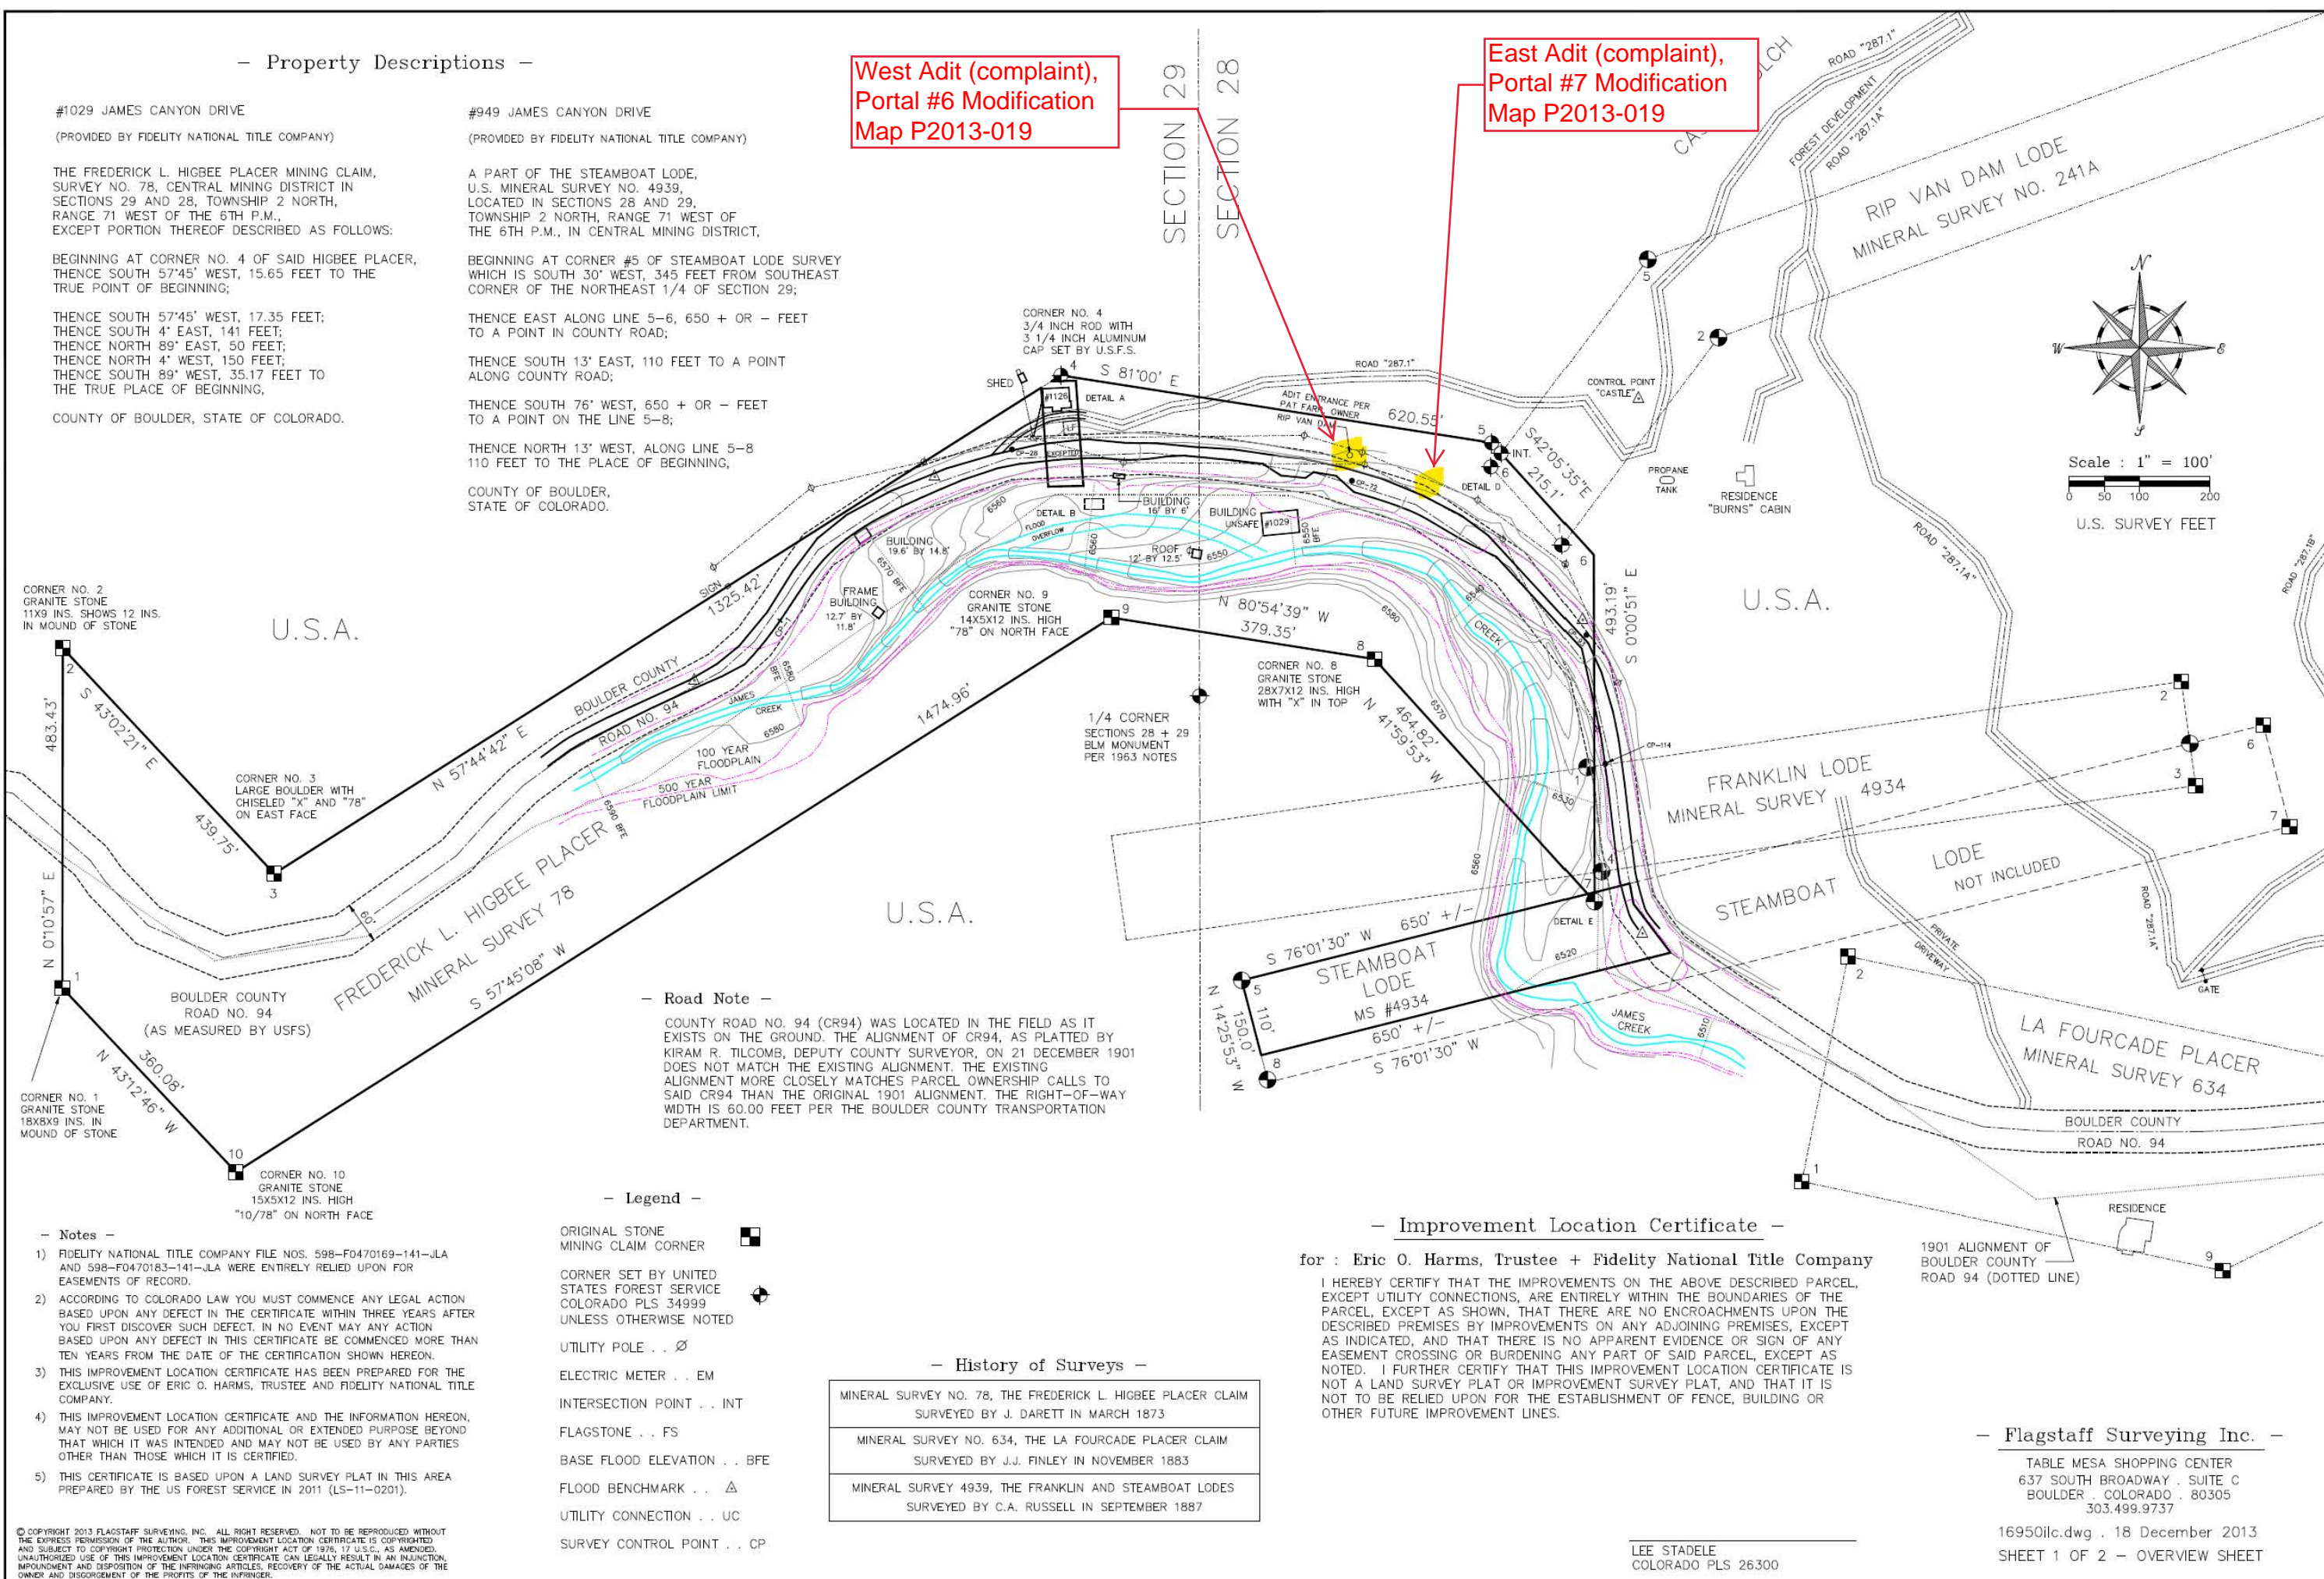
West Adit (complaint),  
Portal #6 Modification  
Map P2013-019

East Adit (complaint),  
Portal #7 Modification  
Map P2013-019
