## MINERALS PROGRAM INSPECTION REPORT

<b>MINE NAME:</b> Castle Gulch	<b>MINE/PROSPECTING ID#:</b> M2022-039	<b>MINERAL:</b> Unknown	<b>COUNTY:</b> Boulder
<b>INSPECTION TYPE:</b> Possible Illegal(Unpermitted Operation)	<b>INSPECTOR(S):</b> Patrick Lennberg	<b>INSP. DATE:</b> September 15, 2022	<b>INSP. TIME:</b> 08:30
<b>OPERATOR:</b> Unknown	<b>REPRESENTATIVES:</b> Eric Harms, Laura Engel	<b>TYPE OF OPERATION:</b> ILL – Illegal (Possible)

NOI P2013-019

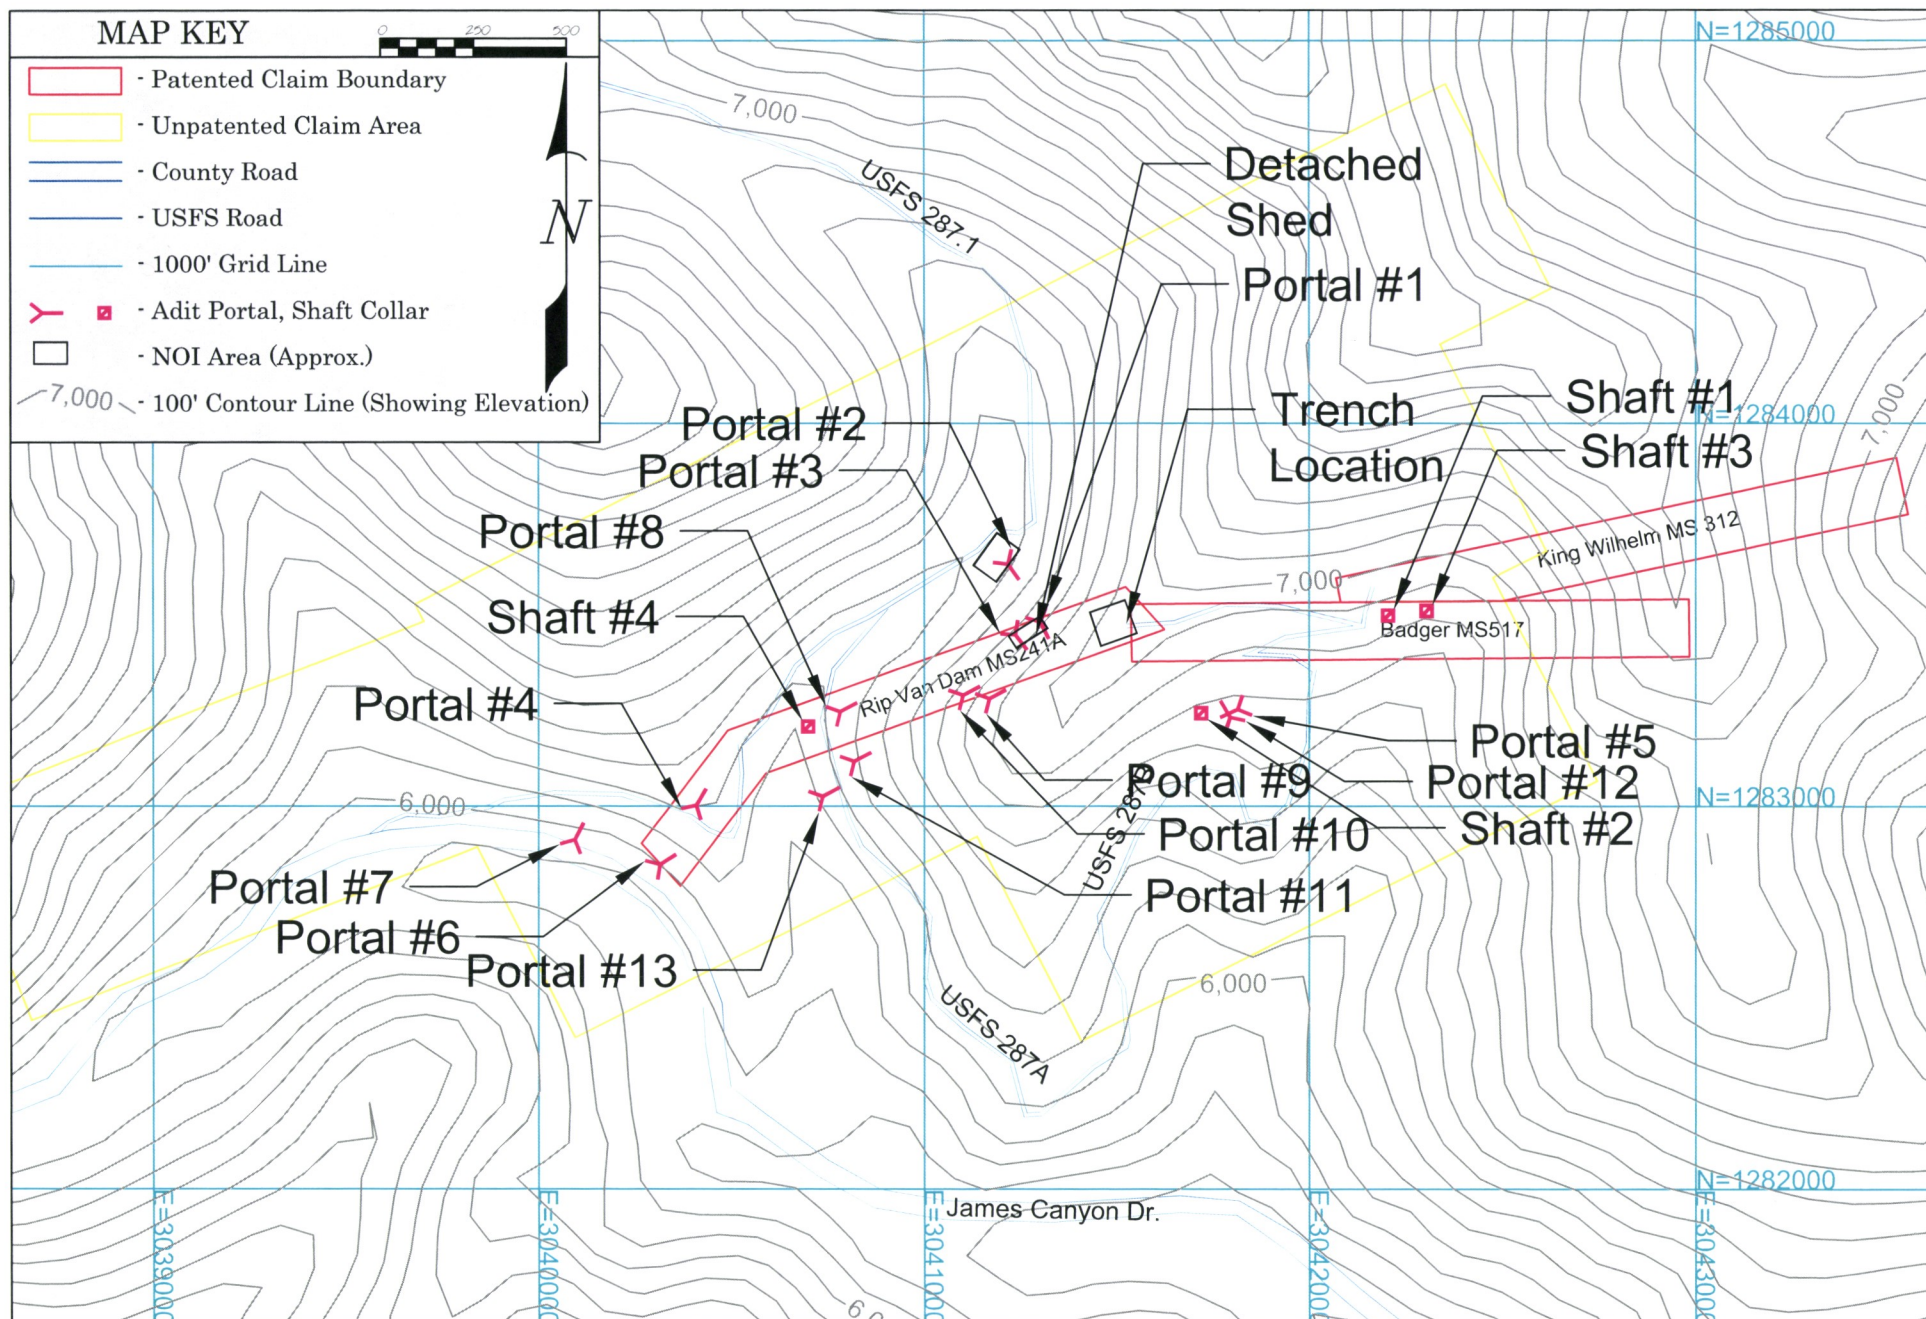
Site Topography and Features

Lastly, the Division performed an inspection of the NOI P-2013-019. JL Mining indicated the only activity they had performed was collecting and running samples through a wash plant at the Rip Van Dam adit, marked Portal #2 on Map 2. The Division noted a temporary shed and converted trailer used for shelter at the entrance to the portal. There was a variety of equipment located at the adit entrance including two water tanks, a couple of troughs, and other assorted equipment. The Division also hiked to locate the mini-excavator. The excavator was found along the road leading to the King Wilhelm claim. The excavator was

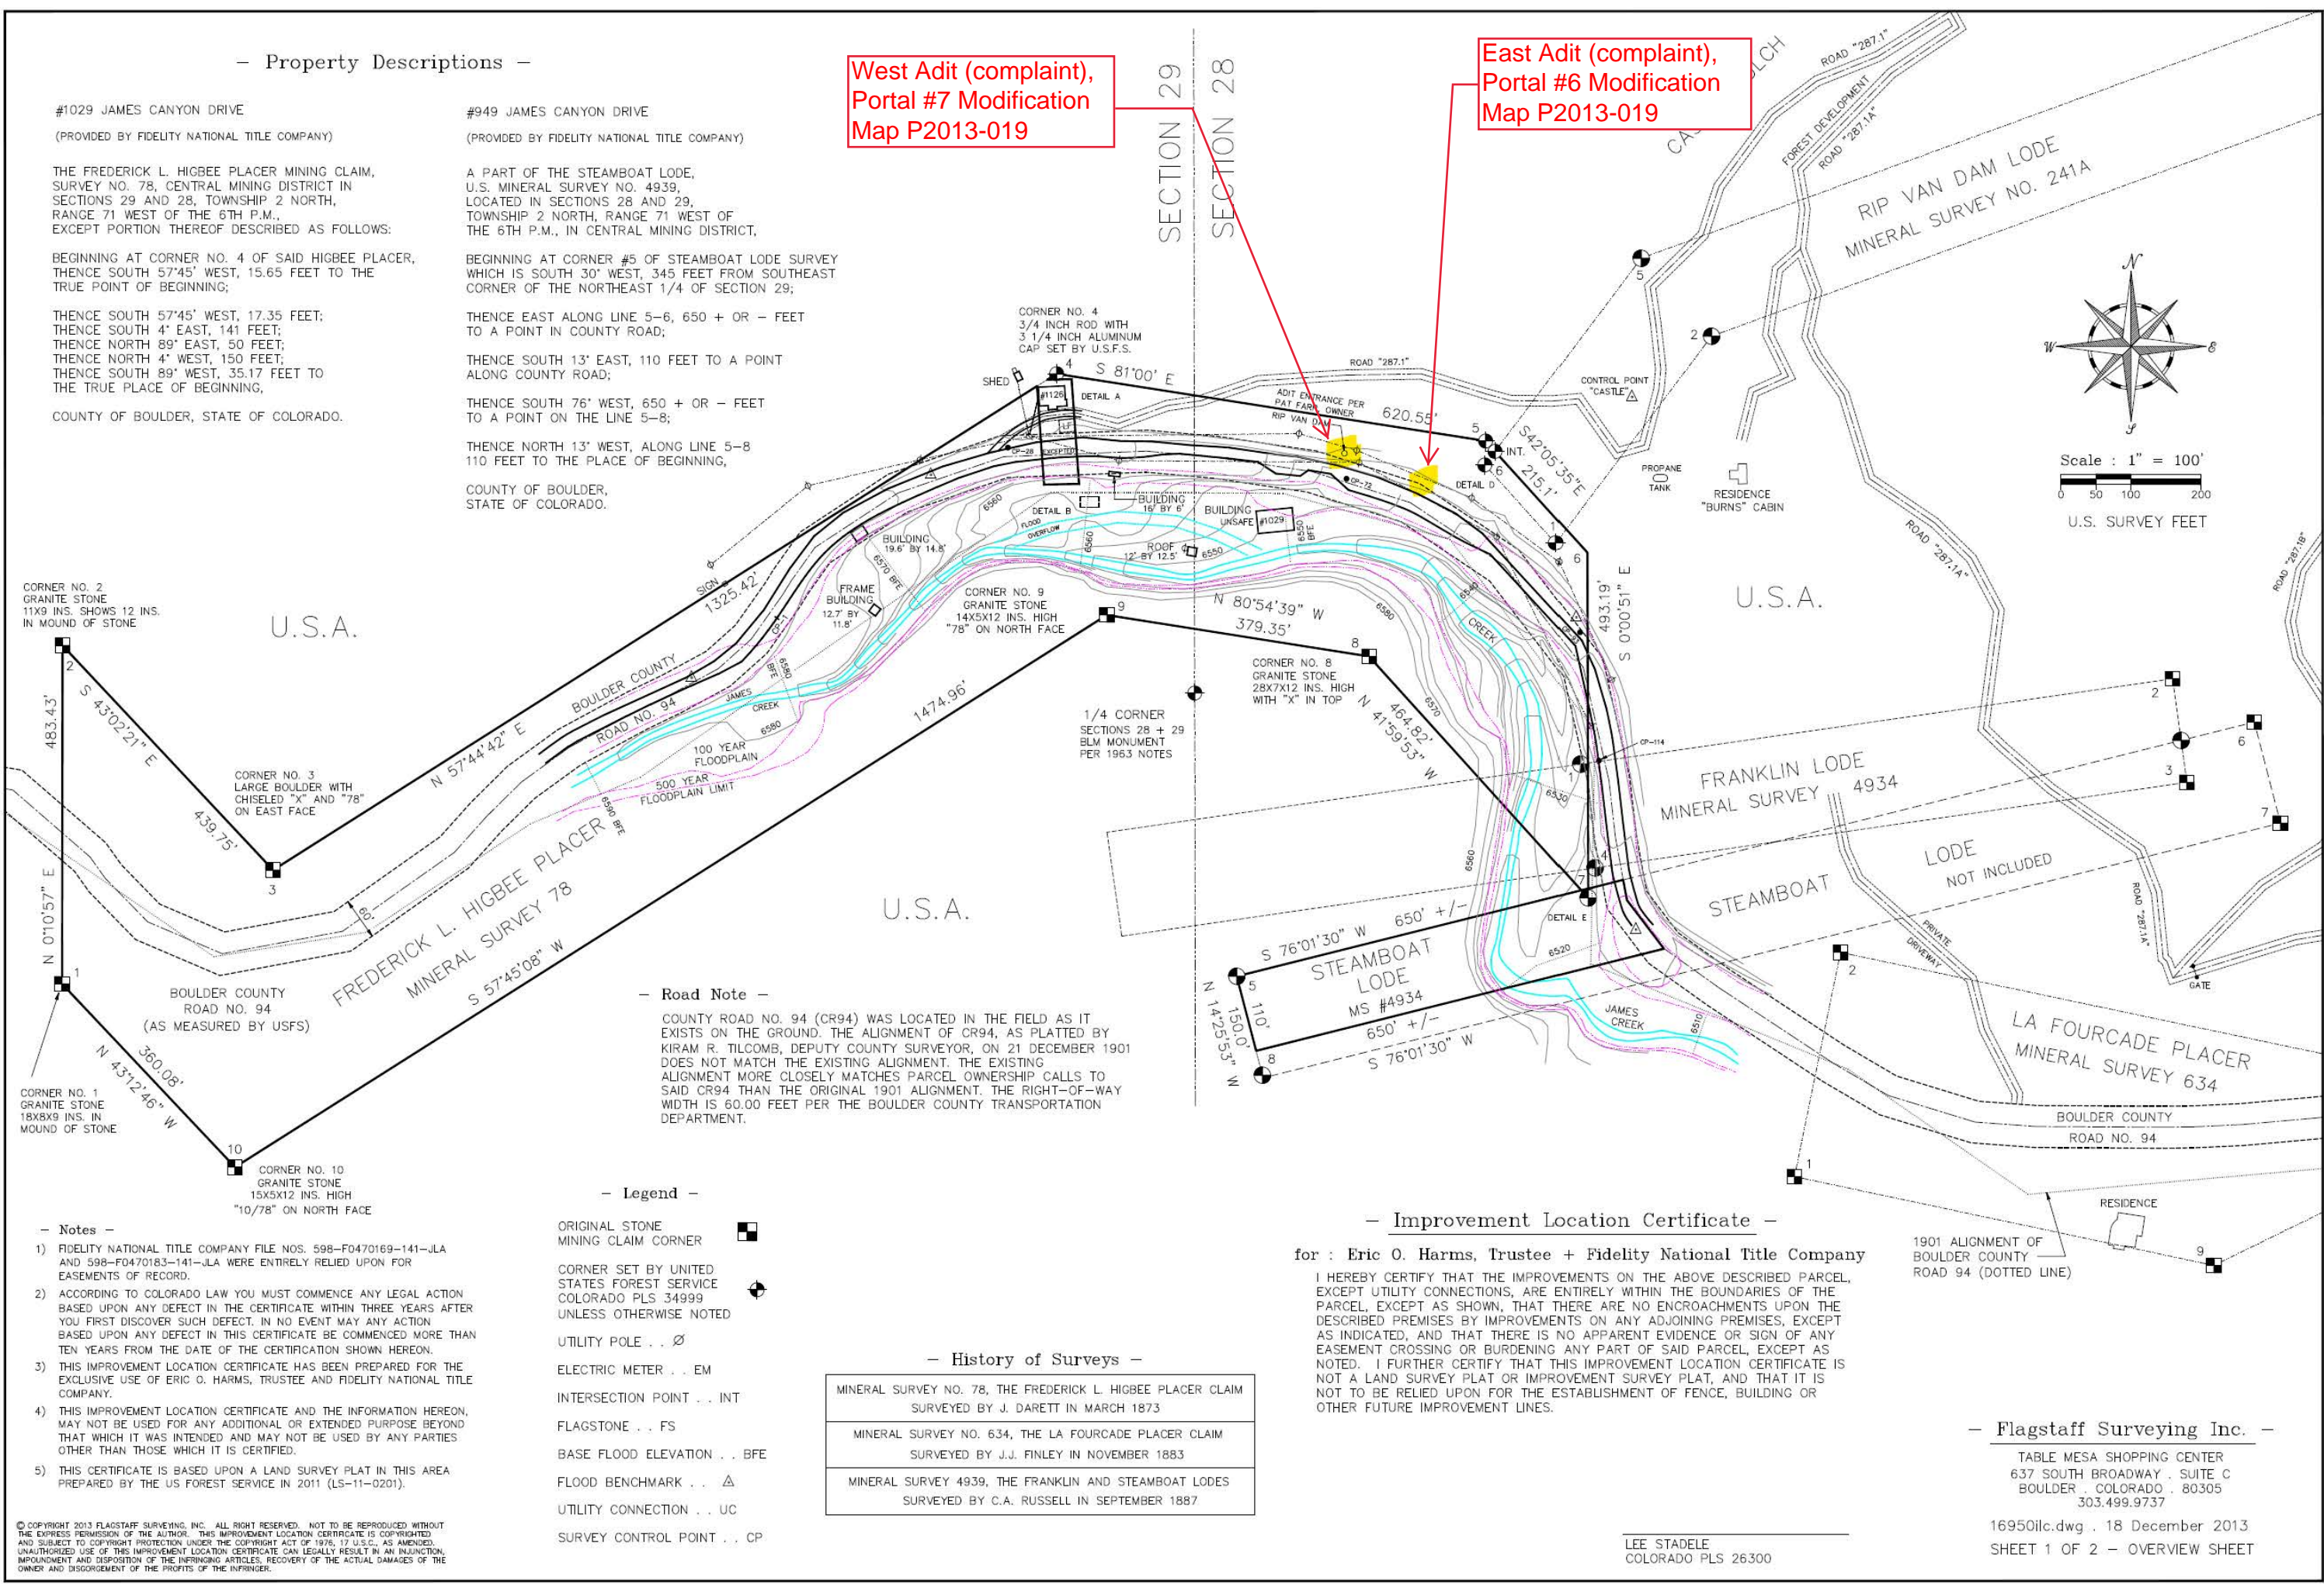
Part of the initial complaint was that JL Mining attempted to access two adits that are located on private property. A map included in the initial complaint (see Map 3) shows the location of the two adits in question. Additional annotations of Map 3 were completed by the Division as part of this inspection report. The West Adit on Map 3 corresponds with Portal #6 on Map 2 and has a stone bulkhead in the entrance. As both maps indicate the adit does not appear to be located on the Rip Van Dam claim and is located on the Higbee Placer claim. It should be noted the adit may also be in the ROW of James Canyon Drive. Upon inspection there was

West Adit (complaint),  
Portal #7 Modification  
Map P2013-019

East Adit (complaint),  
Portal #6 Modification  
Map P2013-019
