MINERALS PROGRAM INSPECTION REPORT

MINE NAME: Equity Exploration Project	MINE/PROSPECTING ID#: P-2011-010	MINERAL: Silver, gold, lead and	COUNTY: Mineral
INSPECTION TYPE: Monitoring	INSPECTOR(S): Lucas West	INSP. DATE: August 31, 2022	INSP. TIME: 11:10
OPERATOR: Rio Grande Silver, Inc.	OPERATOR REPRESENTATIVE: Randy McClure	TYPE OF OPERATION: MP - Mineral Prospecting

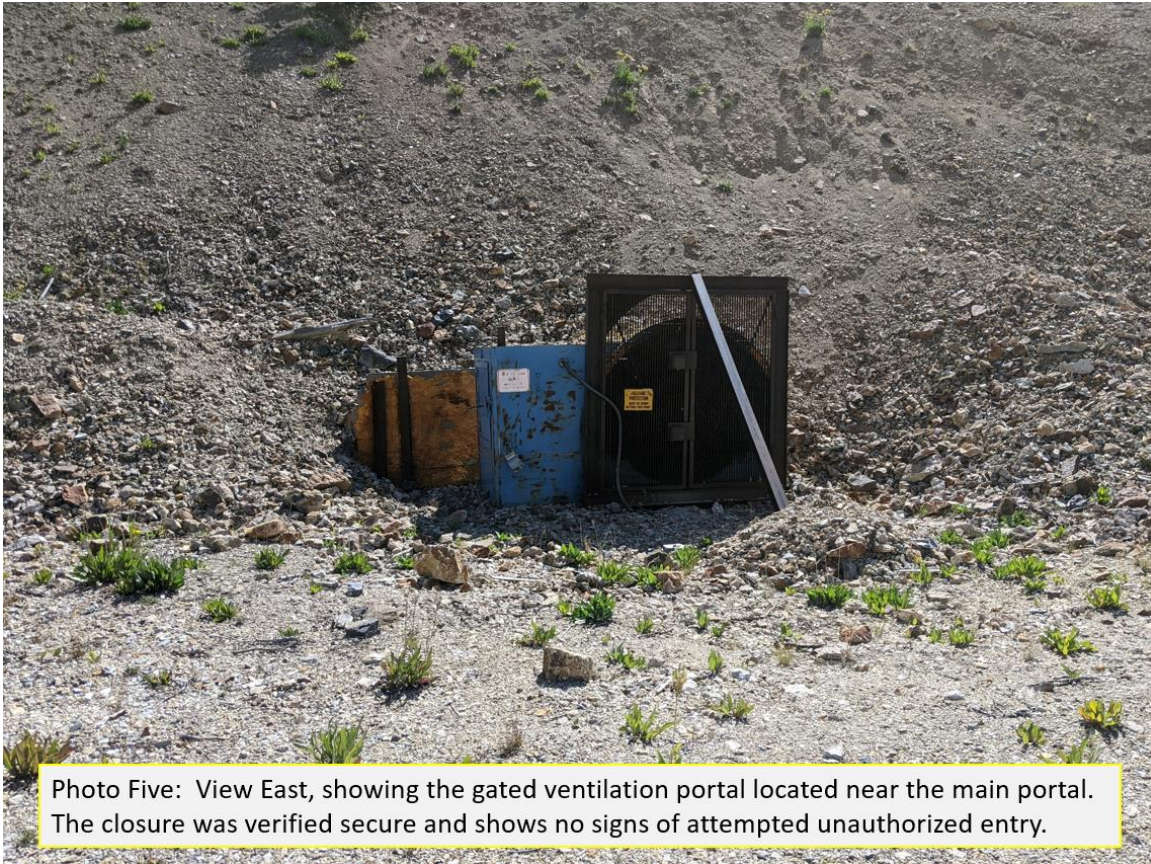
The main portal was observed with a locking metal gate closure that was verified secure at the time of the inspection. The portal can be seen in Photo Four. The closure is in excellent condition and no evidence of vandalism or attempted unauthorized entry was observed. The portal does not have an associated discharge or water management facilities. The ventilation adit, shown in Photo Five was also observed to be in excellent condition. It is closed off and secured with a locking metal gate closure and similar to the main portal, showed no signs of damage or vandalism.
