Pikeview monitoring report

Reference: August 2022 Geotechnical Monitoring Summary Pikeview Quarry

Client/Project
**CONTINENTAL MATERIALS
CORP.
PIKEVIEW QUARRY SLOPE
MONITORING**

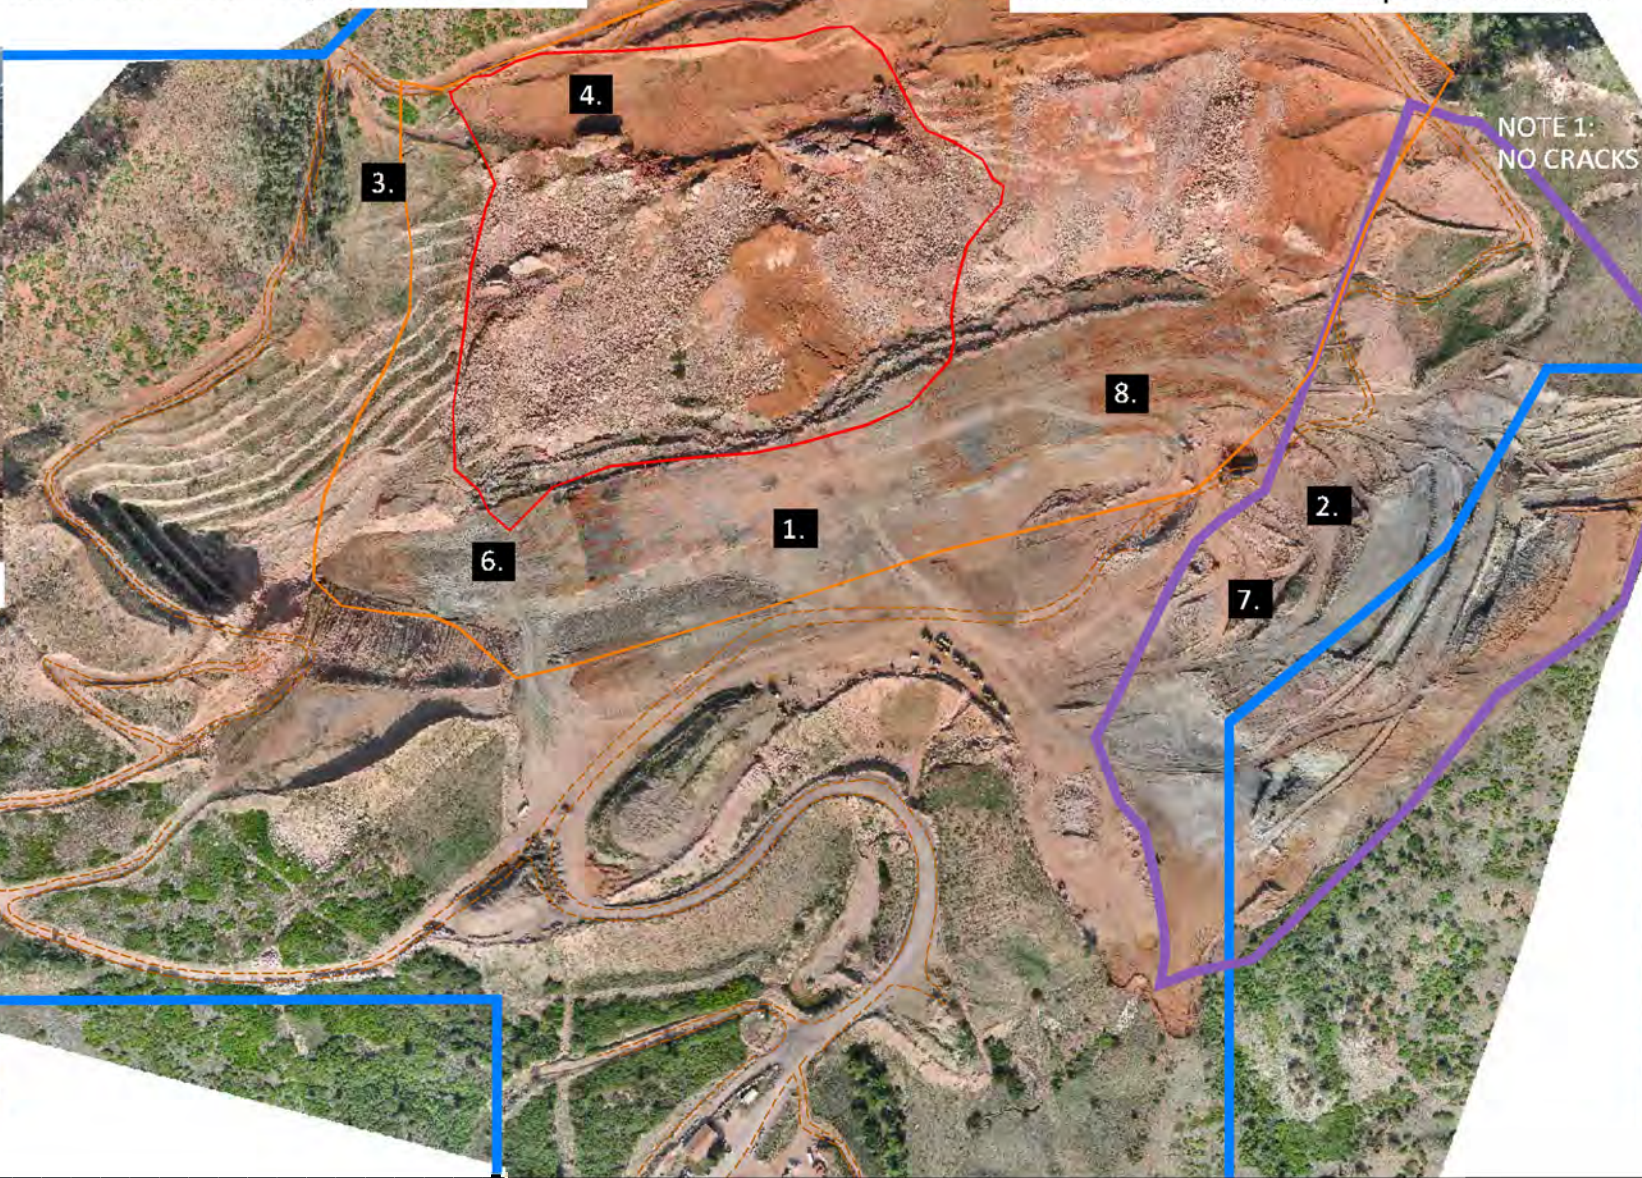
7. Excavator loads haul trucks at north borrow area.

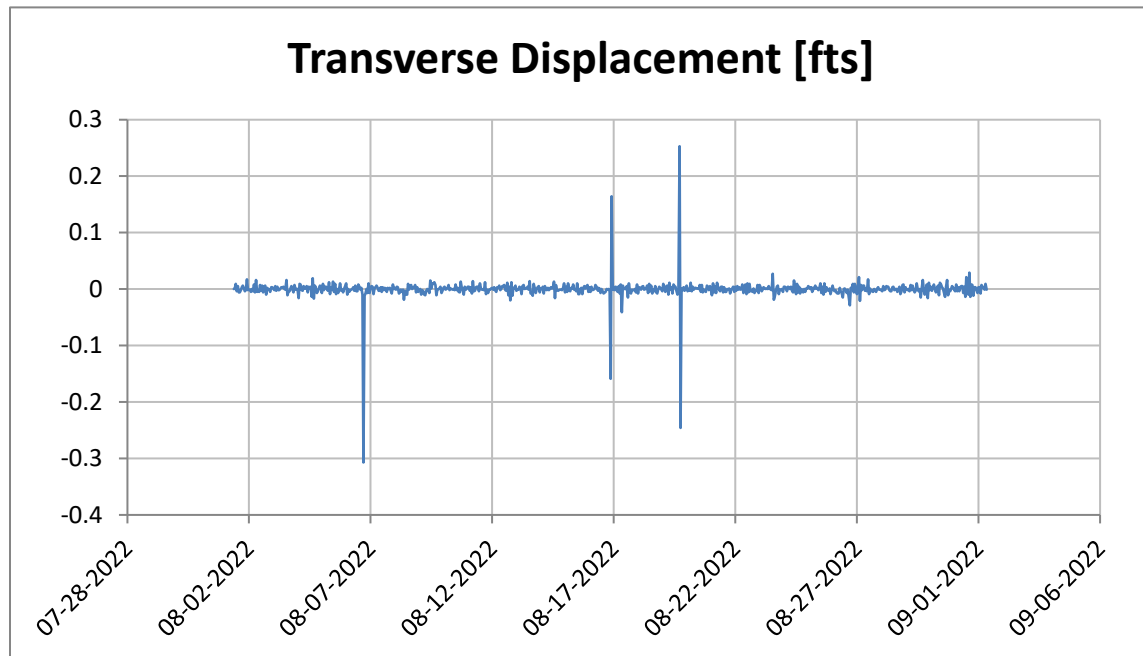
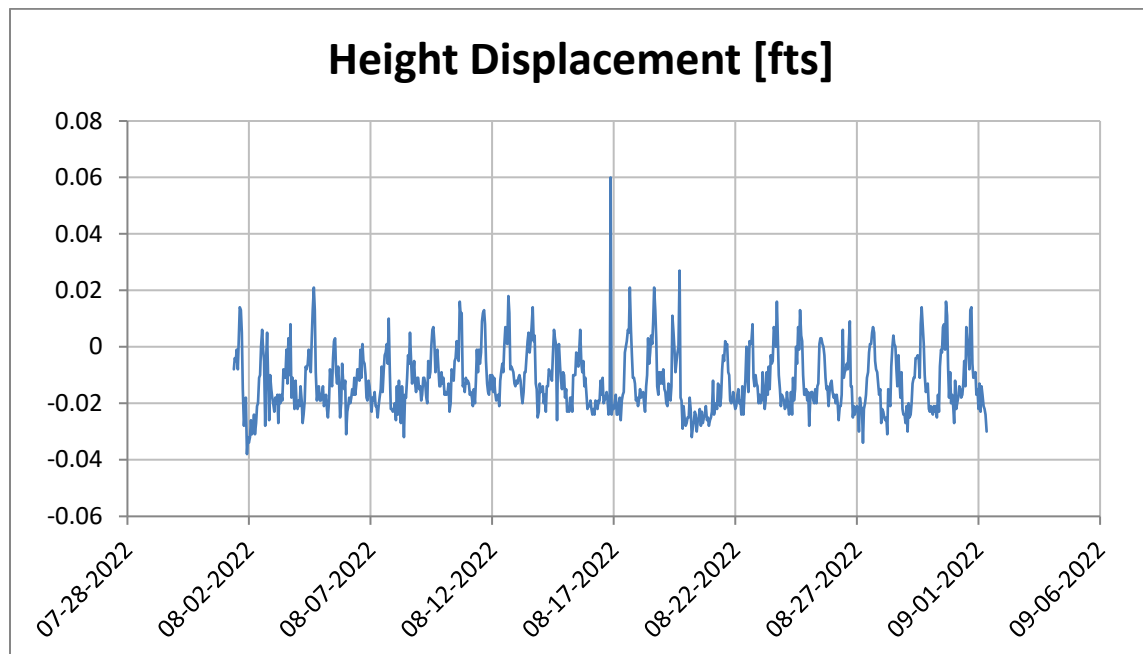
Prism CP6

1. Survey accuracy is +/-0.016 feet.
2. Alarm threshold is +/-0.35 feet.
3. Transverse displacement is in the horizontal direction. Positive direction means closer to the robotic station.
4. Height displacement is in the vertical direction. Positive direction means higher in elevation.
5. Prism records slope creep movements with slow velocity.

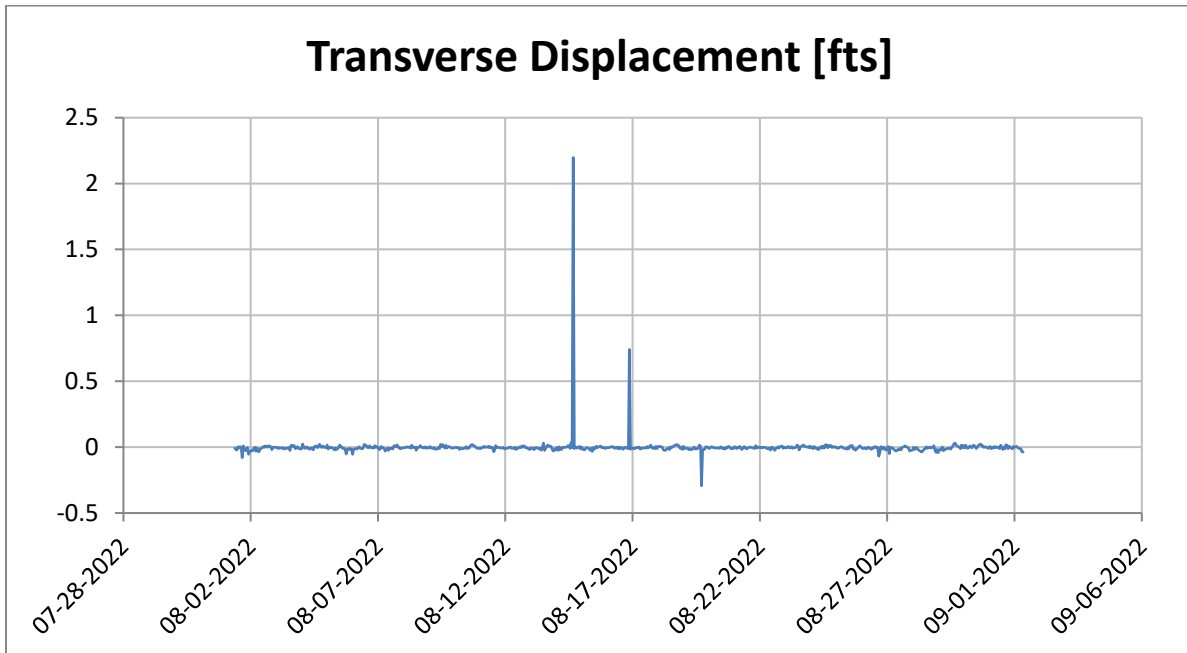
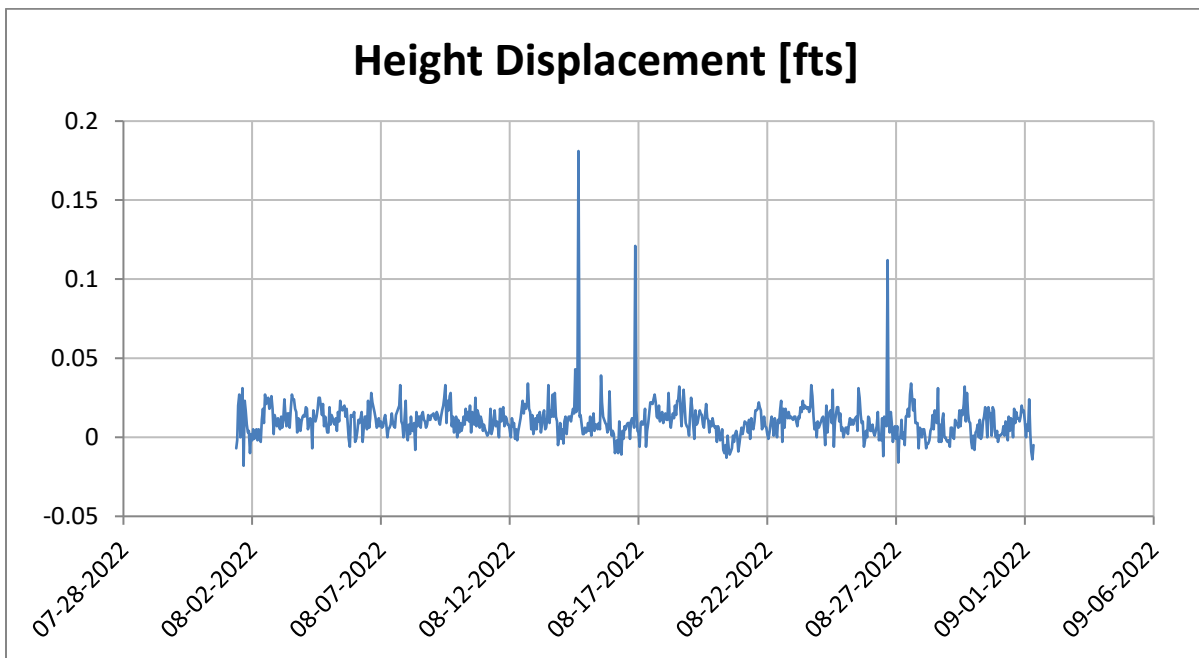
Prism NP3

1. Survey accuracy is ± 0.016 feet.
2. Alarm threshold is ± 0.35 feet.
3. Transverse displacement is in the horizontal direction. Positive direction means closer to the robotic station.
4. Height displacement is in the vertical direction. Positive direction means higher in elevation.
5. Exceedance alerts were received on 8/14, 8/15, 8/16, 8/17, and 8/19.
