MINERALS PROGRAM INSPECTION REPORT
PHONE: (303) 866-3567

MINE NAME: Idarado Mining Co	MINE/PROSPECTING ID#: M-1977-403-HR	MINERAL: Lead, zinc, copper, c gold	COUNTY: San Miguel
INSPECTION TYPE: Monitoring	WEATHER: Clear	INSP. DATE: September 29, 2022	INSP. TIME: 11:05
OPERATOR: Idarado Mining Company	OPERATOR REPRESENTATIVE: Karen DeAgüero	TYPE OF OPERATION: 112d-3 - Designated Mining Operation	
REASON FOR INSPECTION: Normal I&E Program	BOND CALCULATION TYPE: Complete Bond	BOND AMOUNT: \$226,600.00	
DATE OF COMPLAINT: NA	POST INSP. CONTACTS: None	JOINT INSP. AGENCY: None	
INSPECTOR(S): Lucas West	INSPECTOR'S SIGNATURE:

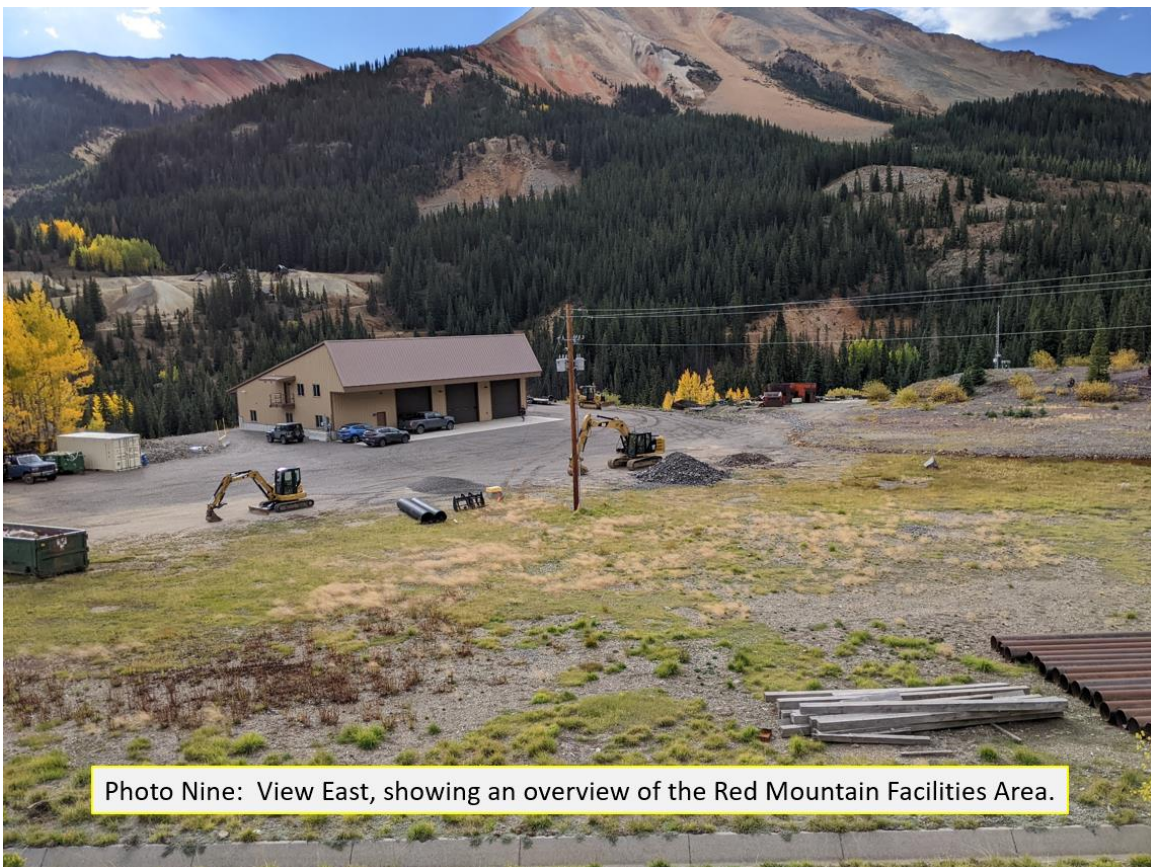
Red Mountain Facilities: The Red Mountain Permit area was also not active during the inspection. The permit area includes all facilities in the vicinity of the Treasury Tunnel, this area can be seen in Photos Nine and Ten as well as the borrow pit that is located on the West side of Highway 550. The site has experienced ongoing maintenance and reclamation activities in the form of the final removal of several structures, and routine property maintenance. The ongoing property maintenance includes monitoring and repair of storm water controls, monitoring for erosional features and other maintenance activities. The most significant work that has been completed is the demolition and removal of the old shop facility and the construction of the new shop in a different portion of the Permitted Area. The old shop has been completely demolished and removed, the only remaining portion of the shop is the concrete foundation which is slated for removal. Located within the shop was a historical air compressor used when the site was active. The compressor has been permitted to remain as historic feature. The footprint of the old shop and compressor can be seen in Photo Eleven.
