MINERALS PROGRAM INSPECTION REPORT

MINE NAME: Slab Canyon Quarry	MINE/PROSPECTING ID#: M-1977-347	MINERAL: Limestone (general)	COUNTY: Larimer
INSPECTION TYPE: Monitoring	INSPECTOR(S): Amy Eschberger	INSP. DATE: August 31, 2022	INSP. TIME: 12:15
OPERATOR: Holcim (US) Inc.	OPERATOR REPRESENTATIVE: Mike Toelle, Tom Newman	TYPE OF OPERATION: 112c - Construction Regular Operation	
REASON FOR INSPECTION: Normal I&E Program	BOND CALCULATION TYPE: None	BOND AMOUNT: \$184,819.00	
DATE OF COMPLAINT: NA	POST INSP. CONTACTS: None	JOINT INSP. AGENCY: None	
WEATHER: Clear	INSPECTOR'S SIGNATURE:

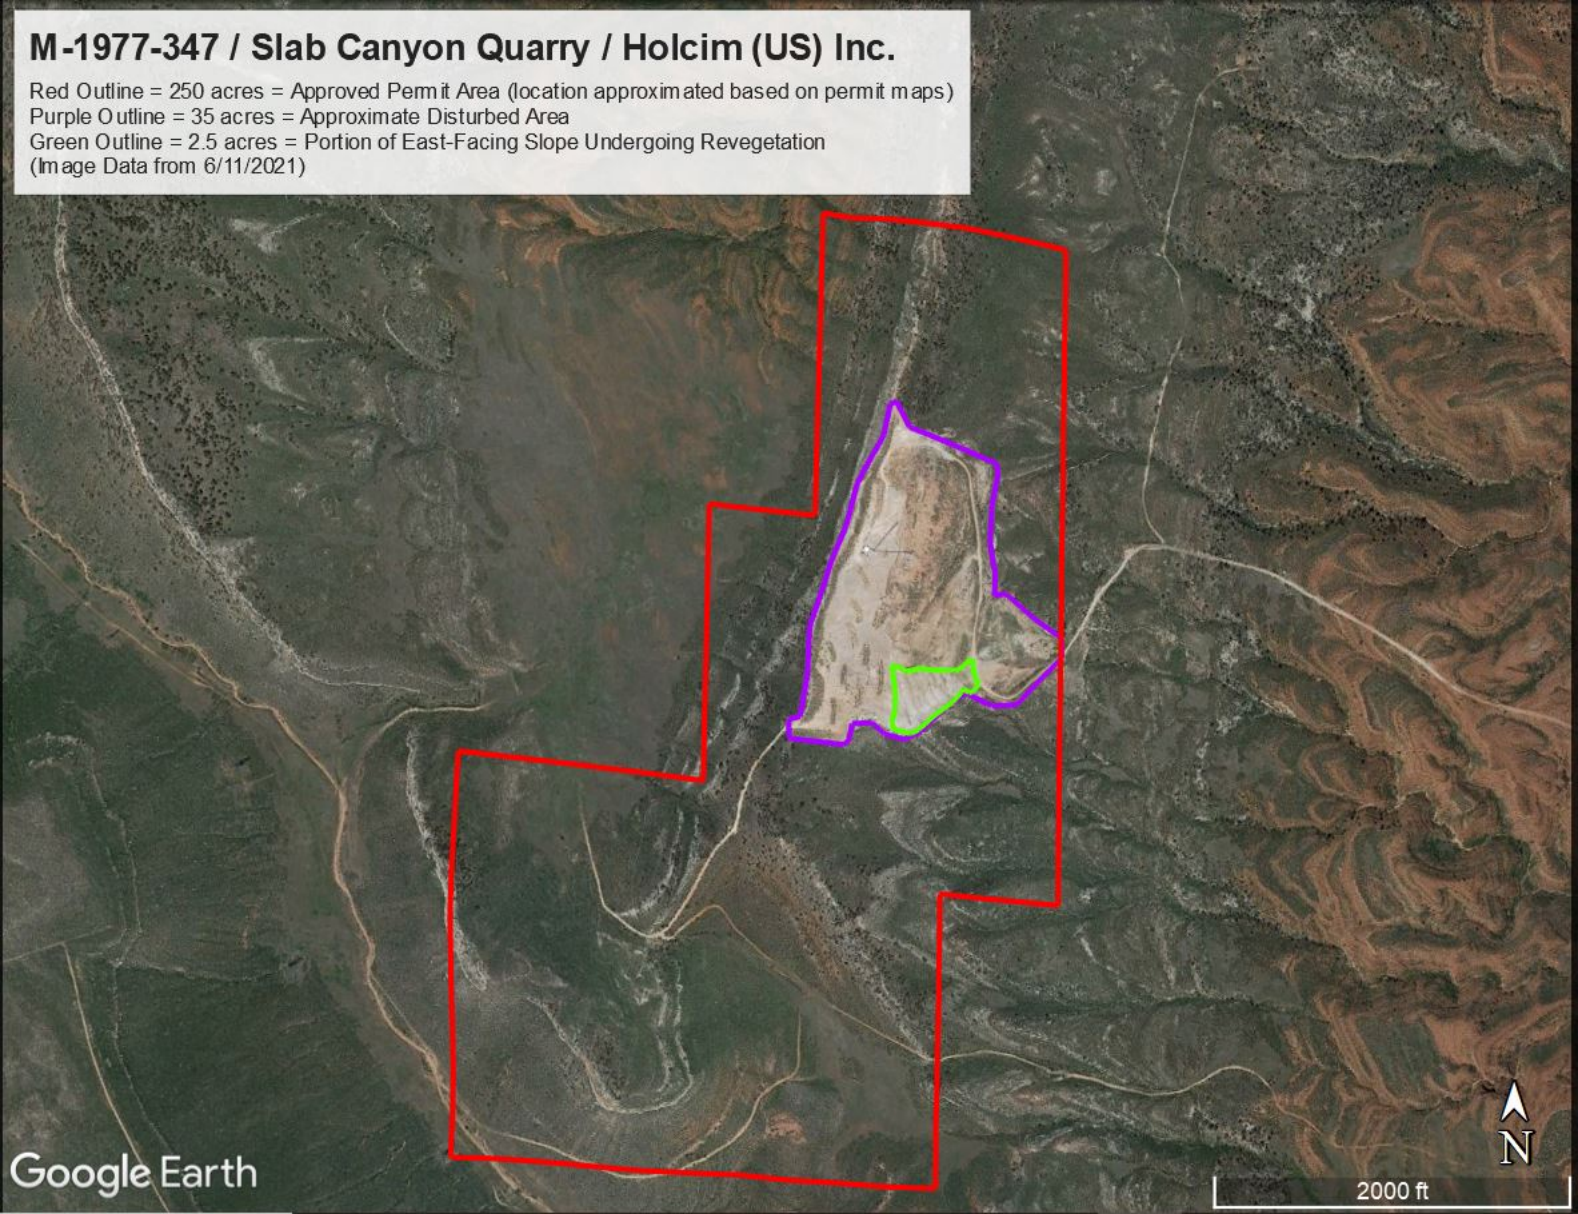
Closer View of Disturbed Area

During the current inspection, the Division observed the berms that had been constructed across the east-facing slope in accordance with TR-2. This modified configuration of the slope appeared to be more stable and no erosion issues were observed. However, none of the trees planted in 2019 had survived. There were some grasses observed growing in the depressions between the berms, and the last few downgradient berms had more grass and shrub cover. However, the majority of this slope was still void of vegetation. During the inspection, there was discussion about submitting an additional Technical Revision to further modify the revegetation plan for this slope, which has proven very difficult to revegetate. One of the possibilities discussed was removing trees from the revegetation plan since their success rate on this slope has been 0%, even with the modifications made per TR-2.

Red Outline = 250 acres = Approved Permit Area (location approximated based on permit maps)

Purple Outline = 35 acres = Approximate Disturbed Area

Green Outline = 2.5 acres = Portion of East-Facing Slope Undergoing Revegetation
(Image Data from 6/11/2021)

It is clear the operator has put forth significant efforts over the years to complete reclamation of the east-facing slope. Nonetheless, the operator should be reminded of Rule 3.1.3, which requires that all reclamation be carried to completion with all reasonable diligence, and that each phase of reclamation be completed within 5 years from the date that reclamation of such phase commenced. Given the amount of time that has passed since mining ceased and final reclamation of the site was initiated, the Division recommends the operator either reseed/replant the bare slope or submit a Technical Revision to revise the revegetation plan for this slope as soon as feasible.
