Re: Roadside Portals Mine, C-1981-041, Response to Letter of Concerns

Partial Phase III Bond Release No. 11

Proposed Decision
and
Findings of Compliance
for the

PERMIT NUMBER C-1981-041

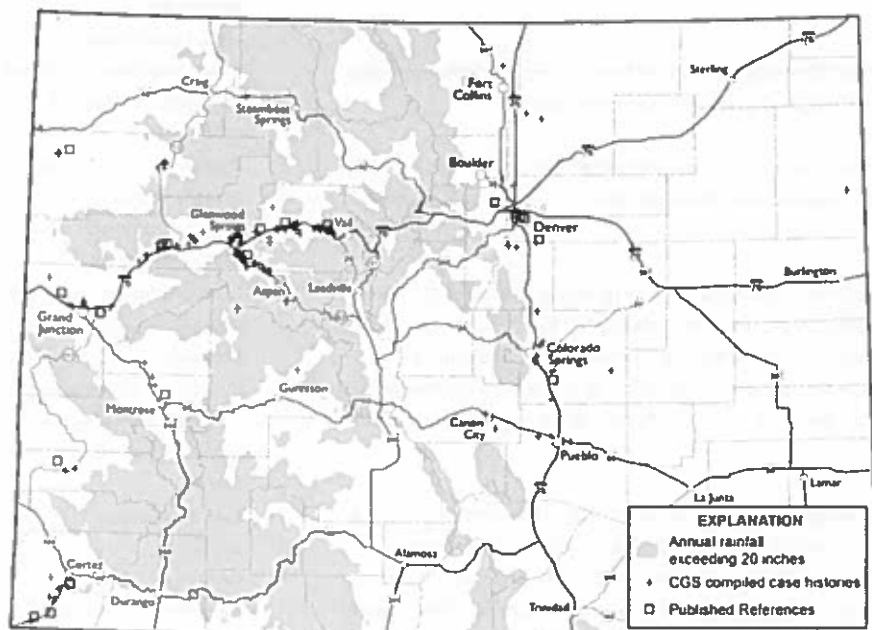
Collapsible soil case histories in Colorado. [Precipitation Data from USDA-NRCS, National Cartography And Geospatial Center, Ft. Worth, Texas, 1999]

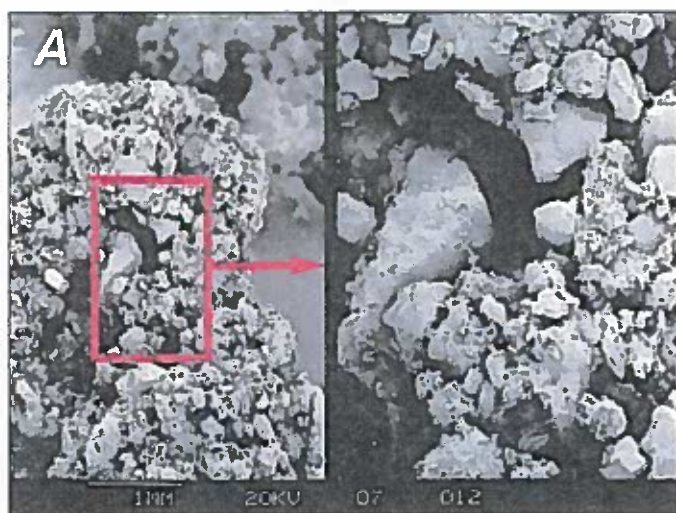
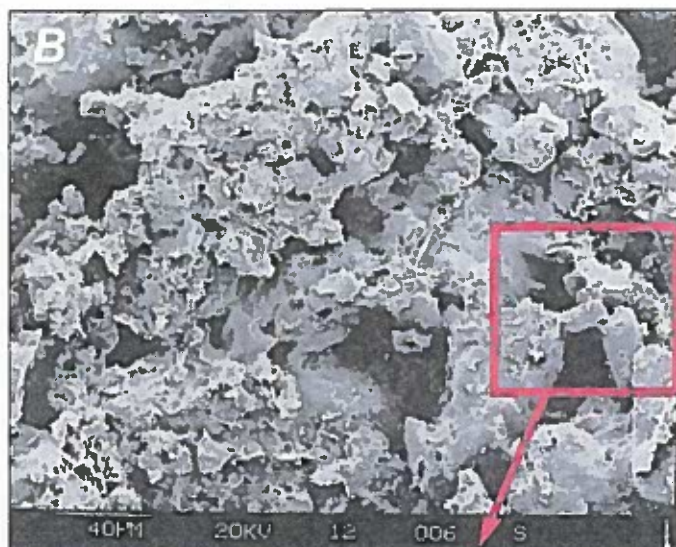
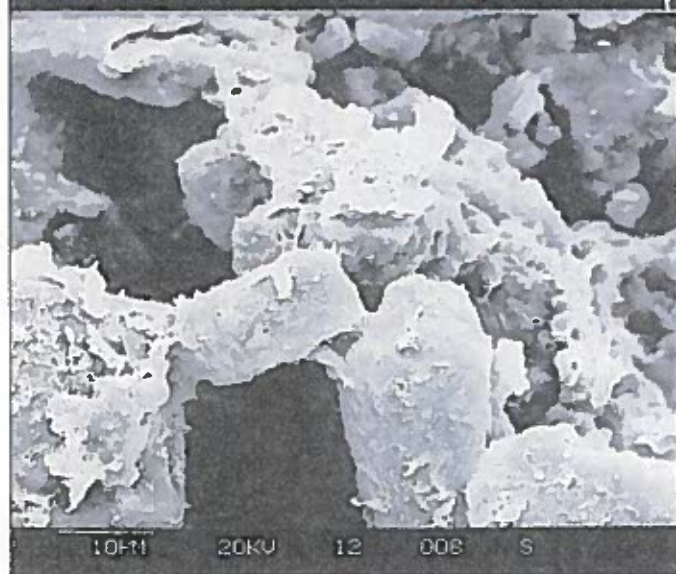
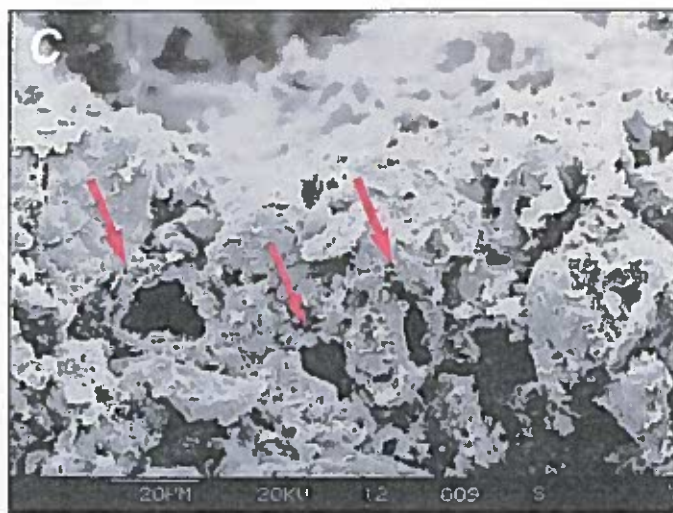
Figure 3-2. SEM images of collapsible clayey-silt soil. A and B, Void space is abundant between discrete soil grains. C, Clay-encrusted "shells" (arrows) line void pockets, and fragile bonds bridge between grains. Scale bar for A (left) is in millimeters. Scale bars for B and C are in micrometers ($1 \mu\text{m} = 0.0001 \text{ cm}$). By comparison, $1/32\text{nd}$ of an inch is $795 \mu\text{m}$, and the no. 200 sieve openings (upper gradational boundary of silt) are $75 \mu\text{m}$. Boxes indicate close-up views shown by arrows. Images courtesy of R. Luehring.

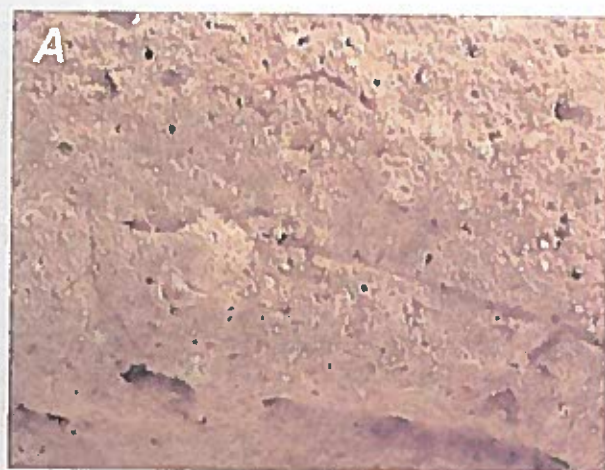
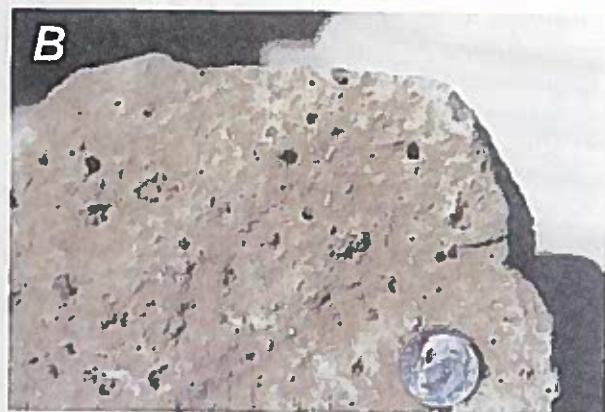
Figure 3-3. Visible, macroscopic voids in collapsible soils. A, A sandy-silt soil in which the primary voids were created at the time of deposition. B, A more clayey soil with secondary voids formed by microdissolution and biogenic activity.
