Subject: Summary of Instrumentation Monitoring  
4<sup>th</sup> Quarter 2022  
Bowie Coal Waste Disposal Area No. 2  
Paonia, Colorado

**SUBJECT: Summary Report, 4<sup>th</sup> Quarter 2022, Inclinator and Active Vibrating Wire Piezometer Data October through December 2022, Bowie Mine #2 Coal Waste Disposal Area (CWDA) #2**

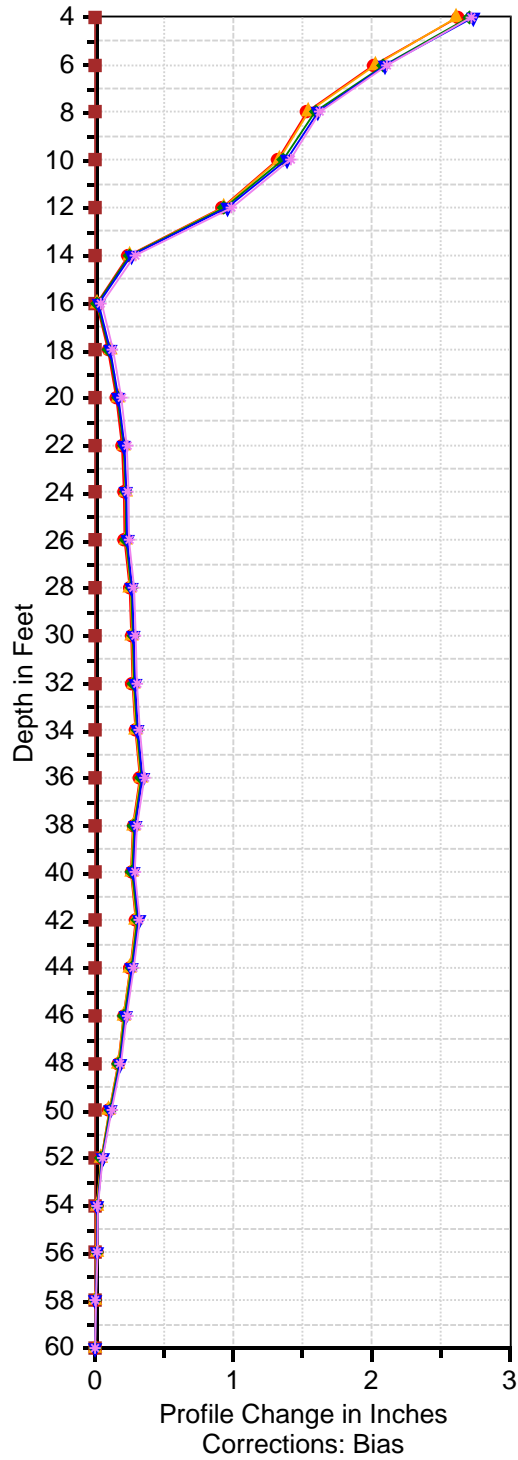
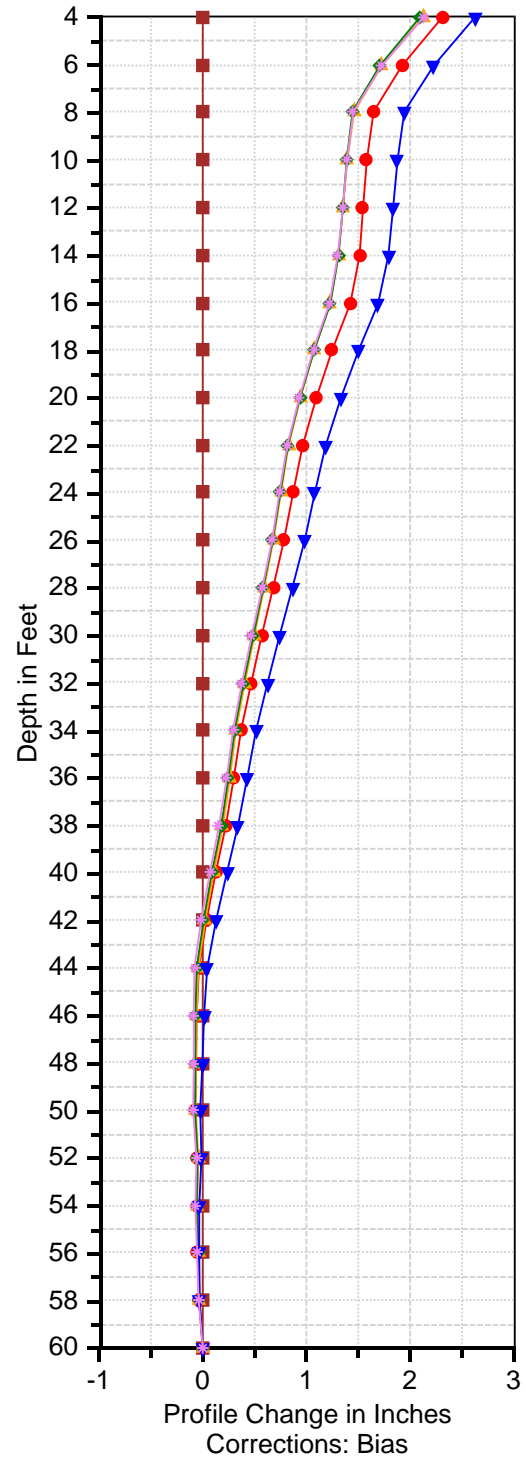
BOWIE BG05\_5 A

As described in previous reports, historic displacements indicated on the plots for the approximate upper 12-14 feet of the inclinometers since installation in 2005 are due to placement of cover soil on the face of the waste pile during revegetation operations in late 2006 and early 2007. This man-caused displacement is documented in a report by Buckhorn Geotech dated December 22, 2008 to Bowie Resources called *Revised Stability Evaluations for Coal Mine Waste Disposal Area No. 2, Bowie No. 2 Mine*.

Based on the current inclinometer readings, there has not been evidence of significant downslope movement (Axis A) in any of the inclinometers since 2007 and they are generally consistent with previous readings. Some "noise" which is understood to be relatively common in orthogonal direction (Axis B) readings, was observed over the past few years for all three inclinometers. This can be due to various mechanical or installation causes that are unrelated to slope movement. For example, grout voids, poor grout coverage, or soil settlement around the instrument can all contribute to vibrations and pipe movement that impacts inclinometer readings. Software bias adjustments were applied which filtered this noise. All readings were

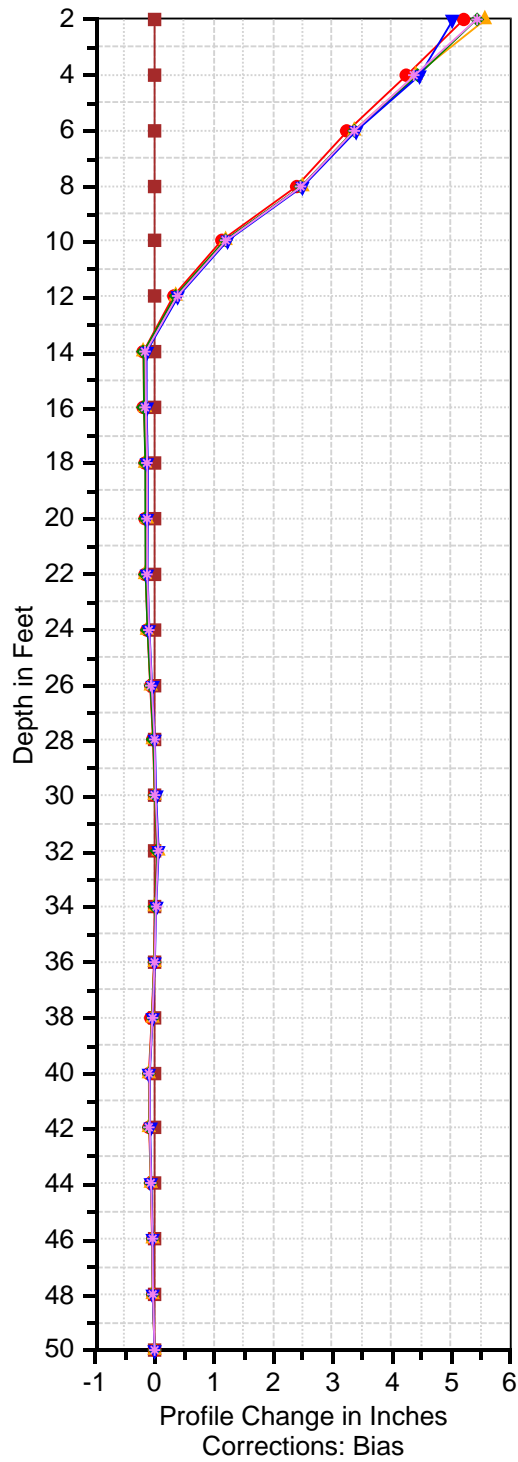
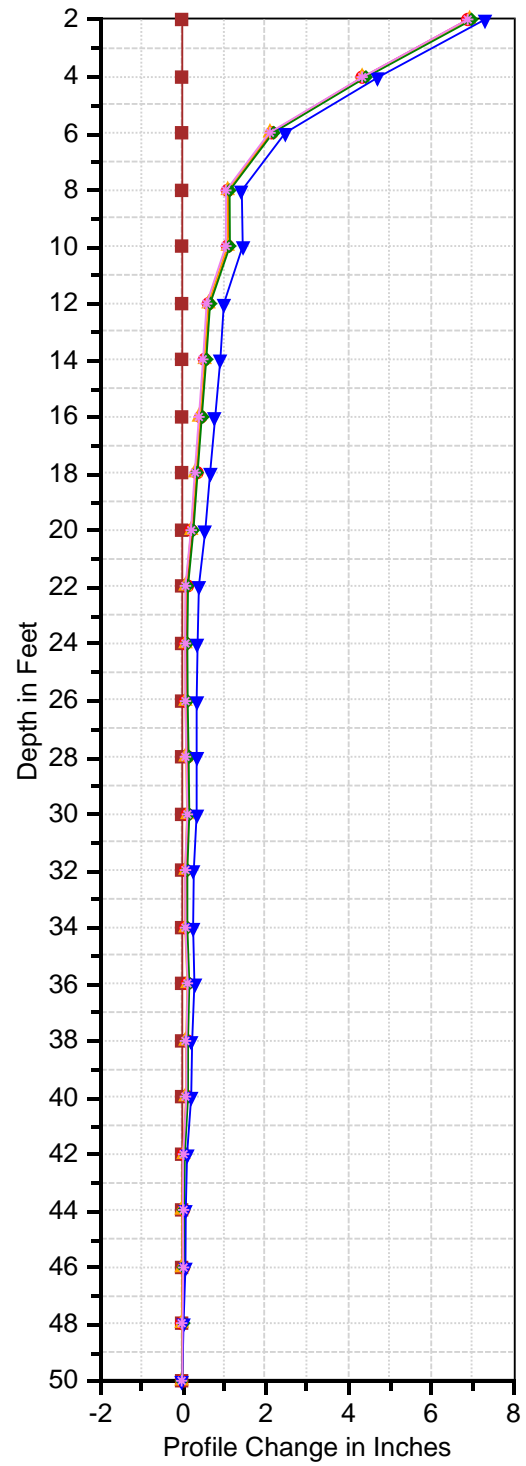
BOWIE BG05\_7 A

Standing water was measured at a depth of 7 feet below grade in the BG05-4 inclinometer pipe and at 10 feet in inclinometer BG05-7. Based on our observations there has usually been water in these pipes. Table 2 below, shows water levels in all three inclinometers for the past eight quarters. There was no water in the BG05-5 pipe and this inclinometer is typically dry. Worth noting is that in order for water to be in inclinometer pipes, the seal may be broken at the seams where the pipes snap together, the grout sleeve could have voids or has deteriorated so that it no longer forms a solid sleeve around the inclinometers, or there is a crack in the pipe, either due to slope movement or other pipe damage. Although it is not known for sure, we suspect the pipes cracked in 2006-2007 when the slope revegetation occurred and impacted the upper 12-14 feet of the inclinometers, thus allowing surface water to enter the pipes.
