To: Jerald Schnabel
Continental Materials Corp.
From: Paul Kos
Denver, CO 80222
File: December 2022 Monitoring Summary
Date: January 31, 2023

Reference: December 2022 Geotechnical Monitoring Summary Pikeview Quarry

CONTINENTAL MATERIALS
CORP.
PIKEVIEW QUARRY SLOPE
MONITORING

Title
OBSERVATIONS FROM
DECEMBER INSPECTION

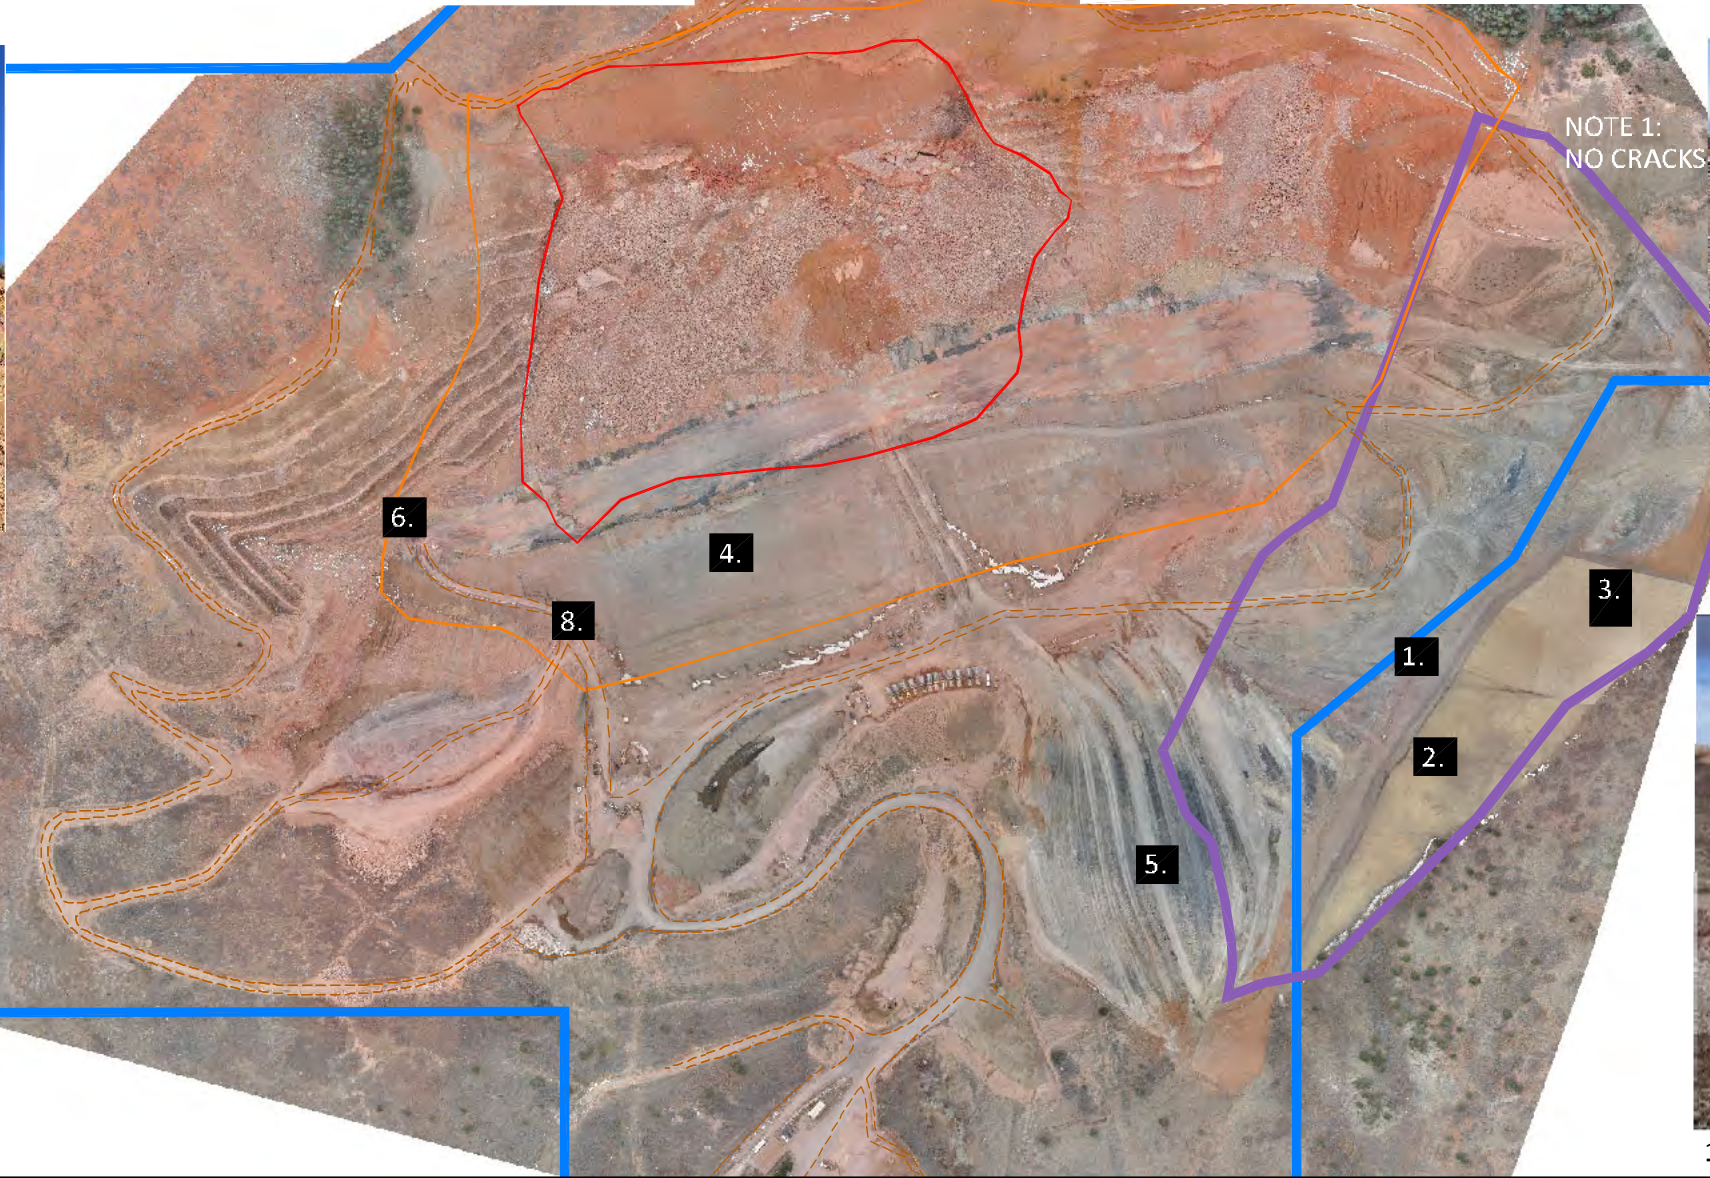
- Known cracks were monitored for changes. Currently the cracks are not growing in any of the areas on the slopes of the site. The hummocky field in the area immediately above the southern extent of the slide shows evidence of cracking but they are not fresh or active. No new or open cracks were found immediately inside or next to the slide area. (Photo 7)

7. View of middle peak above the slide

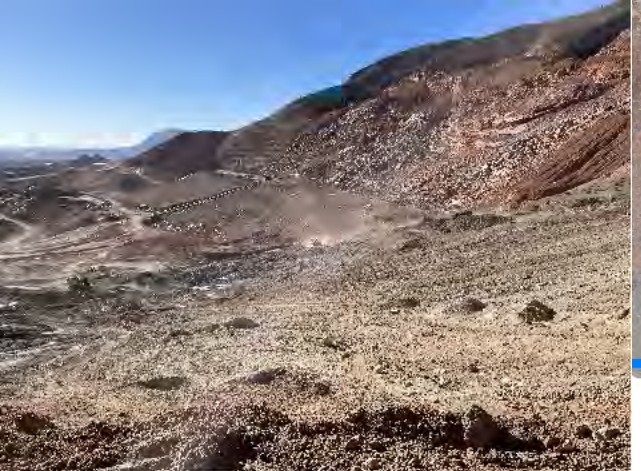
8. View to the south of pit floor

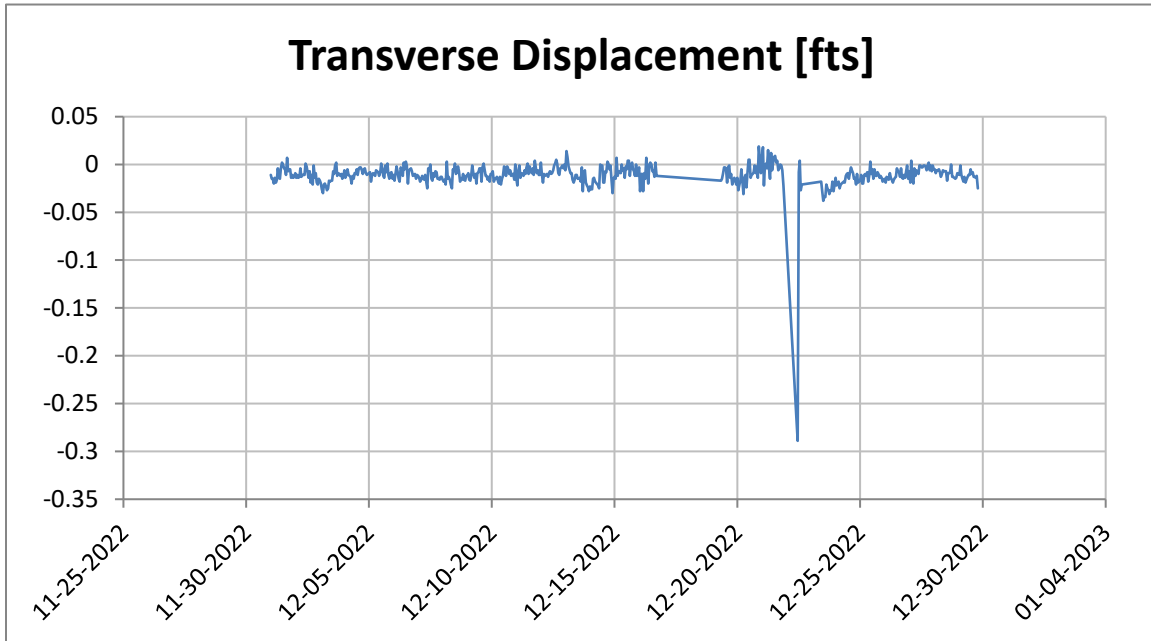
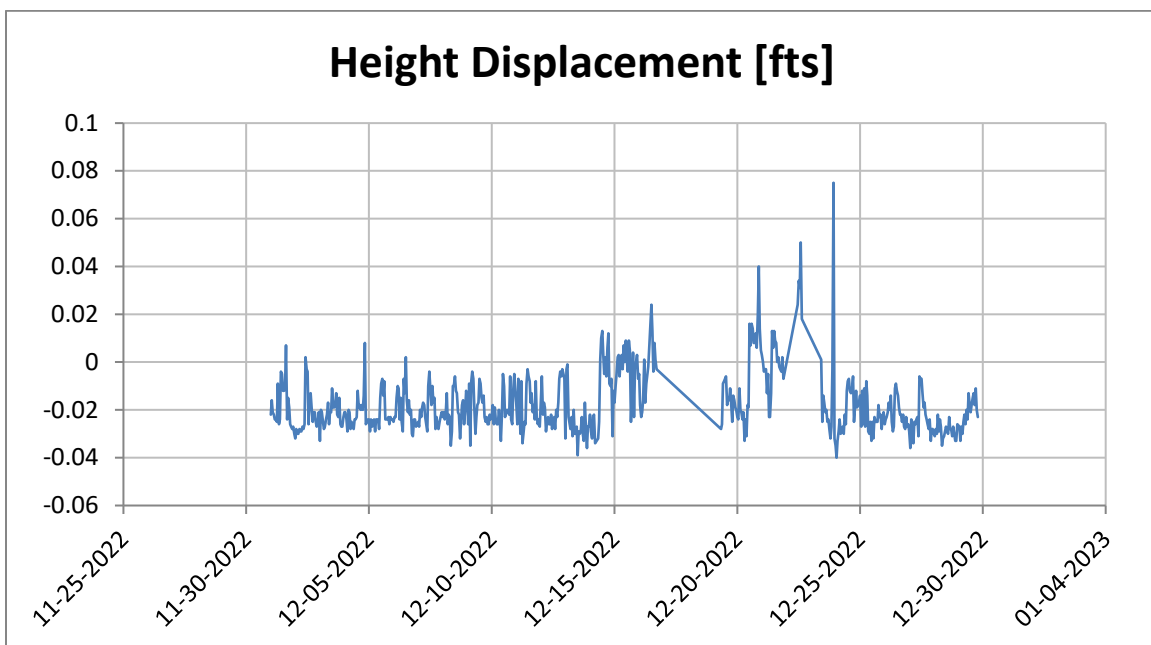
Prism P1

1. Survey accuracy is ± 0.016 feet.
2. Alarm threshold is ± 0.35 feet.
3. Transverse displacement is in the horizontal direction. Positive direction means closer to the robotic station.
4. Height displacement is in the vertical direction. Positive direction means higher in elevation.
5. Exceedance alerts were received on 12/22.

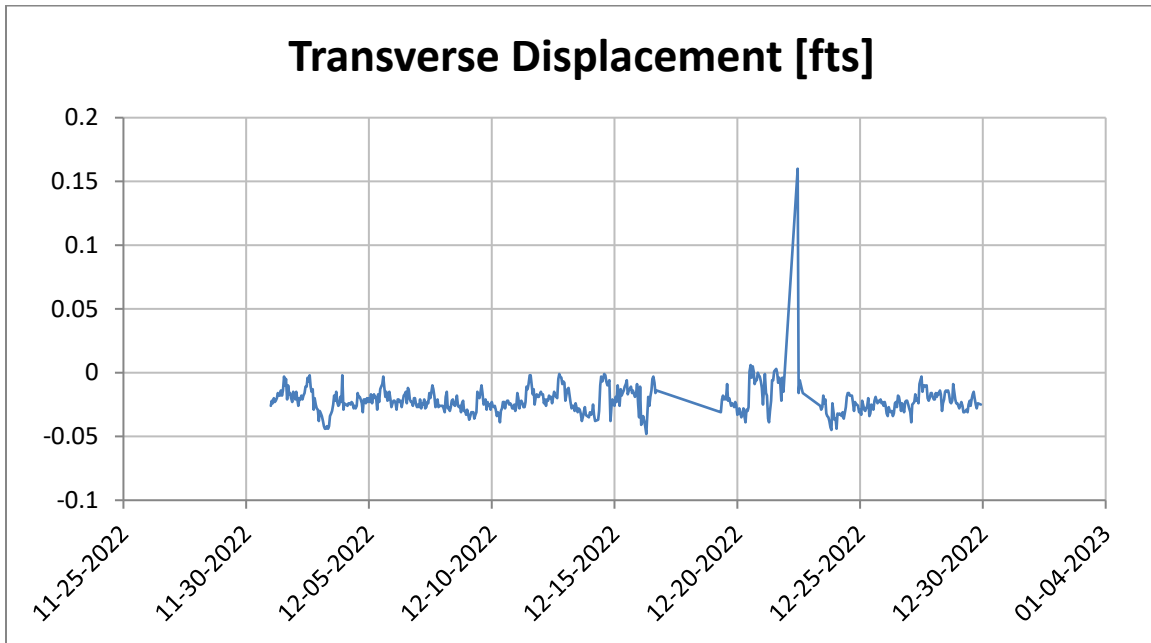
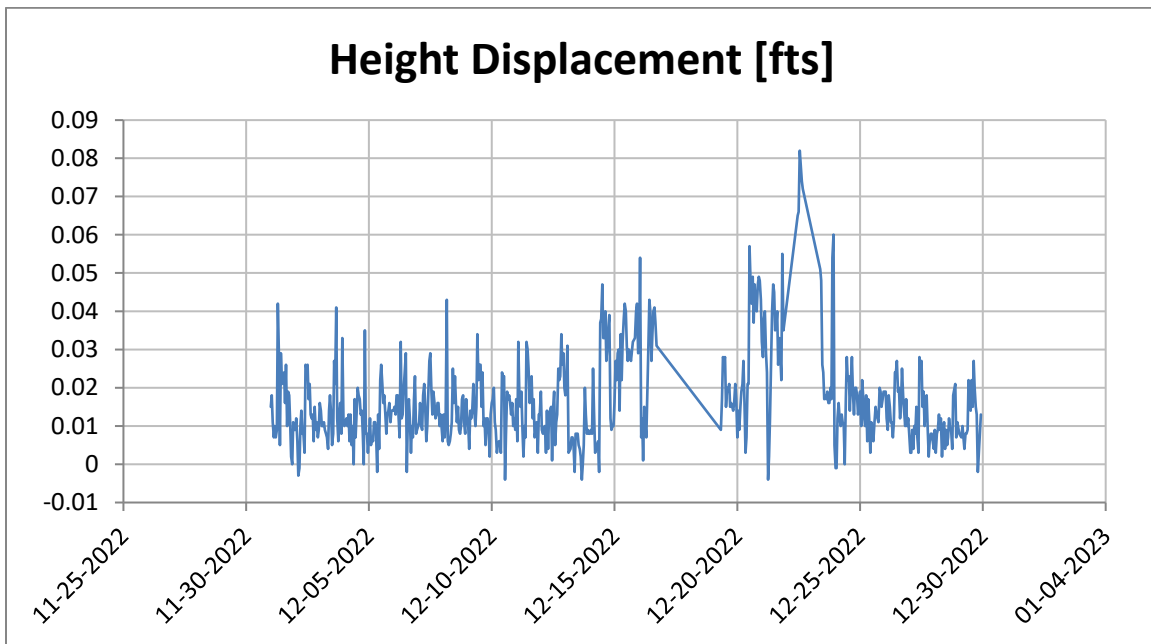
Prism P25

1. Survey accuracy is +/-0.016 feet.
2. Alarm threshold is +/-0.35 feet.
3. Transverse displacement is in the horizontal direction. Positive direction means closer to the robotic station.
4. Height displacement is in the vertical direction. Positive direction means higher in elevation.
5. Exceedance alerts were received on 12/22.

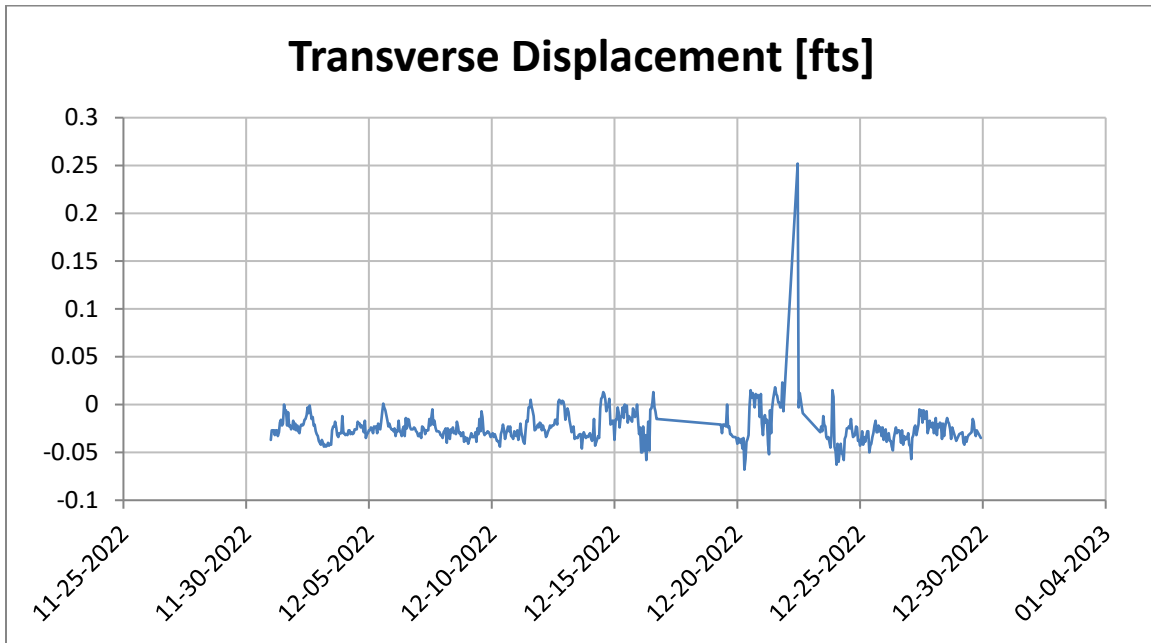
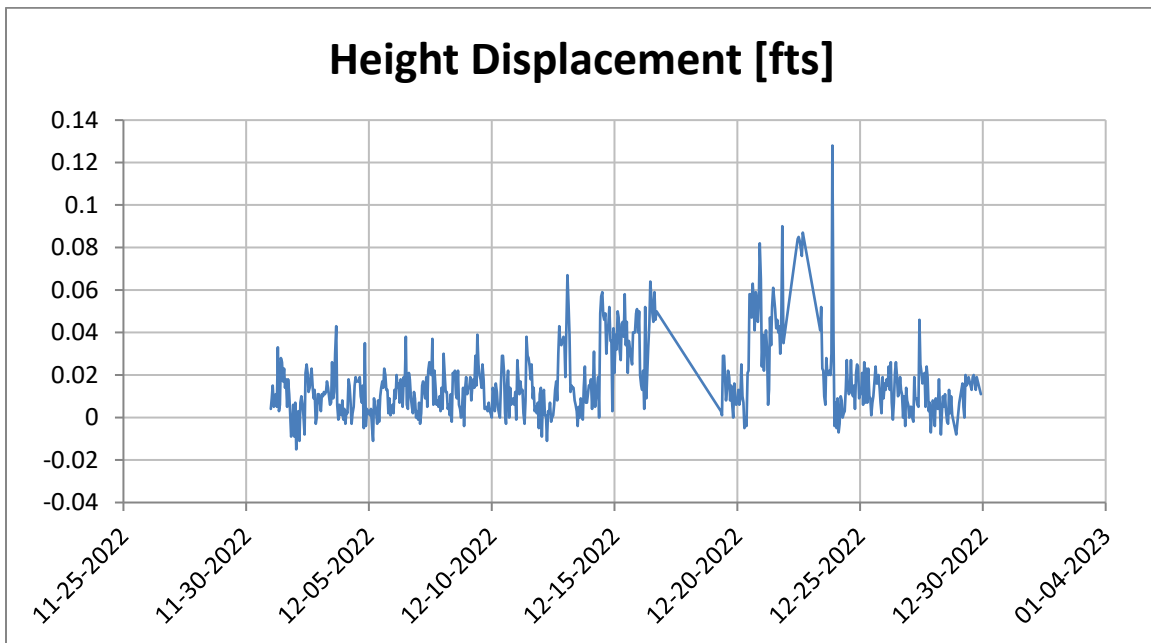
Prism P32

1. Survey accuracy is +/-0.016 feet.
2. Alarm threshold is +/-0.35 feet.
3. Transverse displacement is in the horizontal direction. Positive direction means closer to the robotic station.
4. Height displacement is in the vertical direction. Positive direction means higher in elevation.
5. Exceedance alerts were received on 12/22 and 12/24.

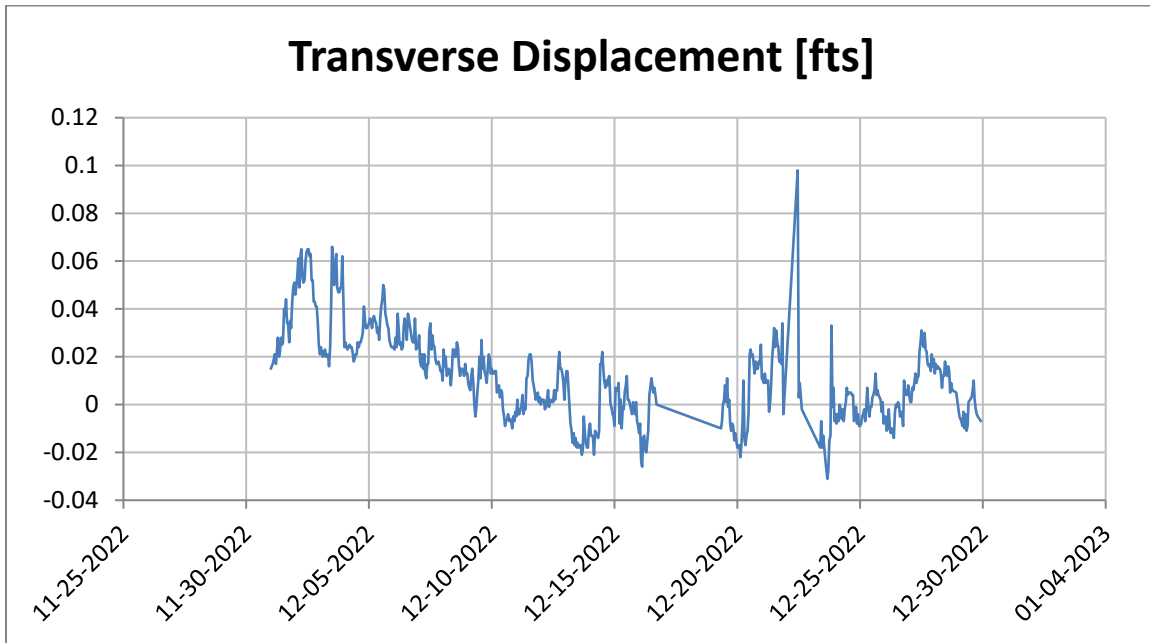
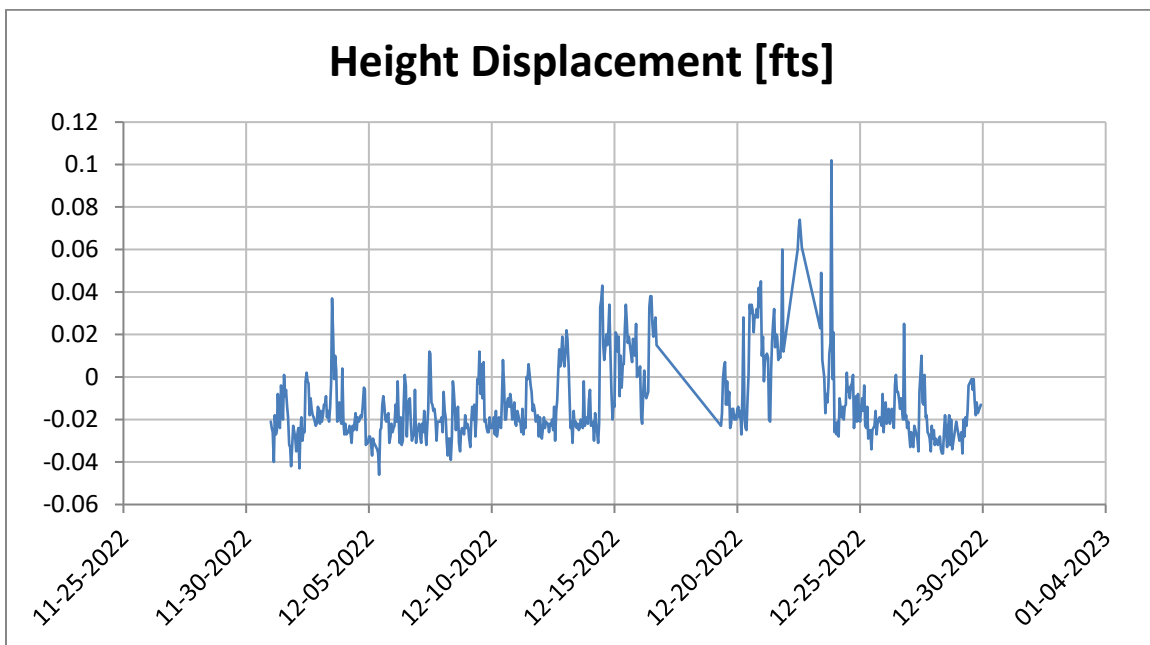
Prism P33

1. Survey accuracy is +/-0.016 feet.
2. Alarm threshold is +/-0.35 feet.
3. Transverse displacement is in the horizontal direction. Positive direction means closer to the robotic station.
4. Height displacement is in the vertical direction. Positive direction means higher in elevation.
5. Exceedance alerts were received on 12/22.

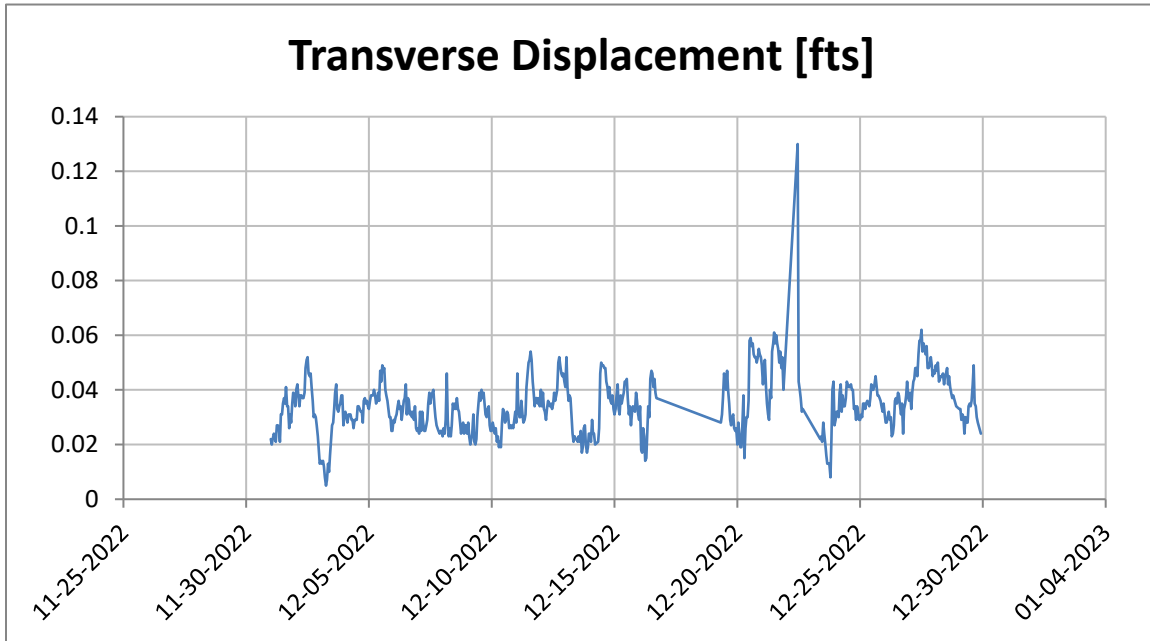
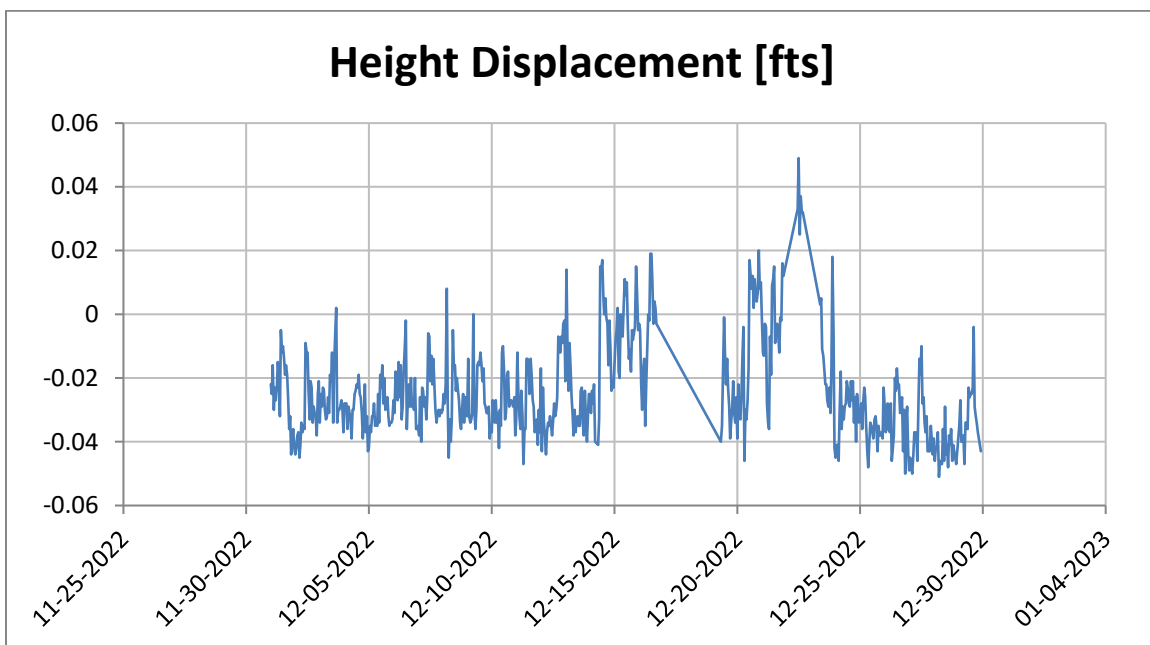
Prism P69A

1. Survey accuracy is +/-0.016 feet.
2. Alarm threshold is +/-0.35 feet.
3. Transverse displacement is in the horizontal direction. Positive direction means closer to the robotic station.
4. Height displacement is in the vertical direction. Positive direction means higher in elevation.
5. Exceedance alerts were received on 12/22.
