Attachment D

SPCC C-1 Diesel and Gas Storage & Filling Station

Date of Inspection	2022-01-19
Inspection Frequency	Monthly

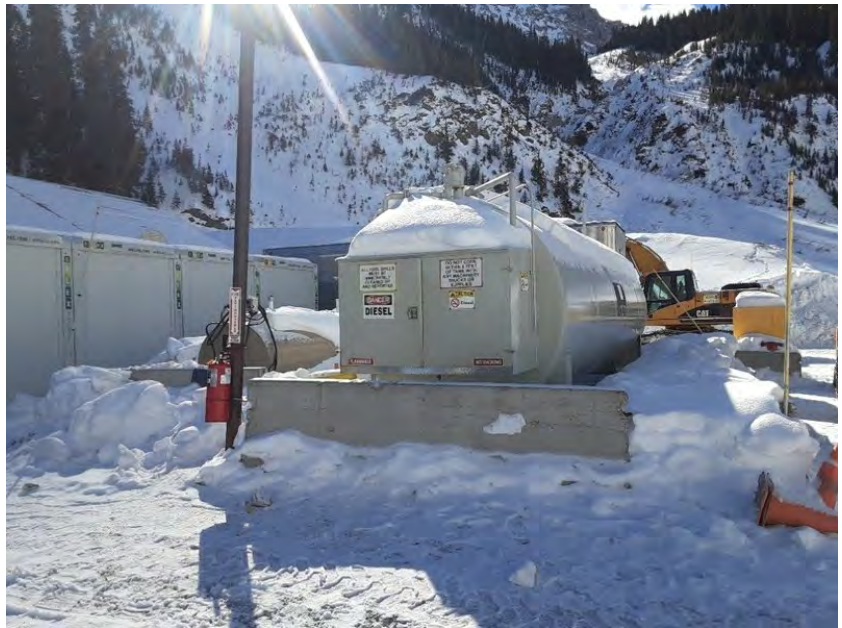
Tank photos (both tanks)

Do gas tank surfaces show signs of leakage?	No
Is gas tank damaged, rusted or otherwise deteriorating?	No
Are gas tank supports damaged, rusted or otherwise deteriorating?	No
Are gas tank foundations eroded or settled?	No
Gas tank fill level gauge functional?	Yes
Note gas fill level (inches)	5
Are gas vents free of obstruction?	Yes
Is gas secondary containment damaged?	No
Is any maintenance required for gas tank?	No
Note corrective action needed for gas tank	NA

Do diesel tank surfaces show signs of leakage?	No
Is diesel tank damaged, rusted or otherwise deteriorating?	No
Are diesel tank supports damaged, rusted or otherwise deteriorating?	No
Are diesel tank foundations eroded or settled?	No
Diesel fill level gauge functional?	Yes
Note diesel fill level (inches)	37
Are diesel tank vents free of obstruction?	Yes
Is diesel secondary containment damaged?	No
Is any maintenance required for diesel tank?	No
Note corrective action needed for diesel tank	NA

Is a spill kit present?	Yes
Is equipment inventory complete?	Yes
Is any maintenance required for response equipment?	No
Note corrective action needed for response equipment	NA

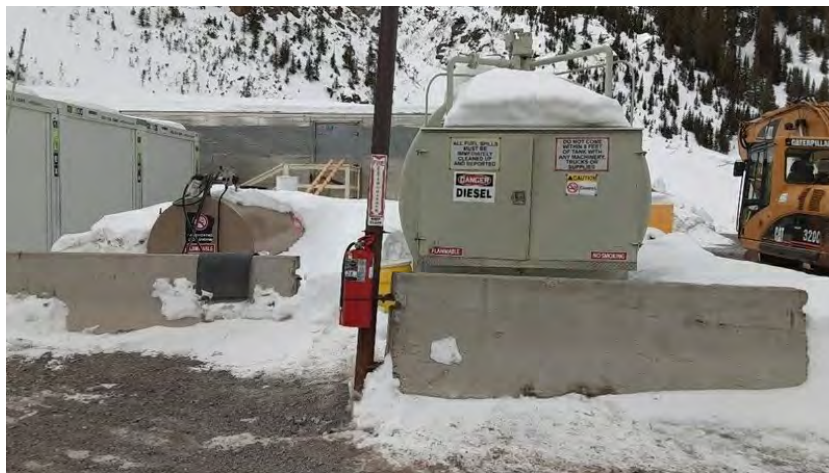
Tank photos (both tanks)

Do gas tank surfaces show signs of leakage?	No
Is gas tank damaged, rusted or otherwise deteriorating?	No
Are gas tank supports damaged, rusted or otherwise deteriorating?	No
Are gas tank foundations eroded or settled?	No
Gas tank fill level gauge functional?	Yes
Note gas fill level (inches)	10
Are gas vents free of obstruction?	Yes
Is gas secondary containment damaged?	No
Is any maintenance required for gas tank?	No
Note corrective action needed for gas tank	NA

Do diesel tank surfaces show signs of leakage?	No
Is diesel tank damaged, rusted or otherwise deteriorating?	No
Are diesel tank supports damaged, rusted or otherwise deteriorating?	No
Are diesel tank foundations eroded or settled?	No
Diesel fill level gauge functional?	Yes
Note diesel fill level (inches)	24
Are diesel tank vents free of obstruction?	Yes
Is diesel secondary containment damaged?	No
Is any maintenance required for diesel tank?	No
Note corrective action needed for diesel tank	NA

Is a spill kit present?	Yes
Is equipment inventory complete?	Yes
Is any maintenance required for response equipment?	No
Note corrective action needed for response equipment	NA

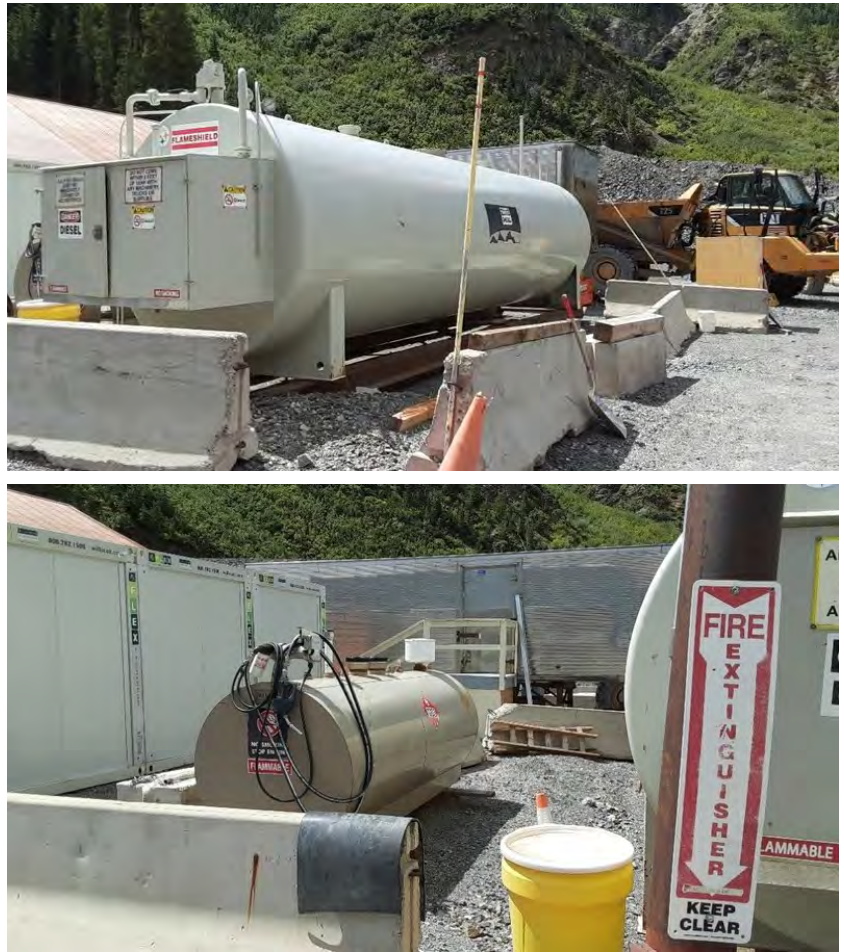
Tank photos (both tanks)

Is a spill kit present?	Yes
Is equipment inventory complete?	Yes
Is any maintenance required for response equipment?	No
Note corrective action needed for response equipment	NA

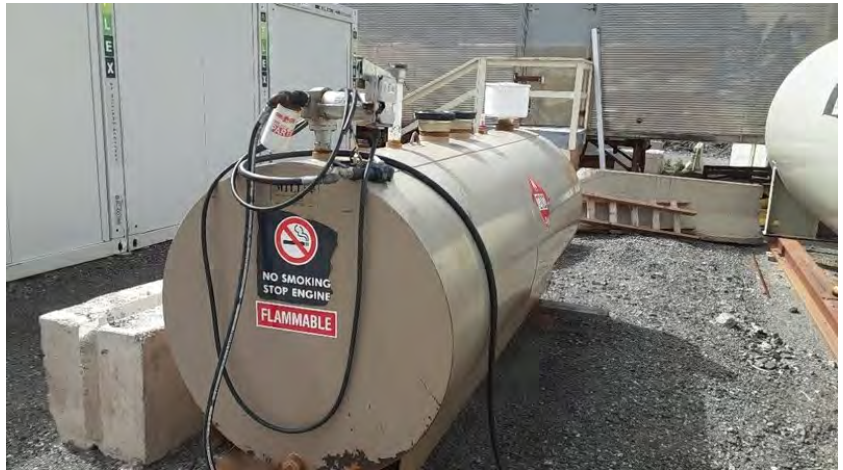
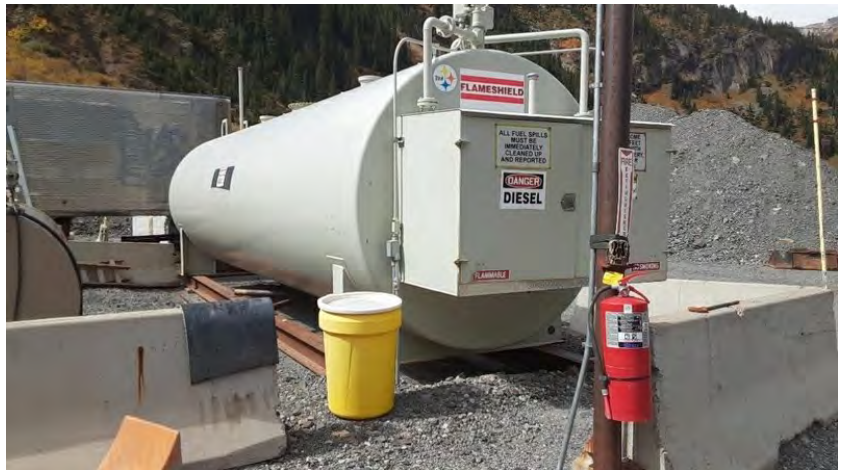
Tank photos (both tanks)

Is a spill kit present?	Yes
Is equipment inventory complete?	Yes
Is any maintenance required for response equipment?	No
Note corrective action needed for response equipment	NA

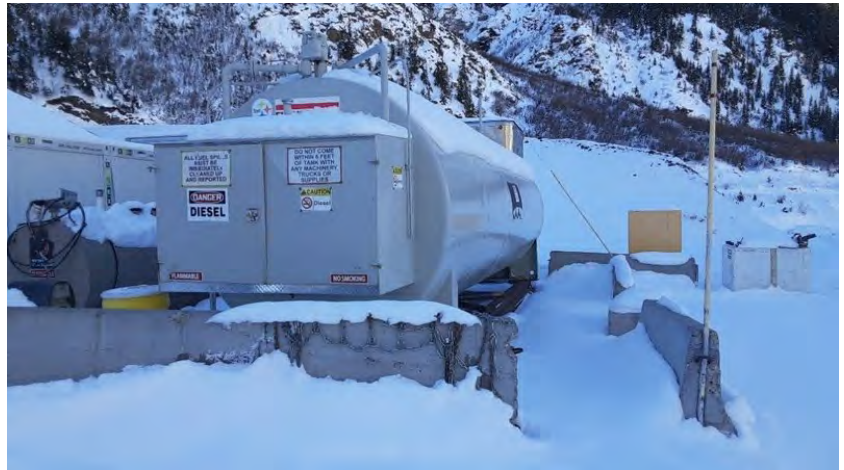
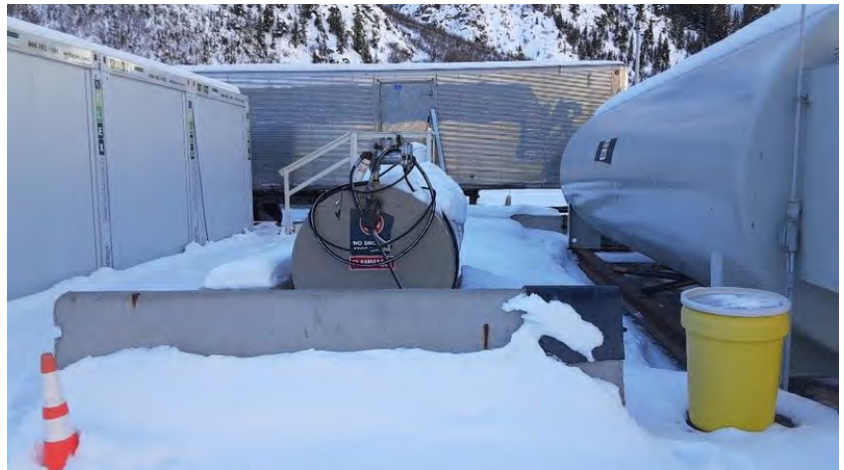
Tank photos (both tanks)

Is a spill kit present?	Yes
Is equipment inventory complete?	Yes
Is any maintenance required for response equipment?	No
Note corrective action needed for response equipment	NA

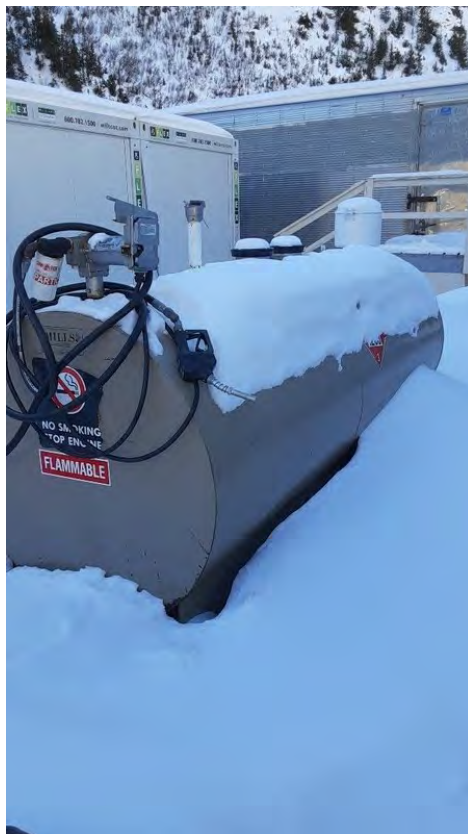
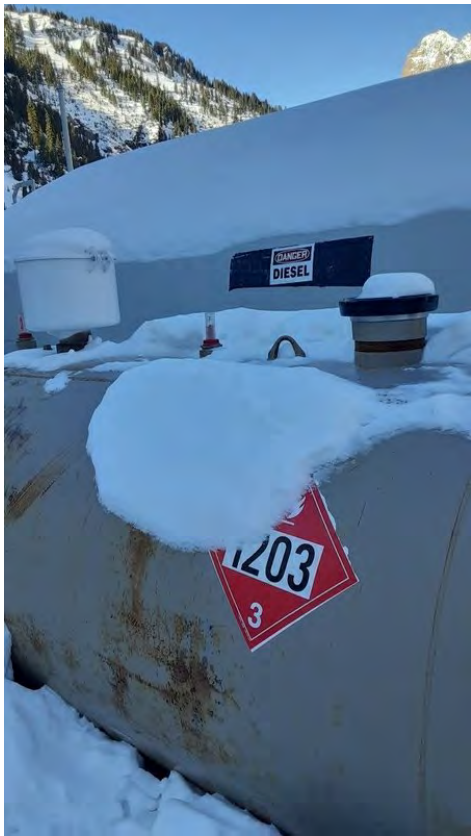
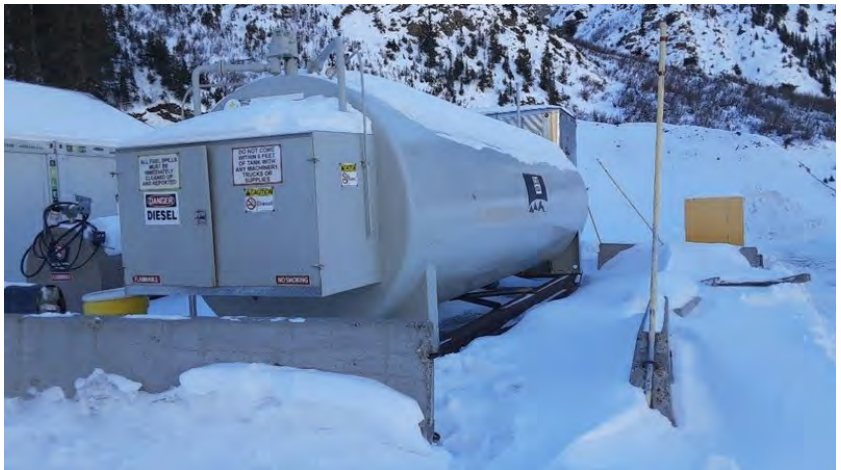
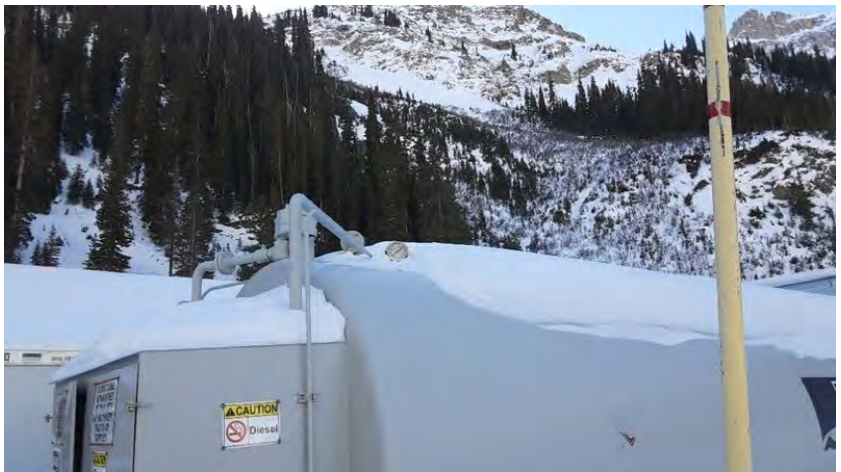
Tank photos (both tanks)

Is a spill kit present?	Yes
Is equipment inventory complete?	Yes
Is any maintenance required for response equipment?	No
Note corrective action needed for response equipment	NA

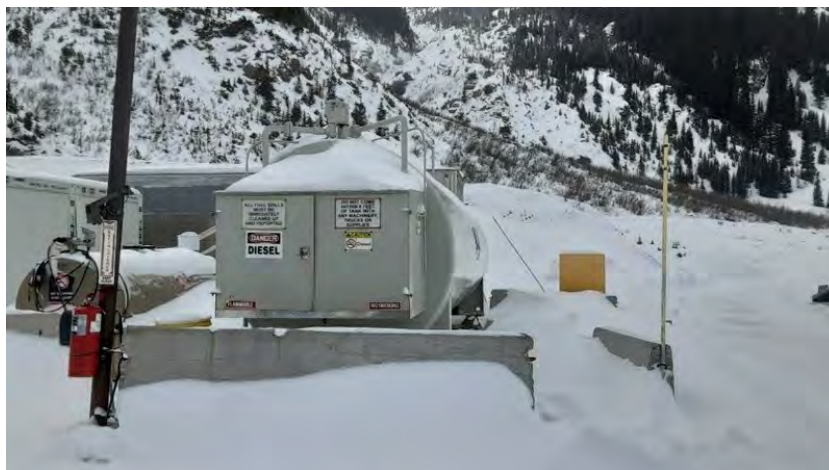
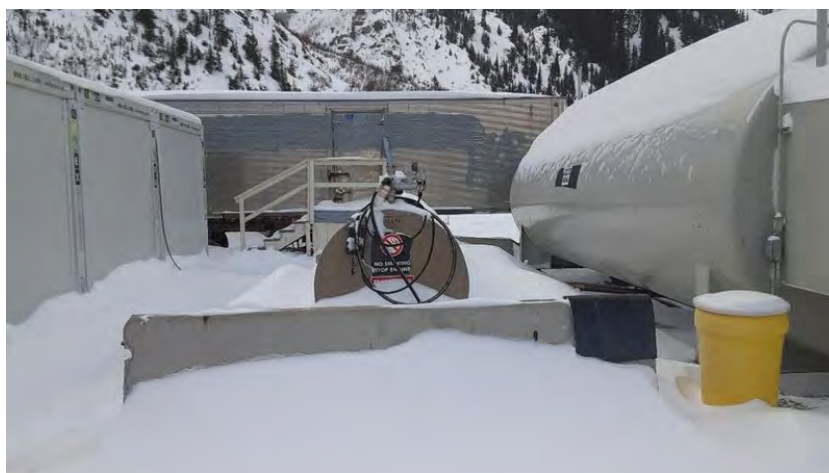
Tank photos (both tanks)

Is a spill kit present?	Yes
Is equipment inventory complete?	Yes
Is any maintenance required for response equipment?	No
Note corrective action needed for response equipment	NA

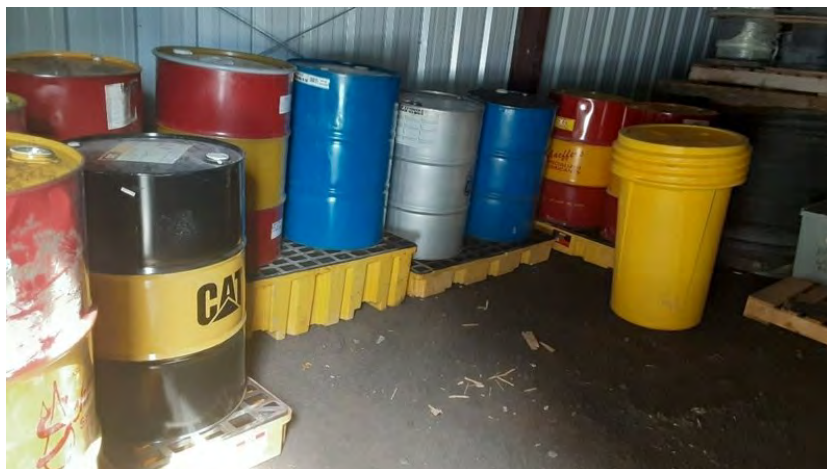
Oil storage photo

Is a spill kit present?	Yes
Is equipment inventory complete?	No
Is any maintenance for response equipment required?	Yes
Note corrective action needed for response equipment	Need addition pads and floor dry

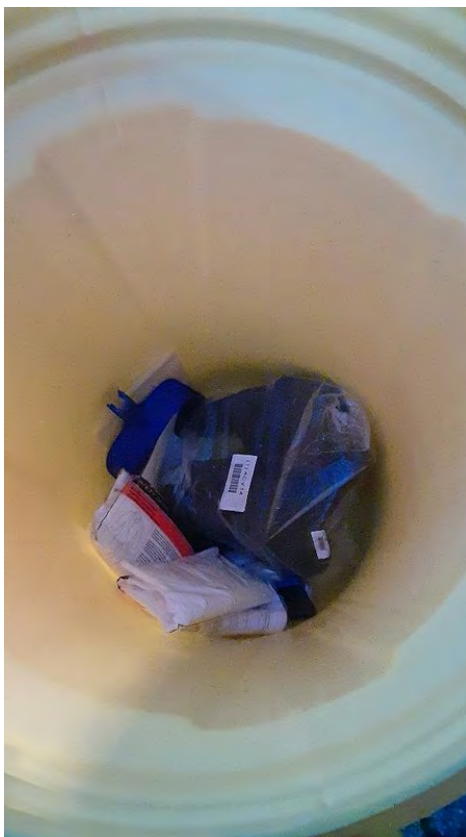
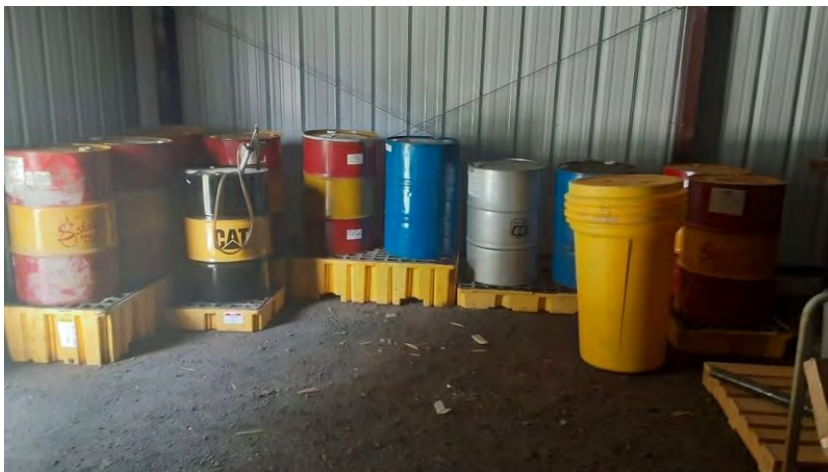
Oil storage photo

Is a spill kit present?	Yes
Is equipment inventory complete?	No
Is any maintenance for response equipment required?	Yes
Note corrective action needed for response equipment	Needs floor dry and pads.

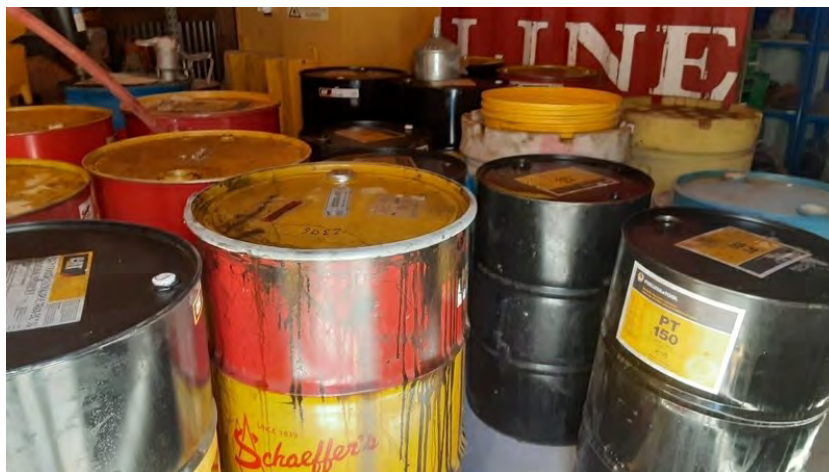
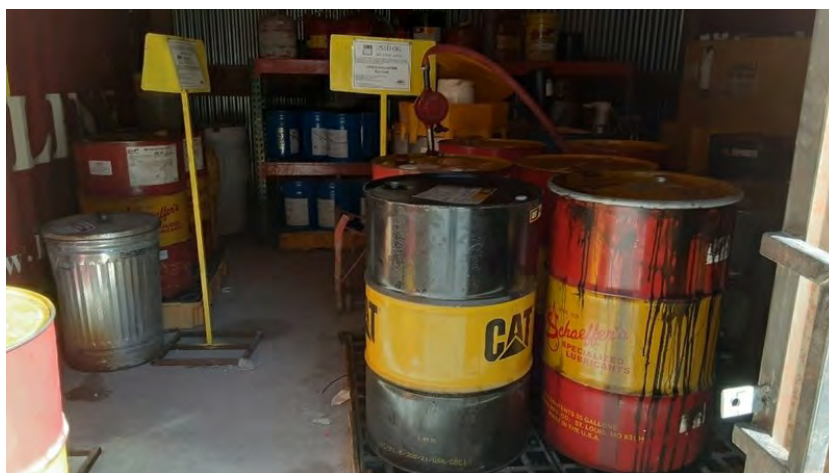
Waste storage photo

Is a spill kit present?	Yes
Is equipment inventory complete?	No
Is any maintenance required for response equipment?	Yes
Note corrective action needed for response equipment	Need more pads

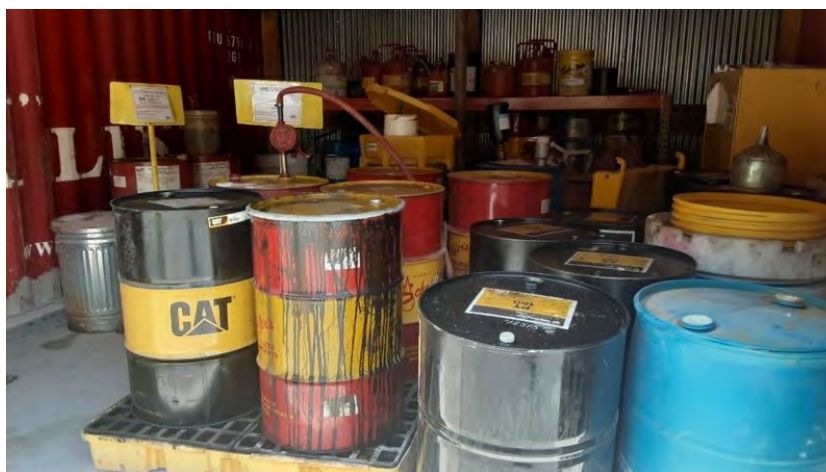
Waste storage photo

Is a spill kit present?	Yes
Is equipment inventory complete?	Yes
Is any maintenance required for response equipment?	Yes
Note corrective action needed for response equipment	Need more sobent pads.

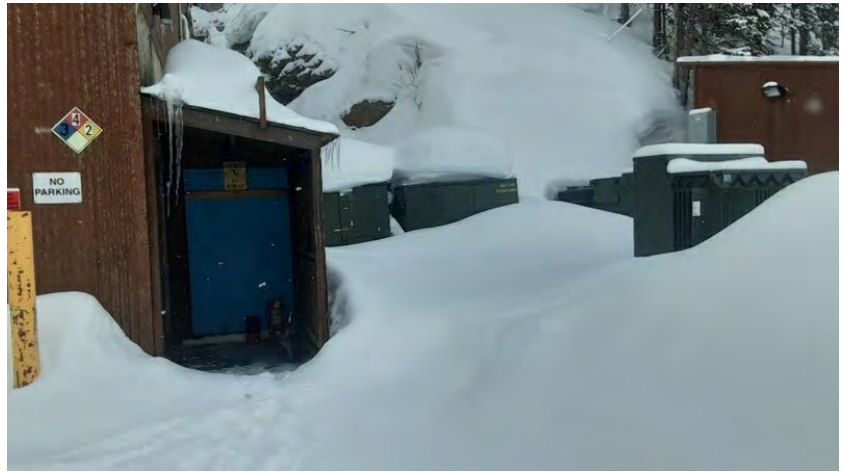
Tank photo

Do tank surfaces show signs of leakage?	No
Is tank damaged, rusted or otherwise deteriorating?	No
Are tank supports damaged, rusted or otherwise deteriorating?	No
Are vents free of obstruction?	Yes
Is any maintenance required for tank?	No
Note corrective action needed for tank	Generator no longer in use. Need to be removed from spcc

Are pipelines or supports damaged, rusted or otherwise deteriorating?	No
Do joints, valves, valve seals, gaskets or other appurtenances show signs of leakage?	No
Loading/unloading connections are capped or blank flanged?	Yes
Is any maintenance required?	No
Note corrective action needed	Generator no longer in use

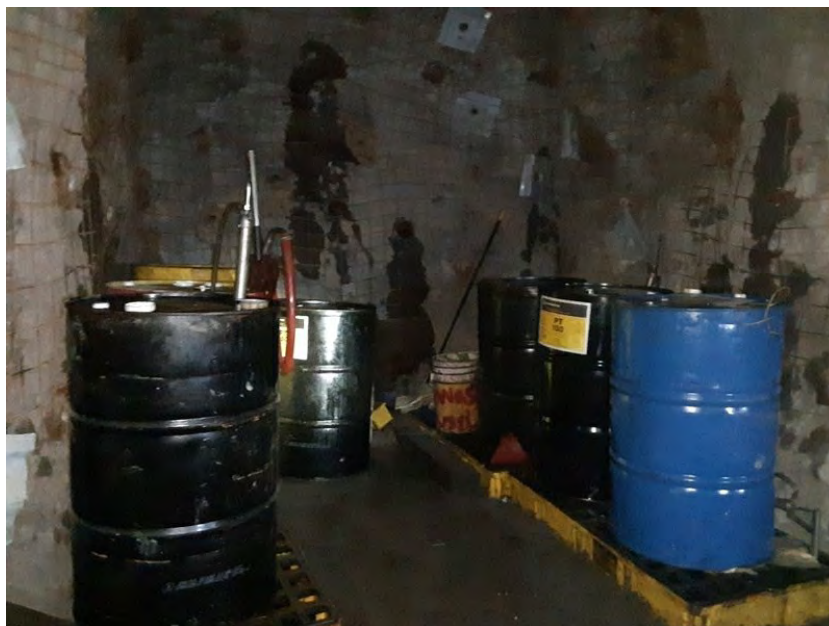
Location photo

Are containers located within the designated storage area?	Yes
Is debris, spills or other fire hazards present in secondary containment?	Yes
Is water present in secondary containment?	No
Are drain valves functional?	N/A
Are drain valves in closed position?	N/A
Are gates/doors functional?	Yes
Is isle space adequate?	Yes
Are containers in good condition?	Yes
Are containers closed at time of inspection?	Yes
Are containers labeled correctly?	Yes
Are there any indications of leakage around containers or storage area?	No
Is any maintenance required?	Yes
Note corrective action needed	Empty barrel needs to be removed.

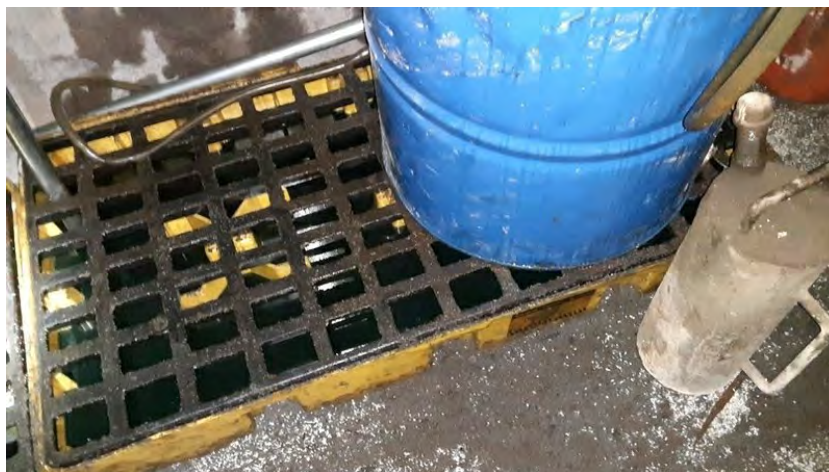
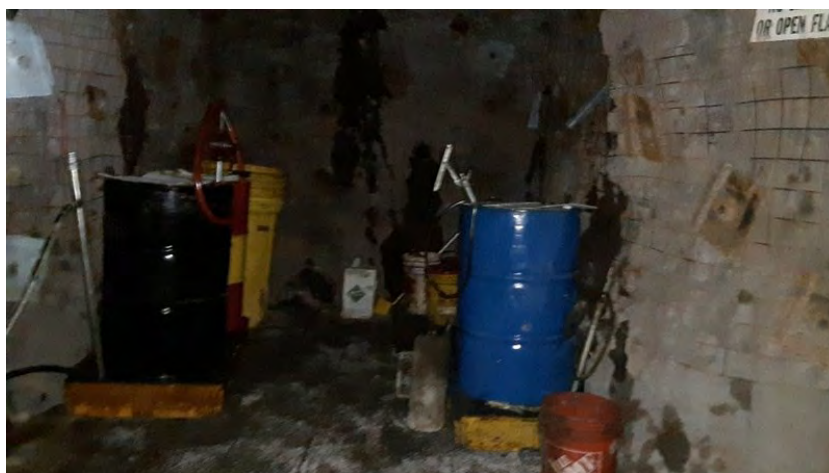
Location photo

Are containers located within the designated storage area?	Yes
Is debris, spills or other fire hazards present in secondary containment?	Yes
Is water present in secondary containment?	No
Are drain valves functional?	N/A
Are drain valves in closed position?	N/A
Are gates/doors functional?	Yes
Is isle space adequate?	Yes
Are containers in good condition?	Yes
Are containers closed at time of inspection?	Yes
Are containers labeled correctly?	Yes
Are there any indications of leakage around containers or storage area?	No
Is any maintenance required?	Yes
Note corrective action needed	Oil from small spill while transferring rickbdrill oil needs to be removed from spill pallets

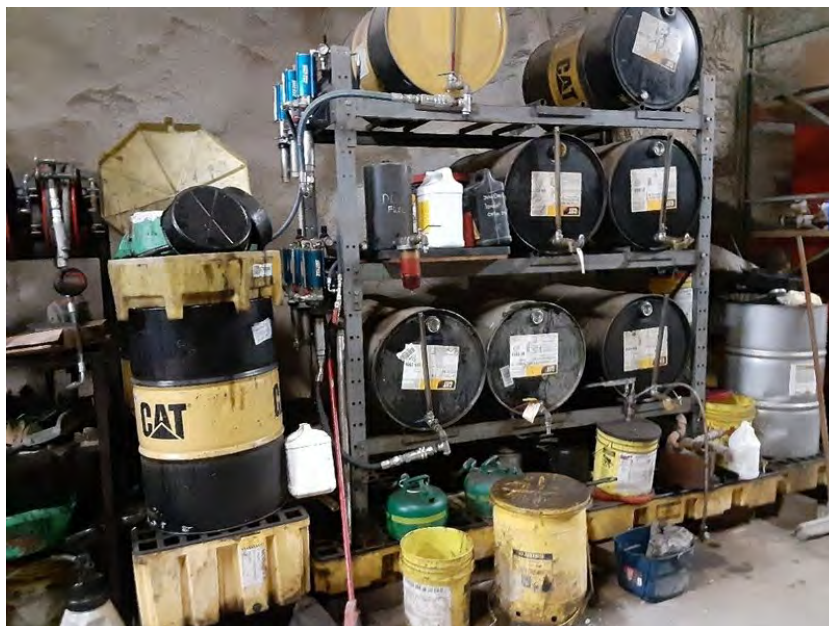
Location photo

Are containers located within the designated storage area?	Yes
Is debris, spills or other fire hazards present in secondary containment?	Yes
Is water present in secondary containment?	No
Are drain valves functional?	Yes
Are drain valves in closed position?	Yes
Are gates/doors functional?	Yes
Is isle space adequate?	Yes
Are containers in good condition?	Yes
Are containers closed at time of inspection?	Yes
Are containers labeled correctly?	Yes
Are there any indications of leakage around containers or storage area?	No
Is any maintenance required?	Yes
Note corrective action needed	Small amount of oil in spill pallet needs to be pumped out.

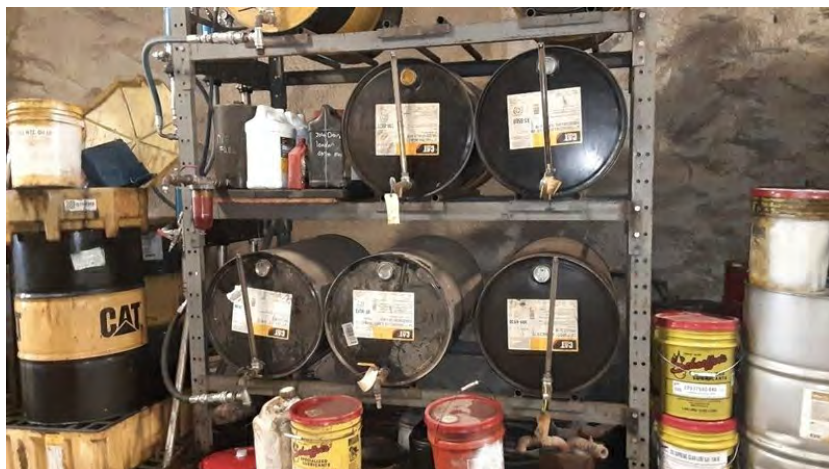
Location photo

Is a spill kit present?	Yes
Is equipment inventory complete?	Yes
Is any maintenance required for response equipment?	No
Note corrective action needed for response equipment	Mechanics say they would like more floor dry

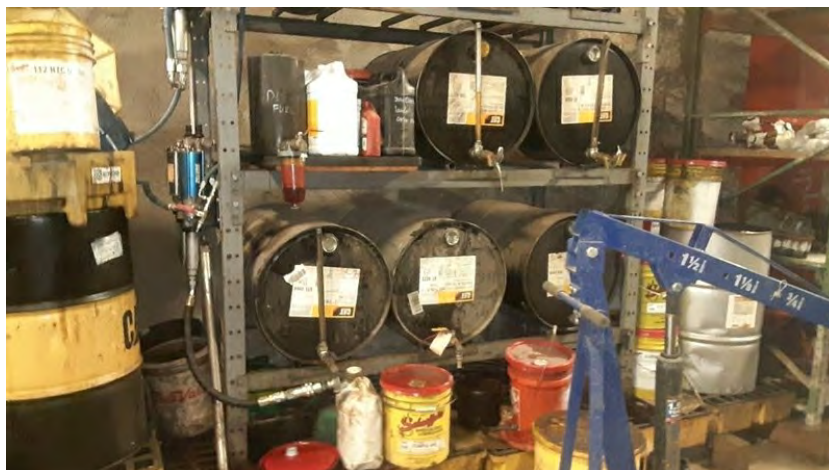
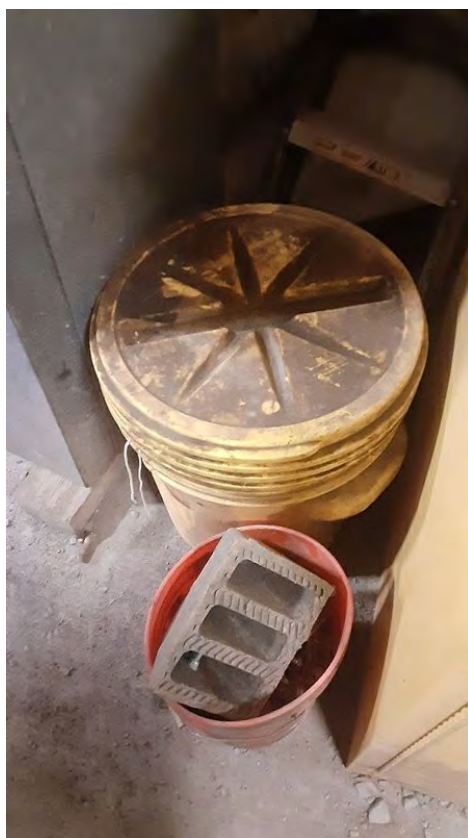
Location photo

Is a spill kit present?	Yes
Is equipment inventory complete?	No
Is any maintenance required for response equipment?	Yes
Note corrective action needed for response equipment	Need floor dry

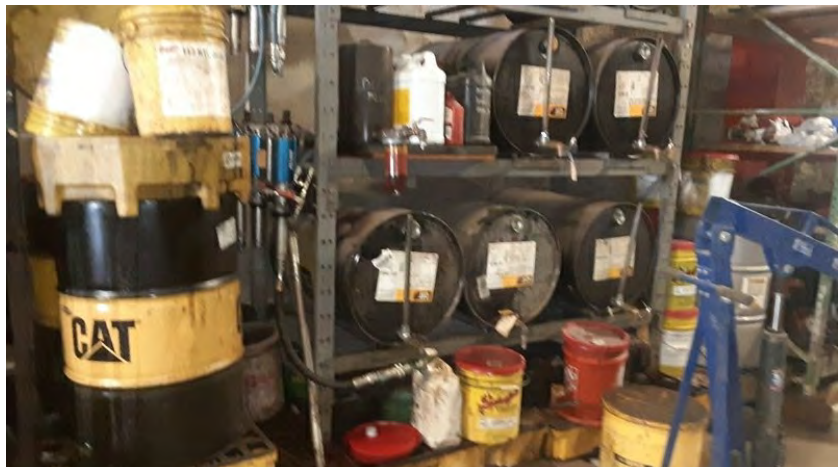
Location photo

Are containers located within the designated storage area?	Yes
Is debris, spills or other fire hazards present in secondary containment?	No
Is water present in secondary containment?	No
Are drain valves functional?	Yes
Are drain valves in closed position?	Yes
Are gates/doors functional?	Yes
Is isle space adequate?	Yes
Are containers in good condition?	Yes
Are containers closed at time of inspection?	Yes
Are containers labeled correctly?	Yes
Are there any indications of leakage around containers or storage area?	No
Is any maintenance required?	No
Note corrective action needed	General housekeeping is needed

Is a spill kit present?	Yes
Is equipment inventory complete?	Yes
Is any maintenance required for response equipment?	No
Note corrective action needed for response equipment	Resupply floor dry

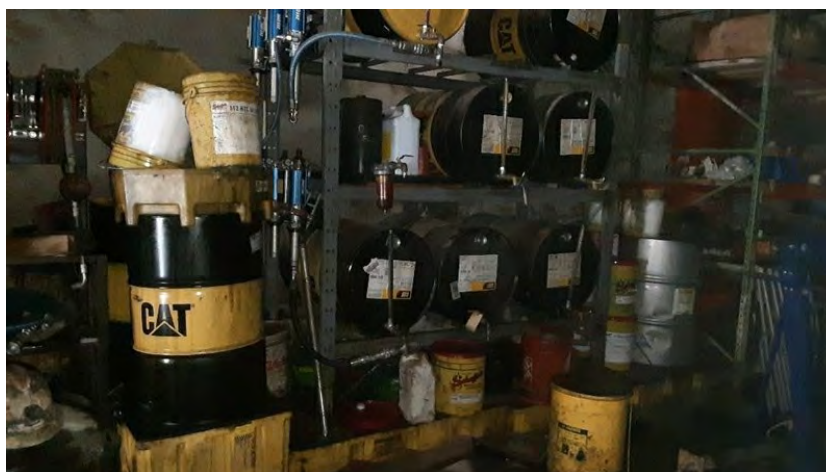
Location photo

Are containers located within the designated storage area?	Yes
Is debris, spills or other fire hazards present in secondary containment?	No
Is water present in secondary containment?	Yes
Are drain valves functional?	Yes
Are drain valves in closed position?	Yes
Are gates/doors functional?	Yes
Is isle space adequate?	Yes
Are containers in good condition?	Yes
Are containers closed at time of inspection?	Yes
Are containers labeled correctly?	Yes
Are there any indications of leakage around containers or storage area?	Yes
Is any maintenance required?	Yes
Note corrective action needed	Runoff caused it to rain in the underground shop. Old oil on the ground was mobilized bit captured by the socks and wattles.

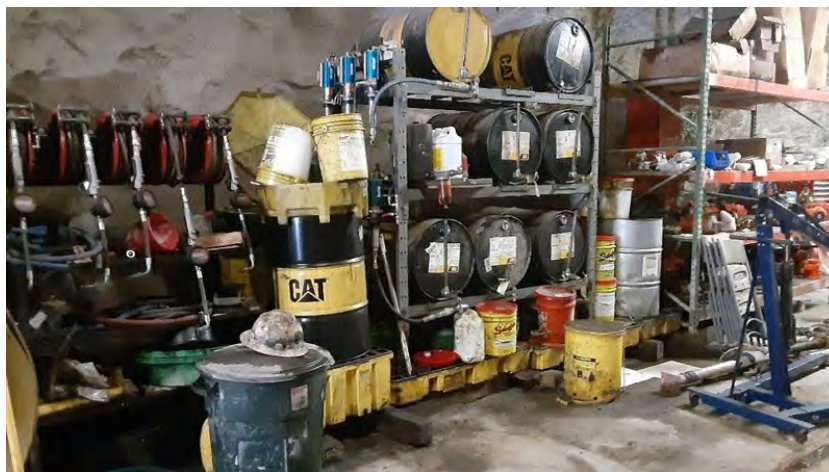
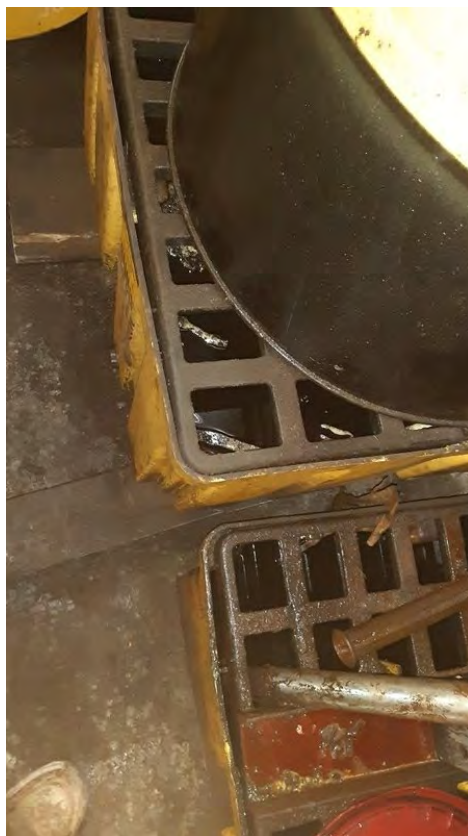
Location photo

Are containers located within the designated storage area?	Yes
Is debris, spills or other fire hazards present in secondary containment?	Yes
Is water present in secondary containment?	Yes
Are drain valves functional?	Yes
Are drain valves in closed position?	Yes
Are gates/doors functional?	Yes
Is isle space adequate?	Yes
Are containers in good condition?	Yes
Are containers closed at time of inspection?	Yes
Are containers labeled correctly?	Yes
Are there any indications of leakage around containers or storage area?	No
Is any maintenance required?	Yes
Note corrective action needed	Secondary containment pallet has water from leaks on roofs and need to be cleaned.

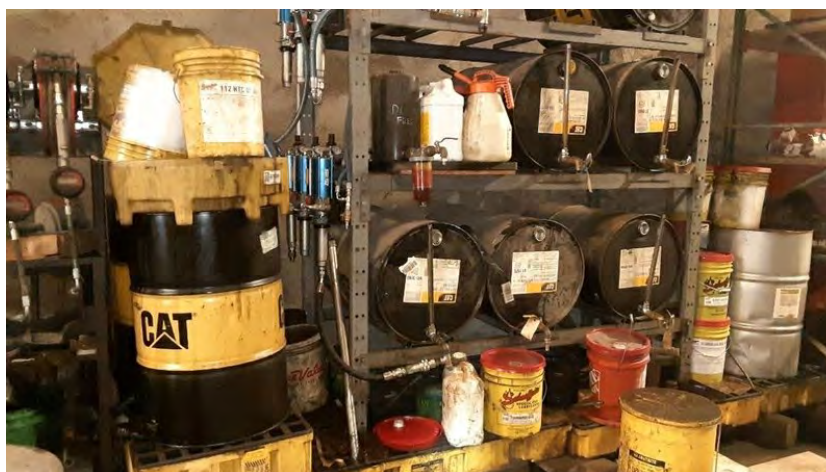
Location photo

Are containers located within the designated storage area?	Yes
Is debris, spills or other fire hazards present in secondary containment?	Yes
Is water present in secondary containment?	Yes
Are drain valves functional?	Yes
Are drain valves in closed position?	Yes
Are gates/doors functional?	Yes
Is isle space adequate?	Yes
Are containers in good condition?	Yes
Are containers closed at time of inspection?	Yes
Are containers labeled correctly?	Yes
Are there any indications of leakage around containers or storage area?	Yes
Is any maintenance required?	Yes
Note corrective action needed	Spill pallets needs to be emptied. Floor around the station needs to be cleaned. Sump in shop needs to be mucked out.

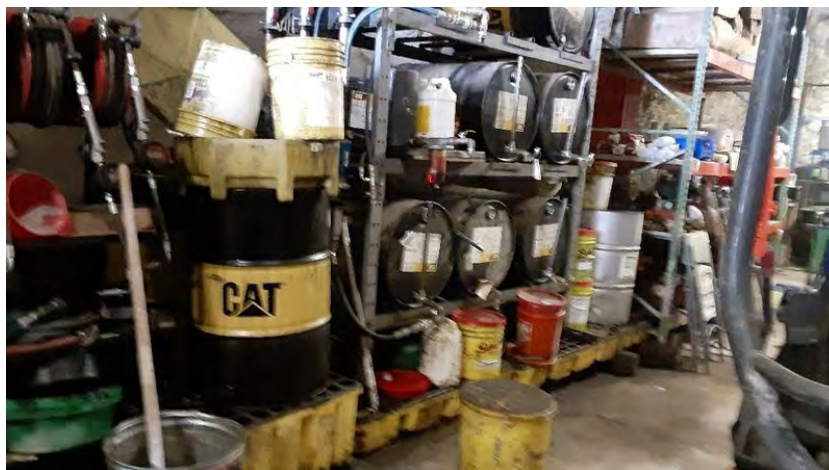
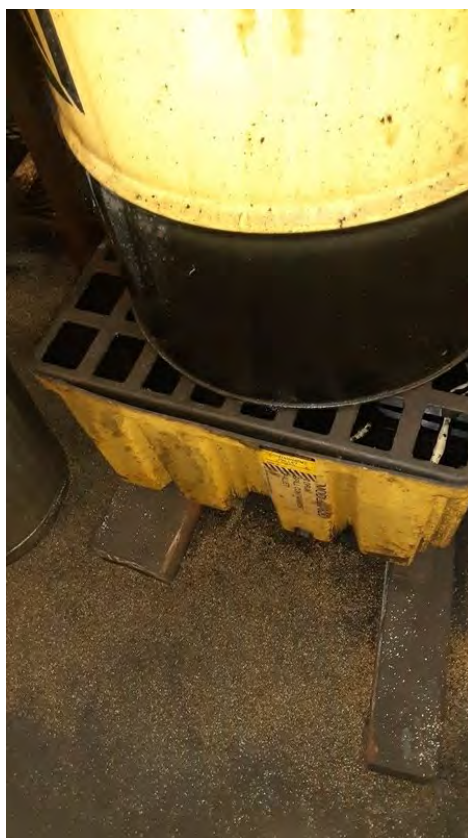
Location photo

Are containers located within the designated storage area?	Yes
Is debris, spills or other fire hazards present in secondary containment?	Yes
Is water present in secondary containment?	Yes
Are drain valves functional?	Yes
Are drain valves in closed position?	Yes
Are gates/doors functional?	Yes
Is isle space adequate?	Yes
Are containers in good condition?	Yes
Are containers closed at time of inspection?	Yes
Are containers labeled correctly?	Yes
Are there any indications of leakage around containers or storage area?	Yes
Is any maintenance required?	Yes
Note corrective action needed	Spill pallets need to be emptied and floor needs to be cleaned before spring runoff

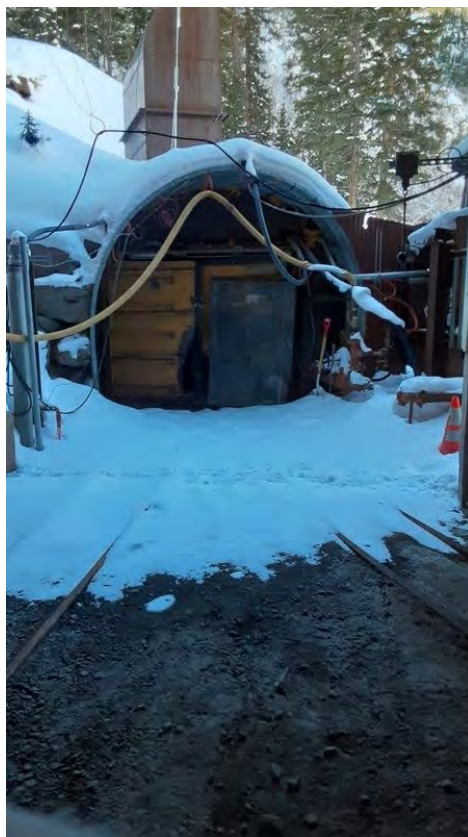
Location photo

Is a spill kit present?	No
Is equipment inventory complete?	No
Is any maintenance required for response equipment?	No
Note corrective action needed for response equipment	NA inactive.

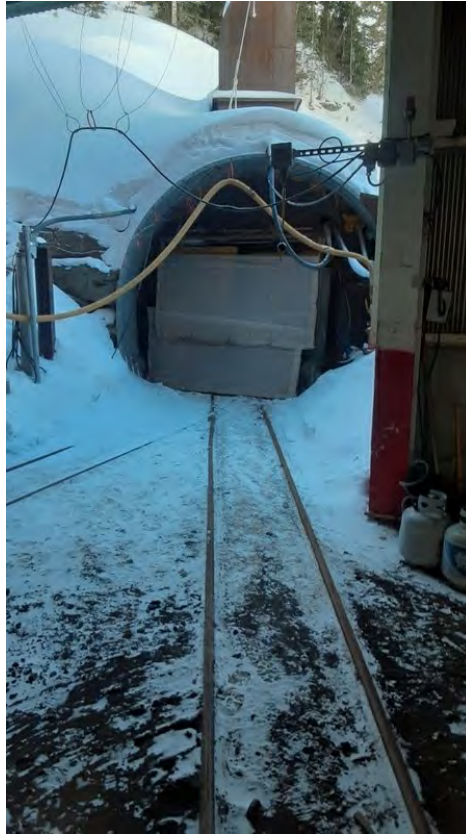
Location photo

Are containers located within the designated storage area?	No
Is debris, spills or other fire hazards present in secondary containment?	No
Is water present in secondary containment?	No
Are drain valves functional?	N/A
Are drain valves in closed position?	N/A
Are gates/doors functional?	No
Is isle space adequate?	No
Are containers in good condition?	No
Are containers closed at time of inspection?	No
Are containers labeled correctly?	No
Are there any indications of leakage around containers or storage area?	No
Is any maintenance required?	No
Note corrective action needed	Station inactive. Down inactive heading.

Is a spill kit present?	No
Is equipment inventory complete?	No
Is any maintenance required for response equipment?	No
Note corrective action needed for response equipment	Station inactive. Down inactive heading.

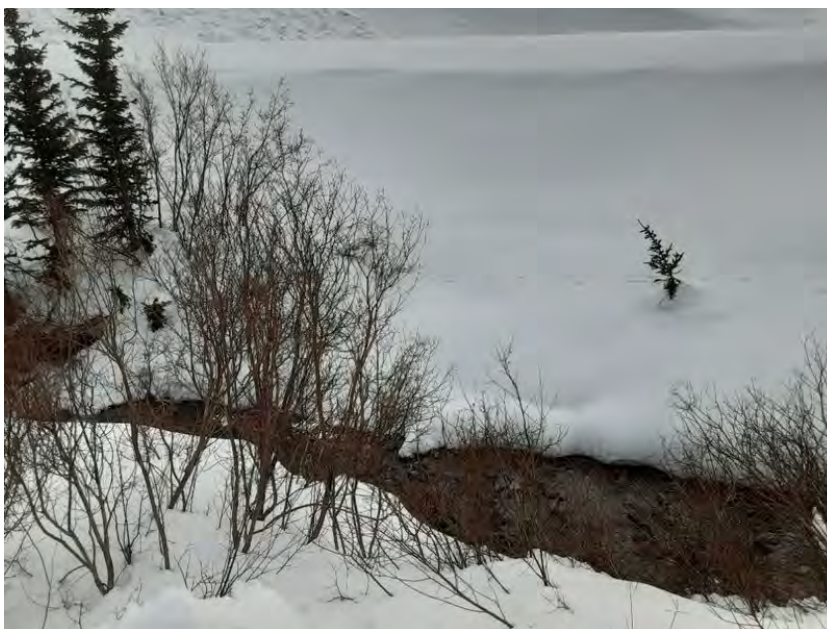
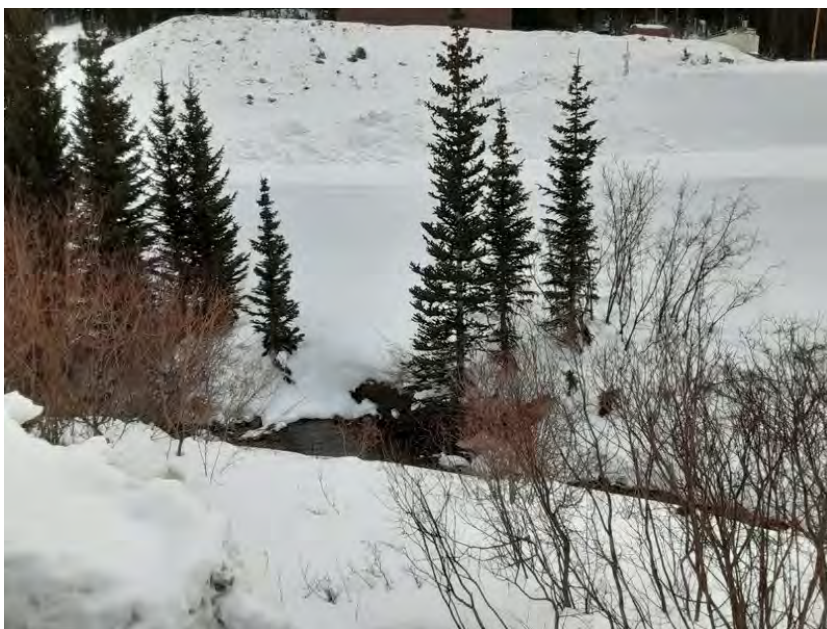
Created	2022-01-19 14:17:50 MST by Environmental Department
Updated	2022-01-19 14:29:28 MST by Environmental Department
Location	37.9739417, -107.7507733
Date	2022-01-19
Time	14:17
Weather Conditions	Cloudy. Ground snow covered
Water Present?	No
Notes	Ground snow covered.
Photos

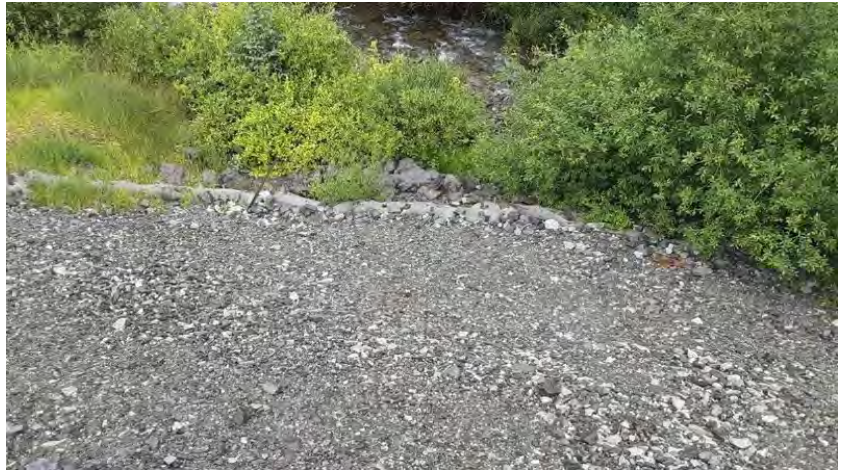
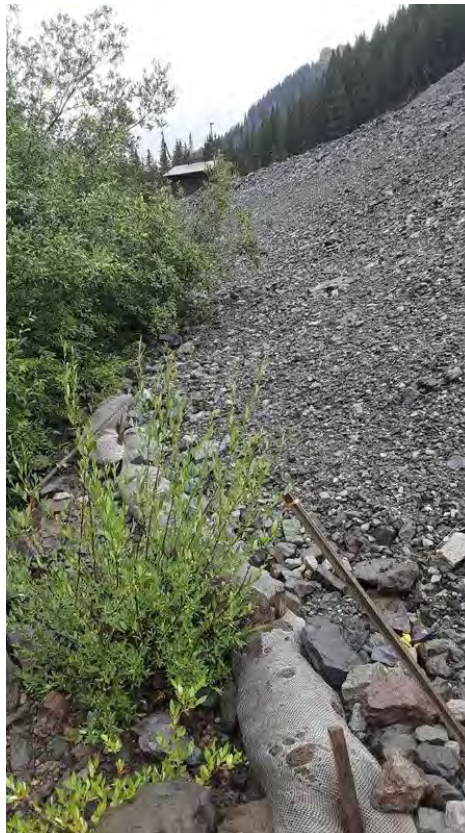
Created	2022-07-25 12:52:50 MDT by Environmental Department
Updated	2022-07-25 13:52:16 MDT by Environmental Department
Location	37.9743183, -107.750533
Date	2022-07-25
Time	12:52
Weather Conditions	Rainy
Water Present?	Yes
Notes	Wet ground from precipitation
Photos

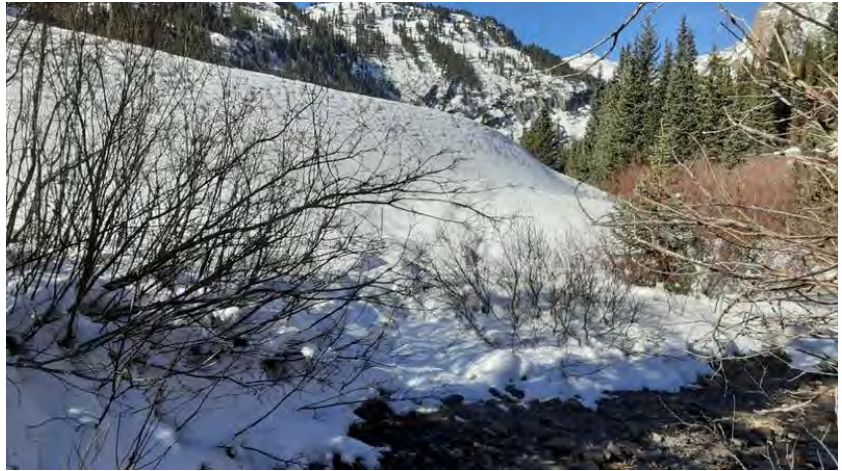
Created	2022-10-31 10:33:32 MDT by Environmental Department
Updated	2022-10-31 10:36:48 MDT by Environmental Department
Location	37.9754454, -107.7482805
Date	2022-10-31
Time	10:33
Weather Conditions	Sunny, ground snow covered.
Water Present?	No
Notes	Area snow covered. Recent storms.
Photos
