**Reference: January 2023 Geotechnical Monitoring Summary Pikeview Quarry**

Client/Project  
CONTINENTAL MATERIALS  
CORP.  
PIKEVIEW QUARRY SLOPE  
MONITORING

OBSERVATIONS FROM  
JANUARY INSPECTION

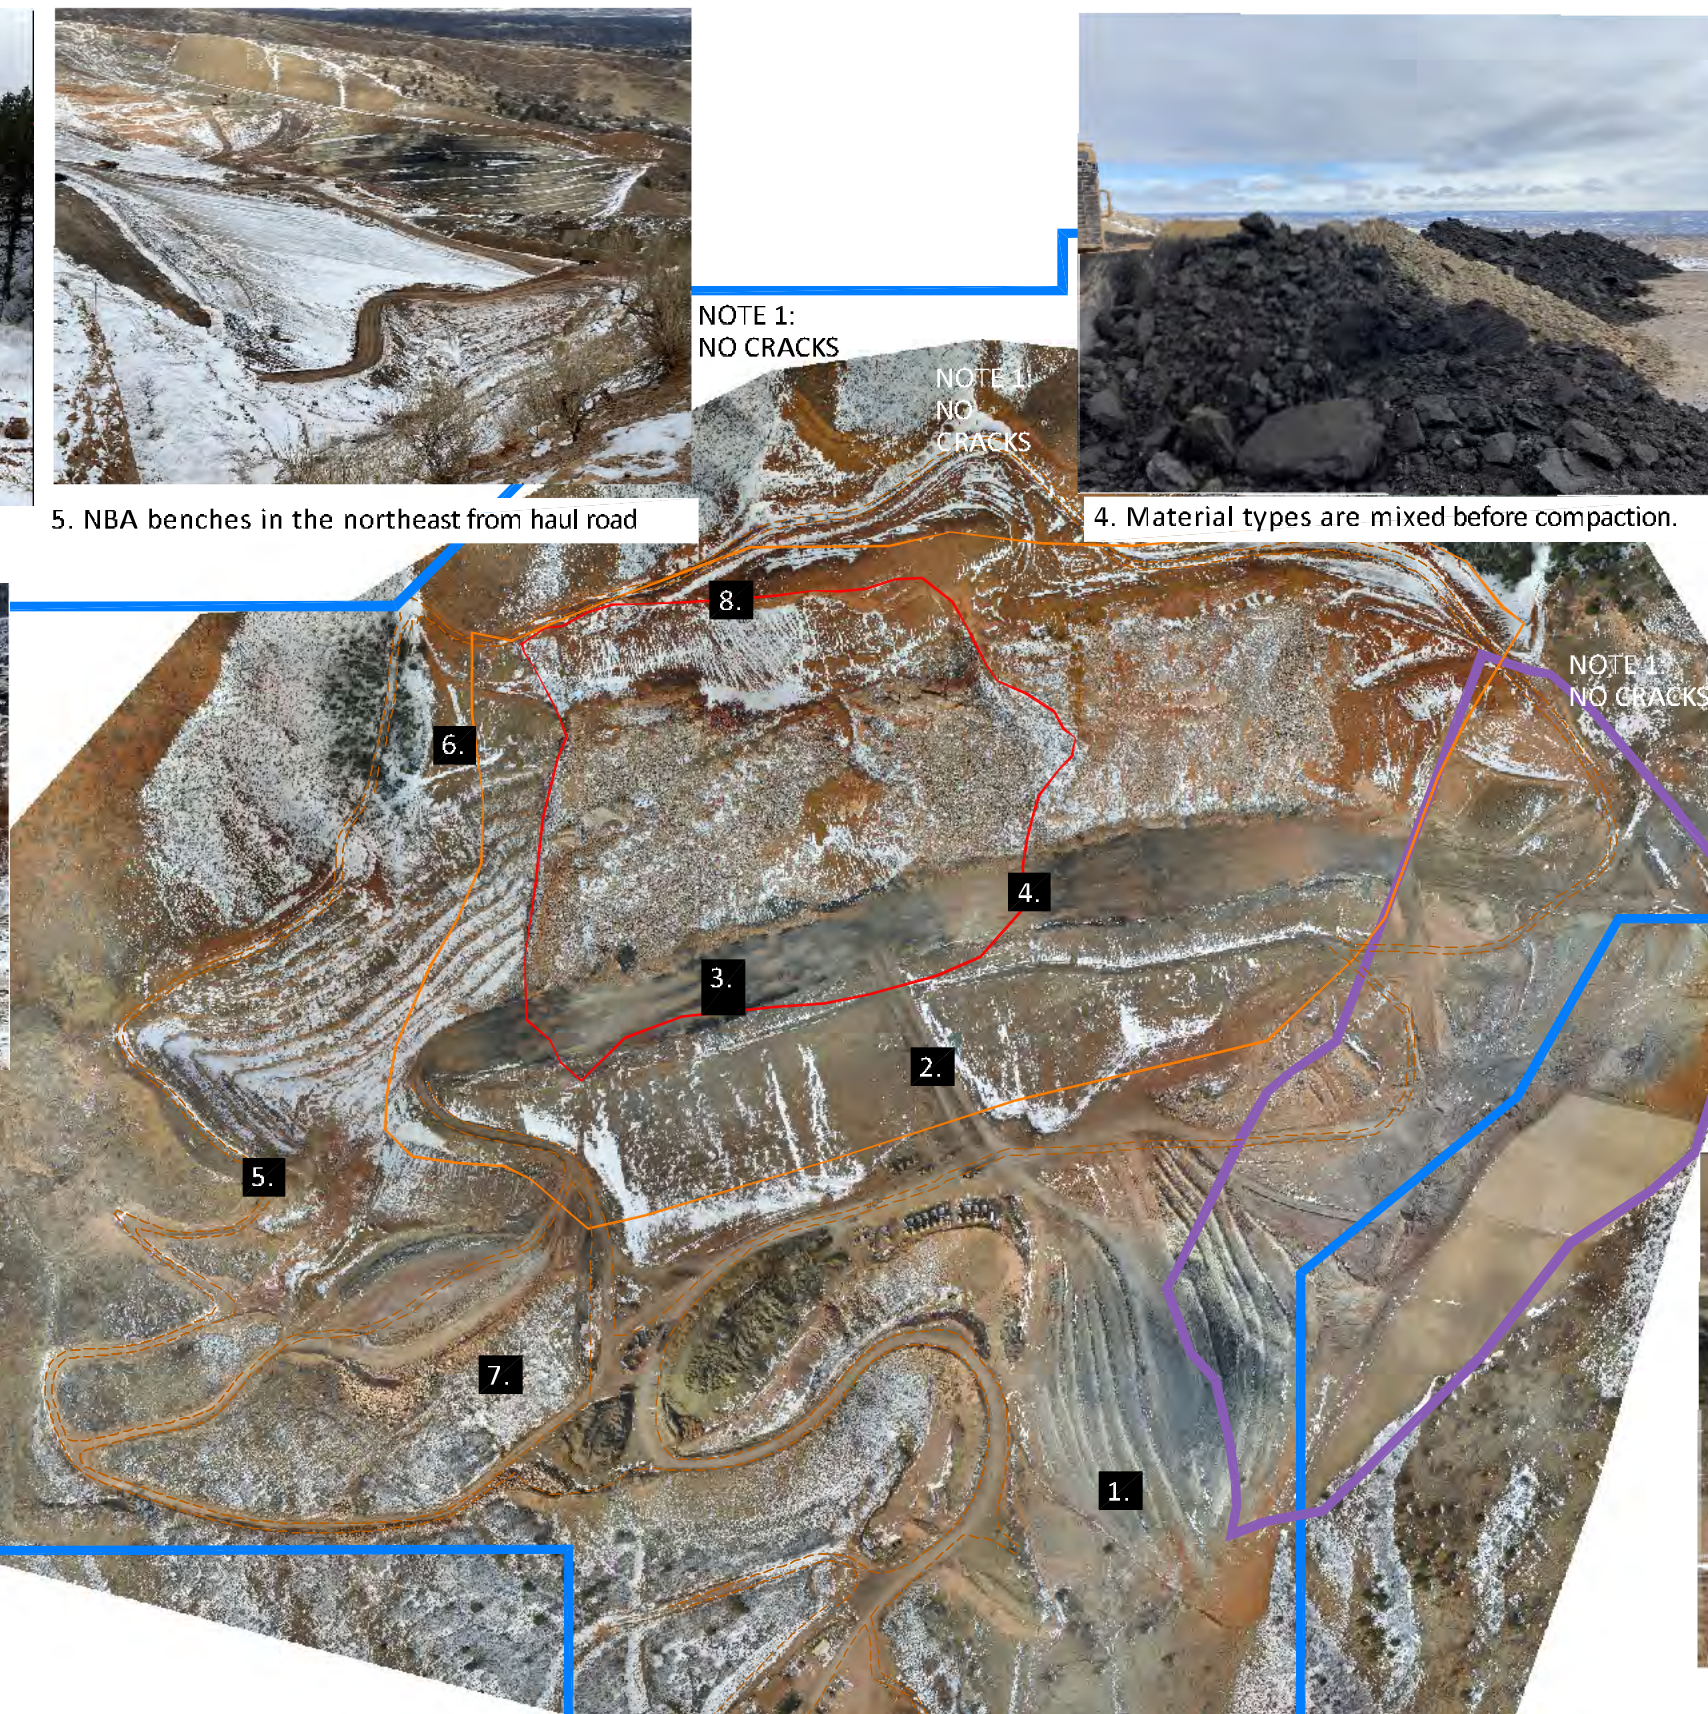
7. Material is hauled from the SBA

- Material is being excavated from the South Borrow Area and hauled to the bench for spreading and compaction. (Photo 7)
- The culvert remains cleared but mostly blocked inside. CMC has partially cleared the debris, but access limitations and supports within the culvert inhibit clearing all the debris. CMC has procured a pump and will begin pumping operations if any water collects behind the culvert. CMC inspects the culvert for ponded water following rain events, and should any water be observed, it will be removed using pumps. To date, no ponding has been observed.

NOTE 1:  
NO CRACKS

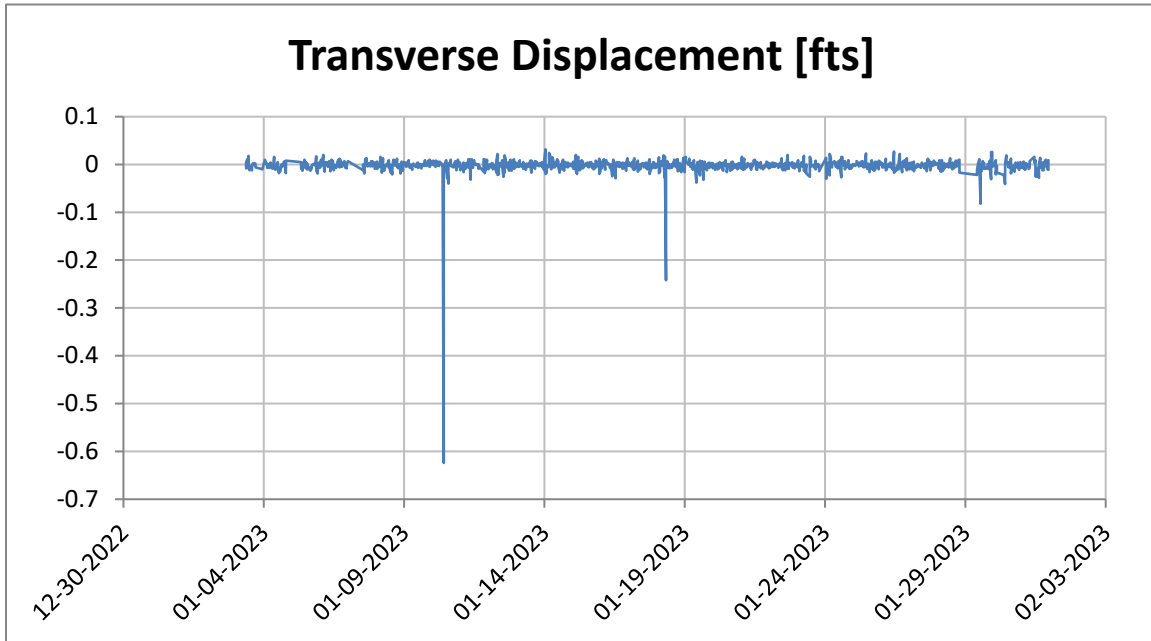
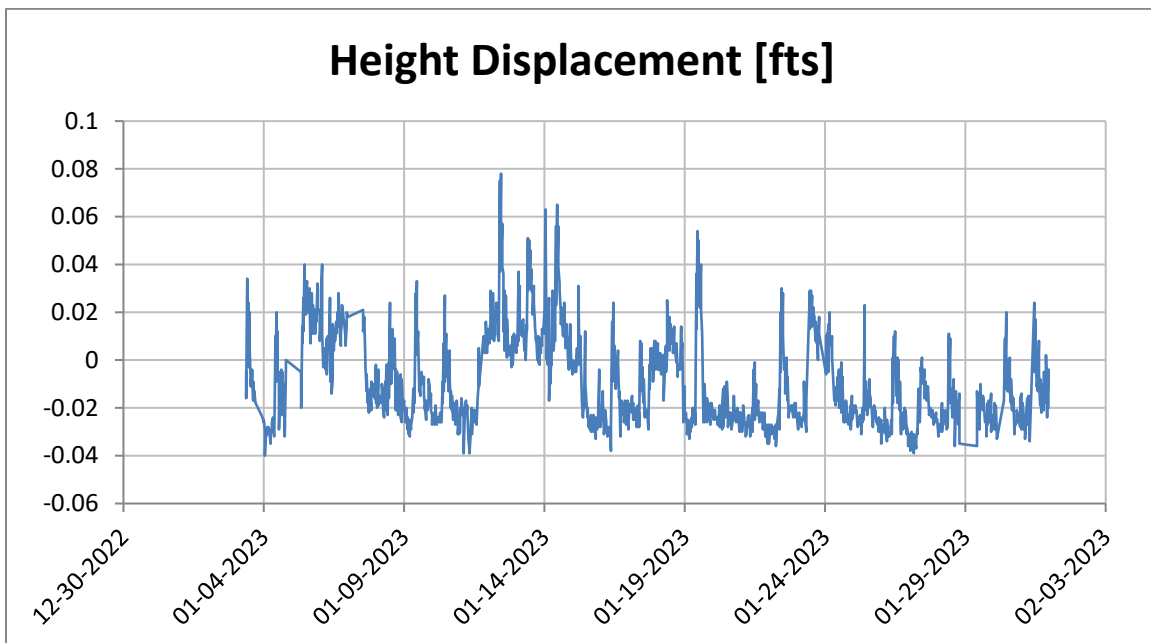
## Prism CP6

| Date(s) | Alarm | Cause/Actions taken | Issue Resolved |
|---|---|---|---|
| Jan 5 | CP6 not found | Single event. Believed to be related to sun glare. | Jan 5 |
| Jan 7 | CP6 not found | Single event. Believed to be related to sun glare. | Jan 7 |

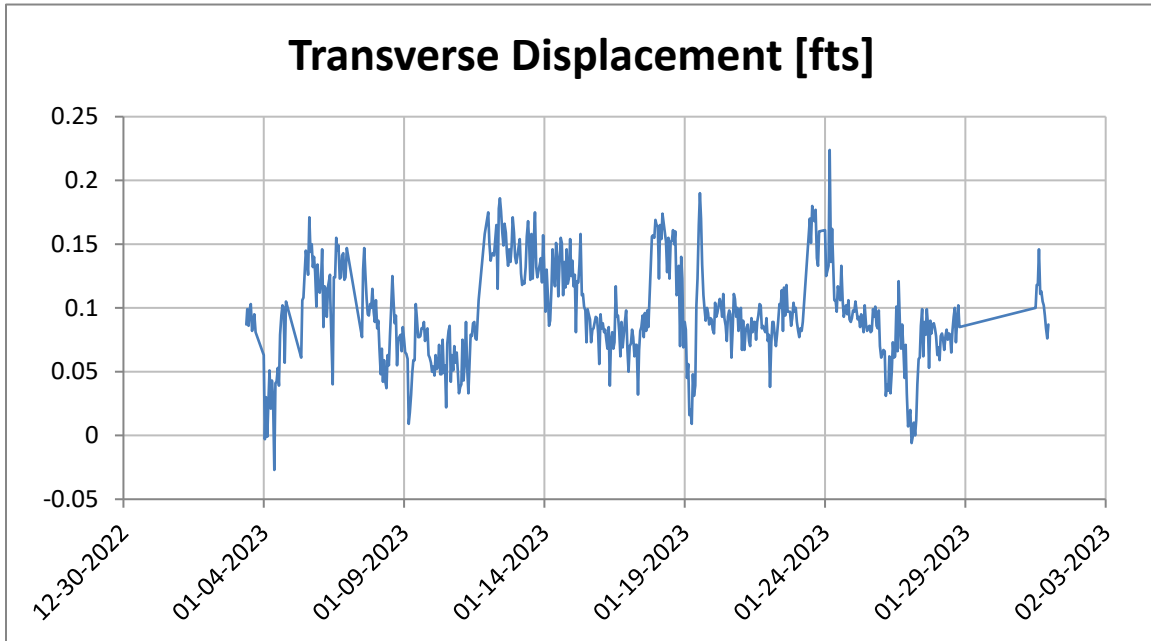
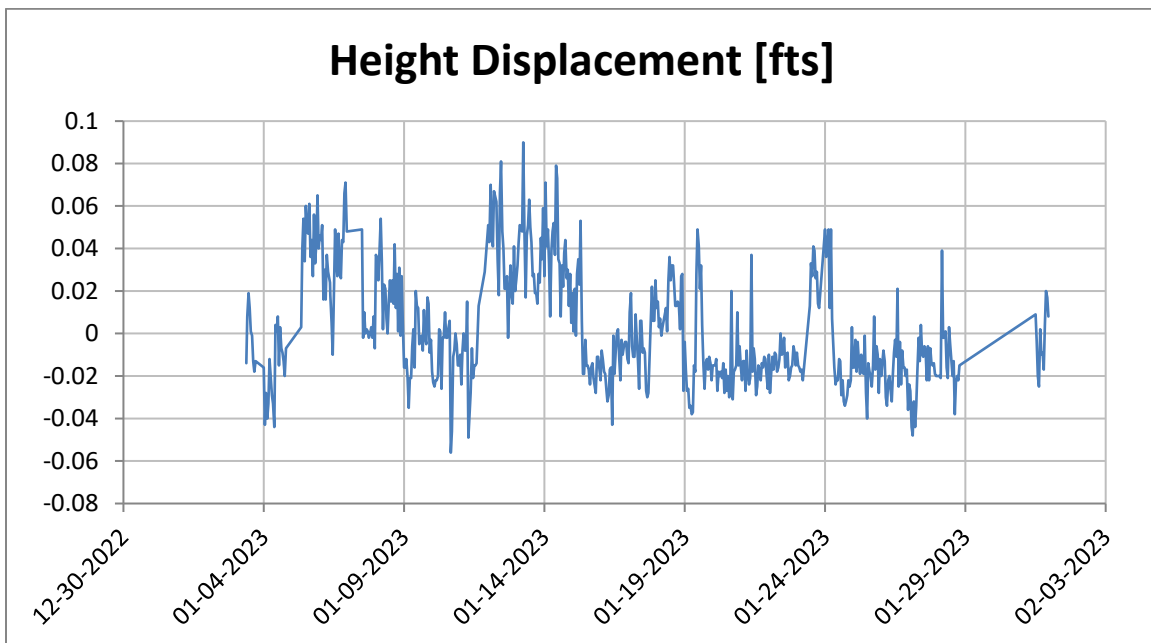
## Prism CP7

| Date(s) | Alarm | Cause/Actions taken | Issue Resolved |
|---|---|---|---|
| Jan 12 | CP7 not found | Single event. Believed to be related to equipment operations. | Jan 12 |

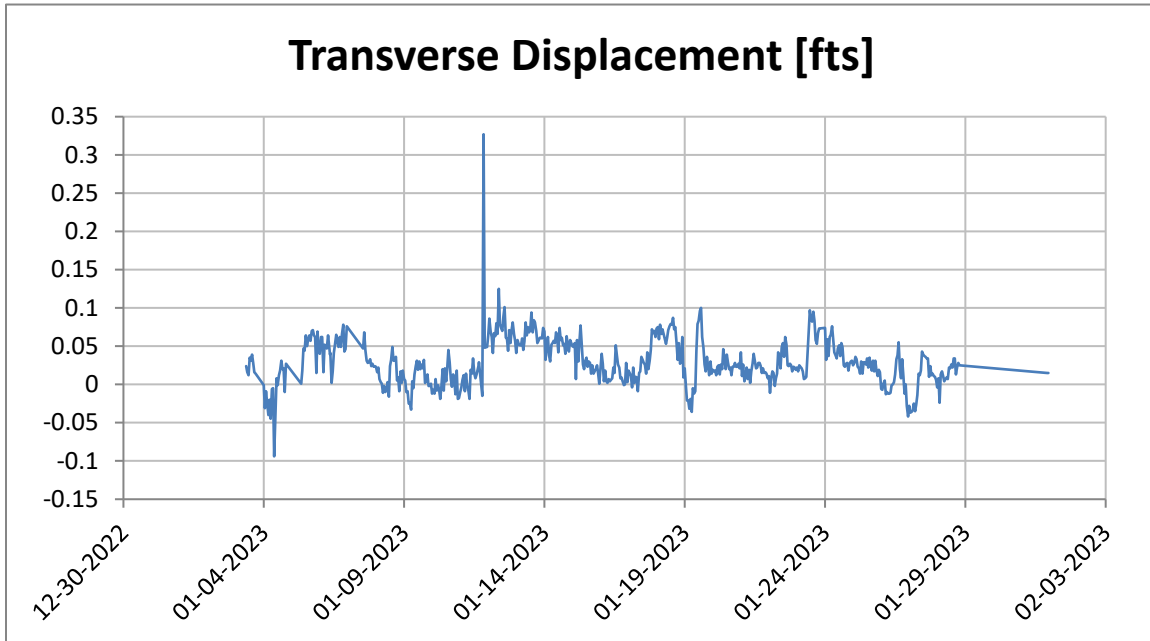
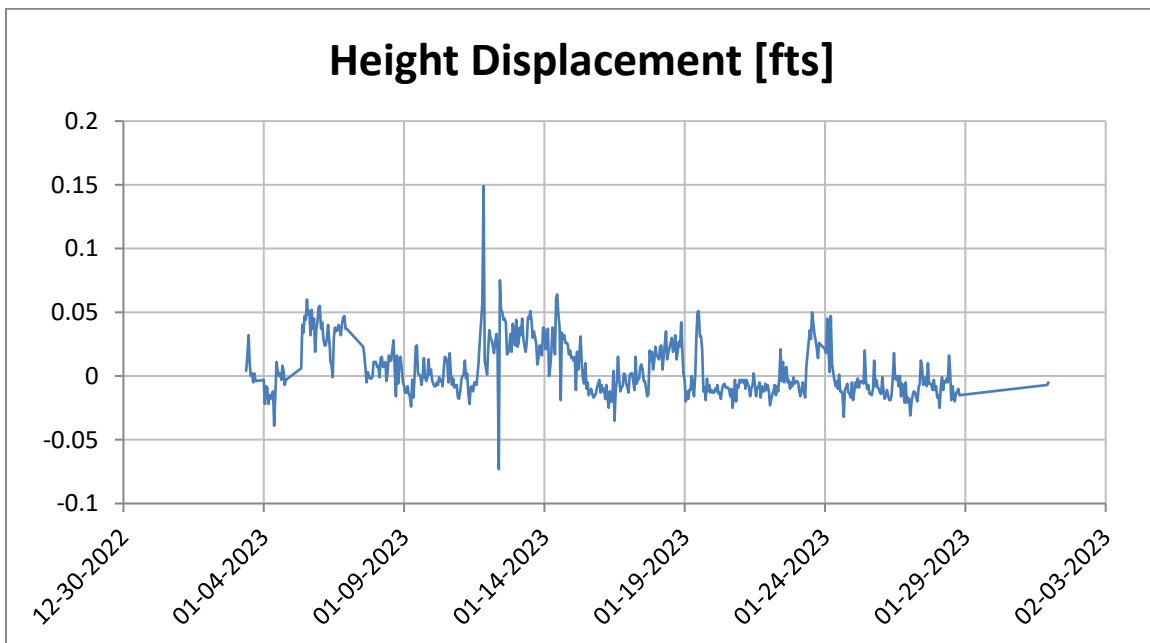
## Prism NP3

| Date(s) | Alarm | Cause/Actions taken | Issue Resolved |
|---|---|---|---|
| Jan 4 | NP2, NP3, and CP6 not found | Single events. Believed to be related to normal equipment operations or sun glare. | Jan 4 |

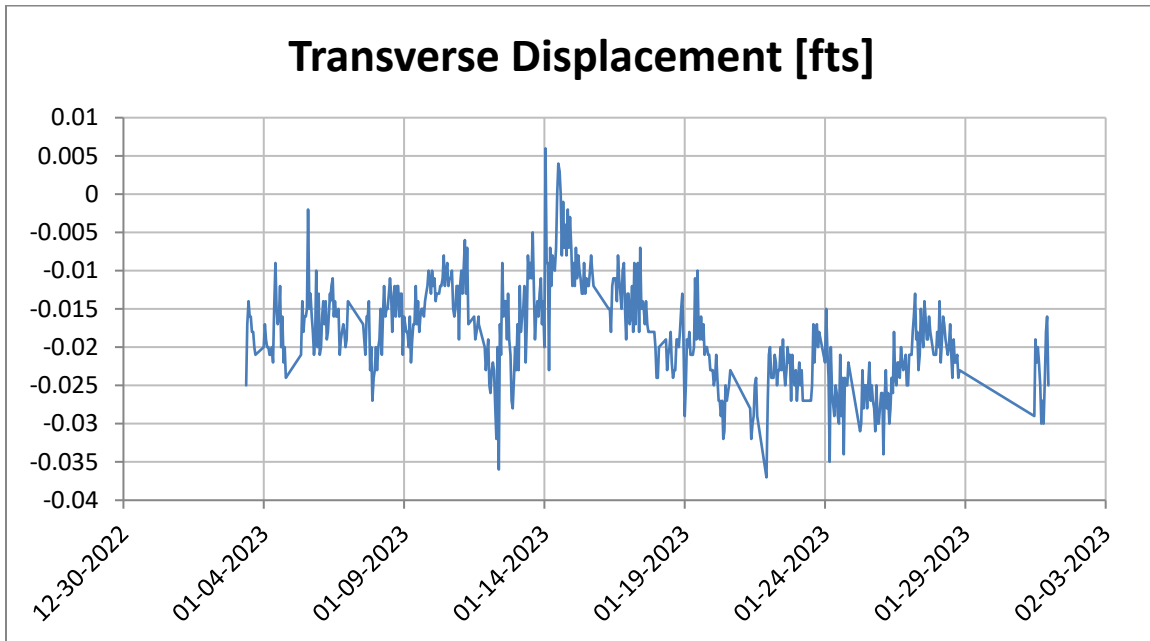
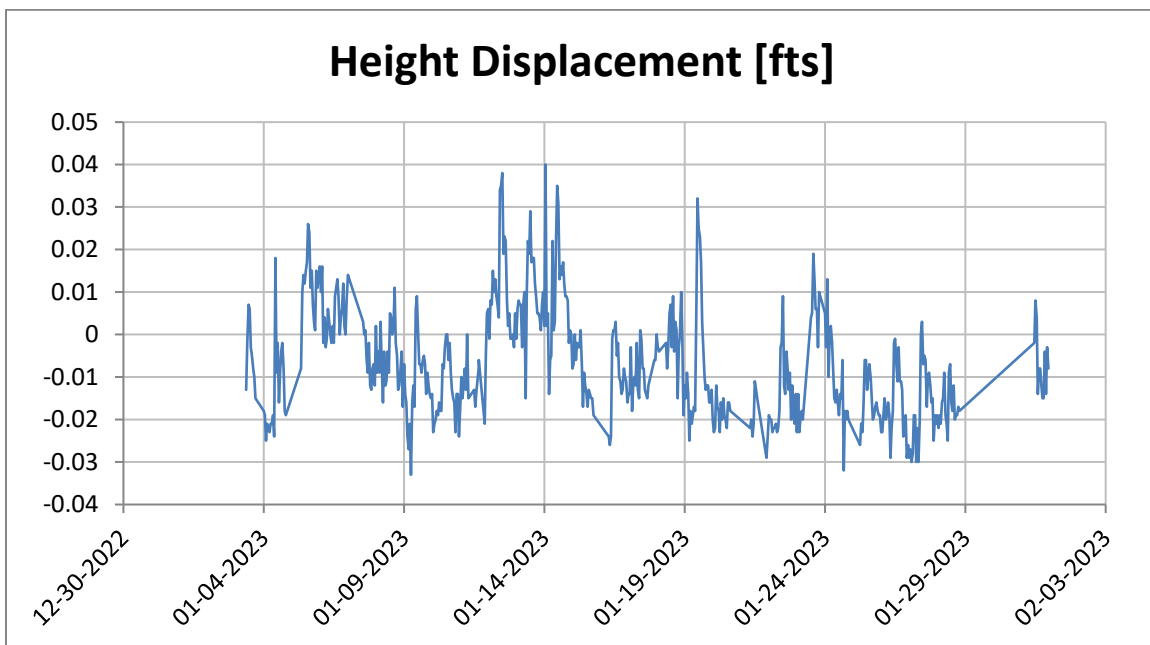
## Prism P5

| Jan 20 to Jan 21 | P5 and P70 not found | Frost on prisms. No work during alerts. | Jan 21 |
