File: February 2023 Monitoring Summary

Date: March 24, 2023

**Reference: February 2023 Geotechnical Monitoring Summary Pikeview Quarry**

PIKEVIEW QUARRY SLOPE  
MONITORING

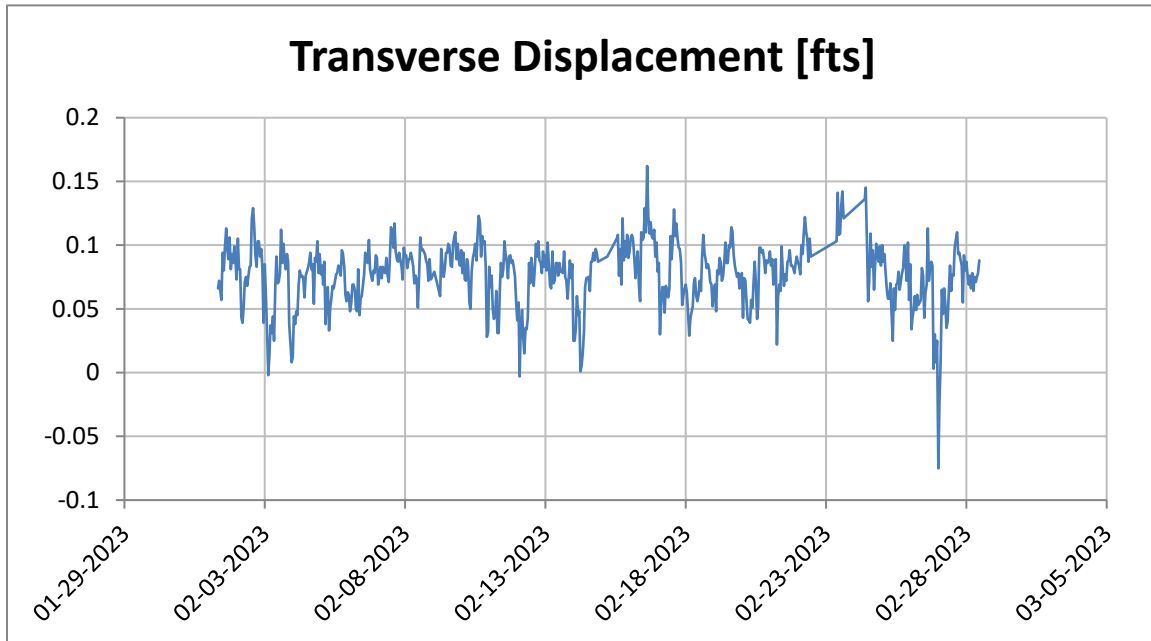
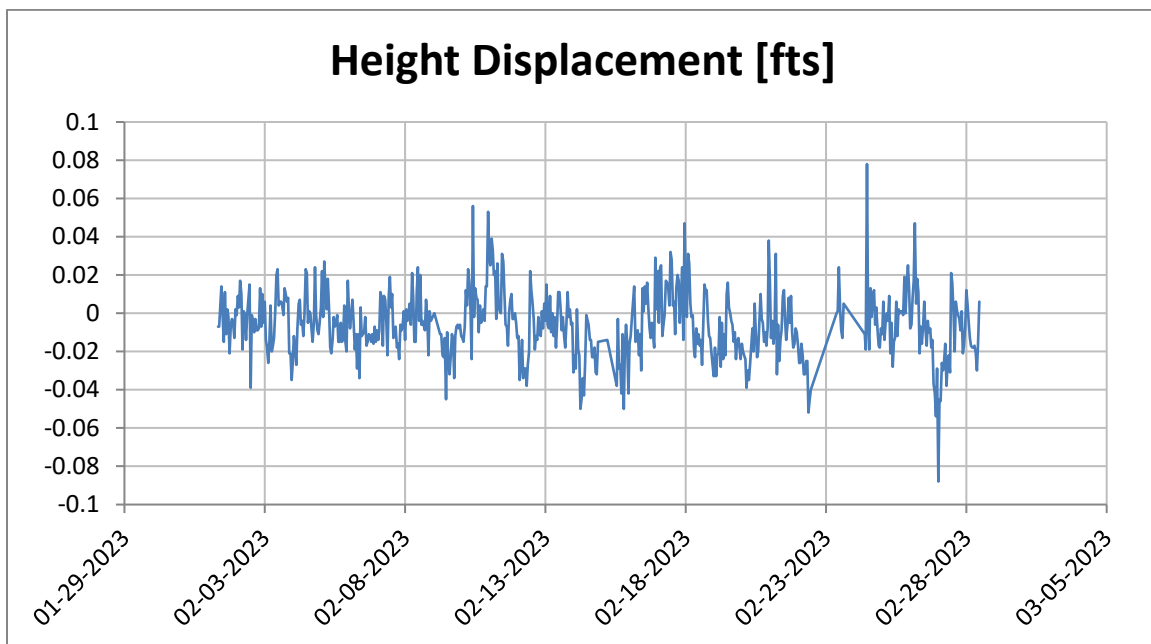
## Prism CP7

Date(s)	Alarm	Cause/Actions taken	Issue Resolved
1-Feb	CP7 not found	Single event. Believed to be related to equipment operations.	1-Feb
2-Feb	Communication errors	Single set of readings impacted before being fixed.	2-Feb
2-Feb	P2 regression limit received	Single event. Believed to be related to animal activity. No signs of movement when prism was inspected.	2-Feb
8-Feb	CP7 not found	Single event. Believed to be related to equipment operations.	8-Feb
8-Feb to 9-Feb	Points not found	Snow and fog. No work being performed at time of alerts.	9-Feb
14-Feb	CP7 not found	Single event. Believed to be related to equipment operations.	14-Feb
14-Feb to 15-Feb	Points not found	Snow and fog. No work being performed at time of alerts.	15-Feb
22-Feb	Points not found	Snow and fog. No work shut down.	22-Feb
23-Feb	Points not found	Snow and fog. Limited work due to weather.	23-Feb
24-Feb	Points not found	Snow and fog. No work being performed at time of alerts.	24-Feb

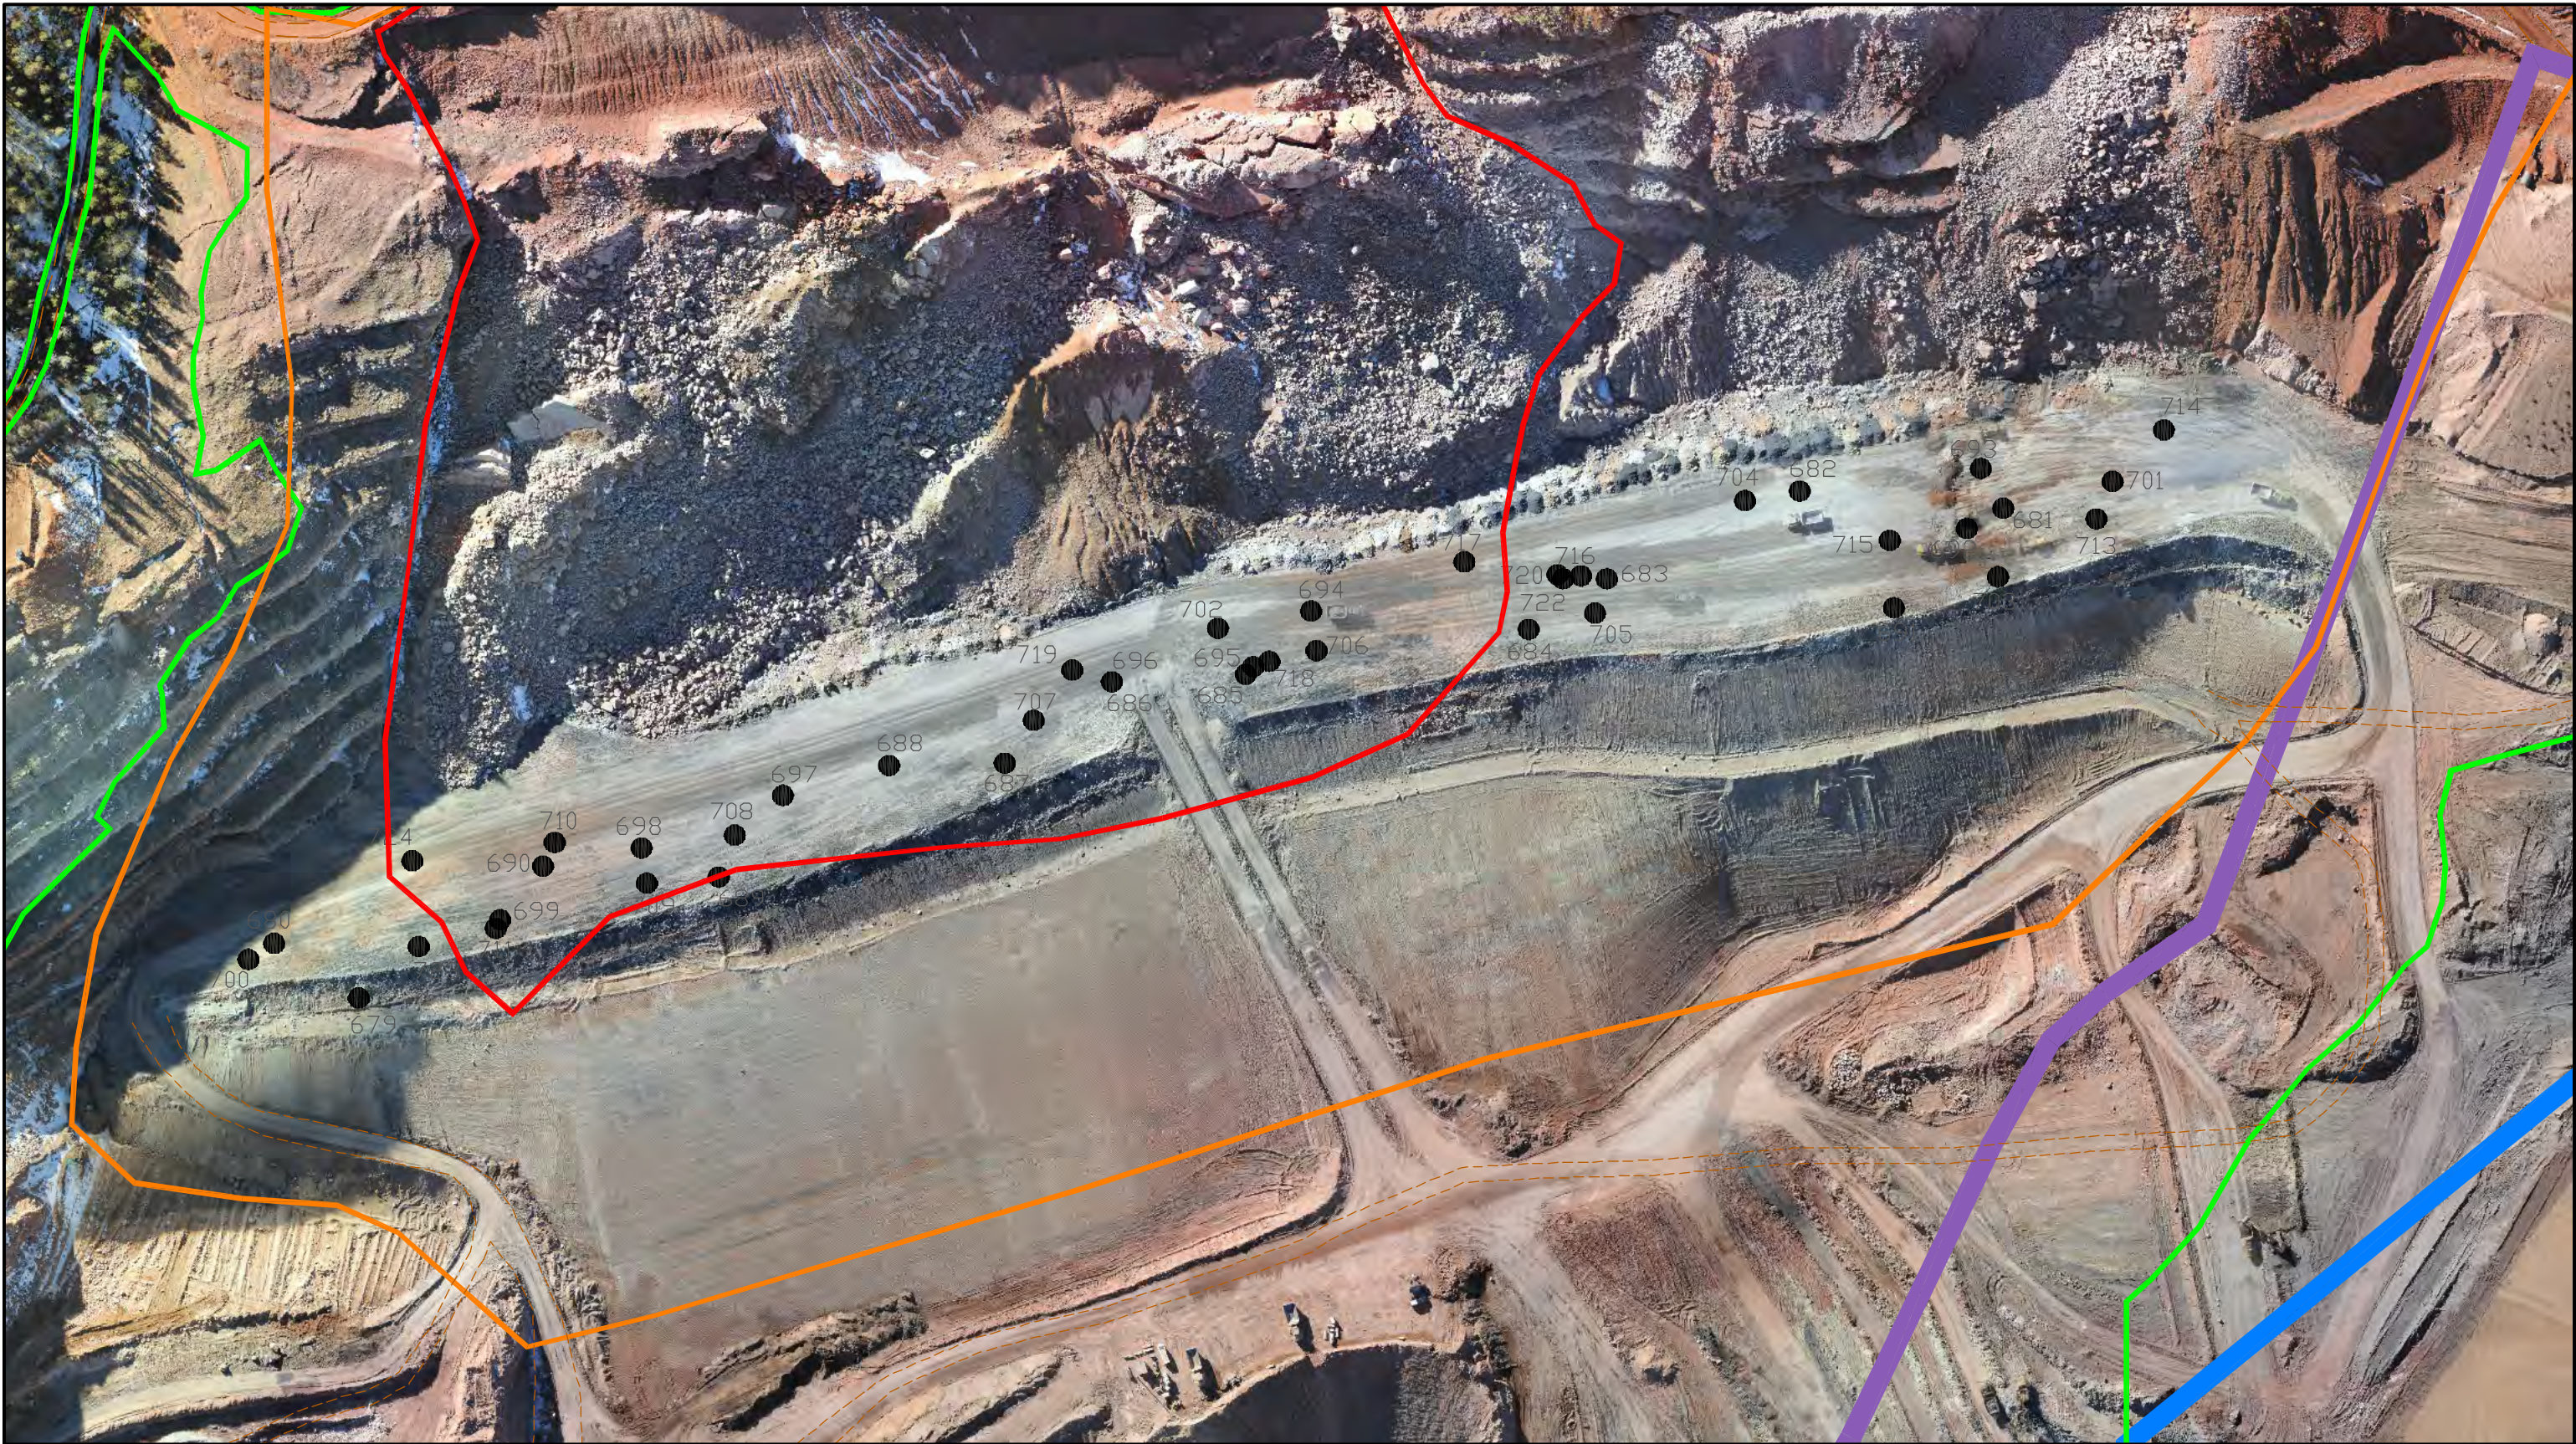
Fill placement started on February 25, 2022 and continued throughout February 2023. Fill was excavated from the Shop and North Borrow Areas and placed in the buttress and buffer zones. Importing fill also continued. All fill is moisture conditioned as necessary and then compacted. Compaction testing began March 2022 and occurs at the rate of at least one test per 5,000 yd<sup>3</sup> placed. During February, approximately 106,700 yd<sup>3</sup> was placed and compacted. This does not include approximately 3,200 yd<sup>3</sup> of imported topsoil. This volume placed in the buttress zone required at least 22 compaction tests. There were 45 compaction tests taken in February. As of February 28, 2022, a total of approximately 2,100,000 yd<sup>3</sup> had been placed and compacted. This required at least 420 compaction tests, and 718 tests have been taken. All tests in February met or exceeded the minimum compaction requirement of 90% of the optimal density as measured by a Standard Proctor Test. These areas were recompacted and the subsequent tests met the project requirements. The compaction testing results are summarized in Appendix D, and the testing locations are shown on Figure 6.
