MINERALS PROGRAM INSPECTION REPORT
PHONE: (303) 866-3567

MINE NAME: Riverbend Operation	MINE/PROSPECTING ID#: M-2000-016	MINERAL: Sand and gravel	COUNTY: Weld
INSPECTION TYPE: Monitoring	WEATHER: Clear	INSP. DATE: April 3, 2023	INSP. TIME: 10:00
OPERATOR: Martin Marietta Materials, Inc.	OPERATOR REPRESENTATIVE: Julie Mikulas	TYPE OF OPERATION: 112c - Construction Regular Operation	
REASON FOR INSPECTION: Citizen Complaint	BOND CALCULATION TYPE: Partial Bond	BOND AMOUNT: \$3,150,000.00	
DATE OF COMPLAINT: March 27, 2023	POST INSP. CONTACTS: None	JOINT INSP. AGENCY: None	
INSPECTOR(S): Peter Hays	INSPECTOR'S SIGNATURE:

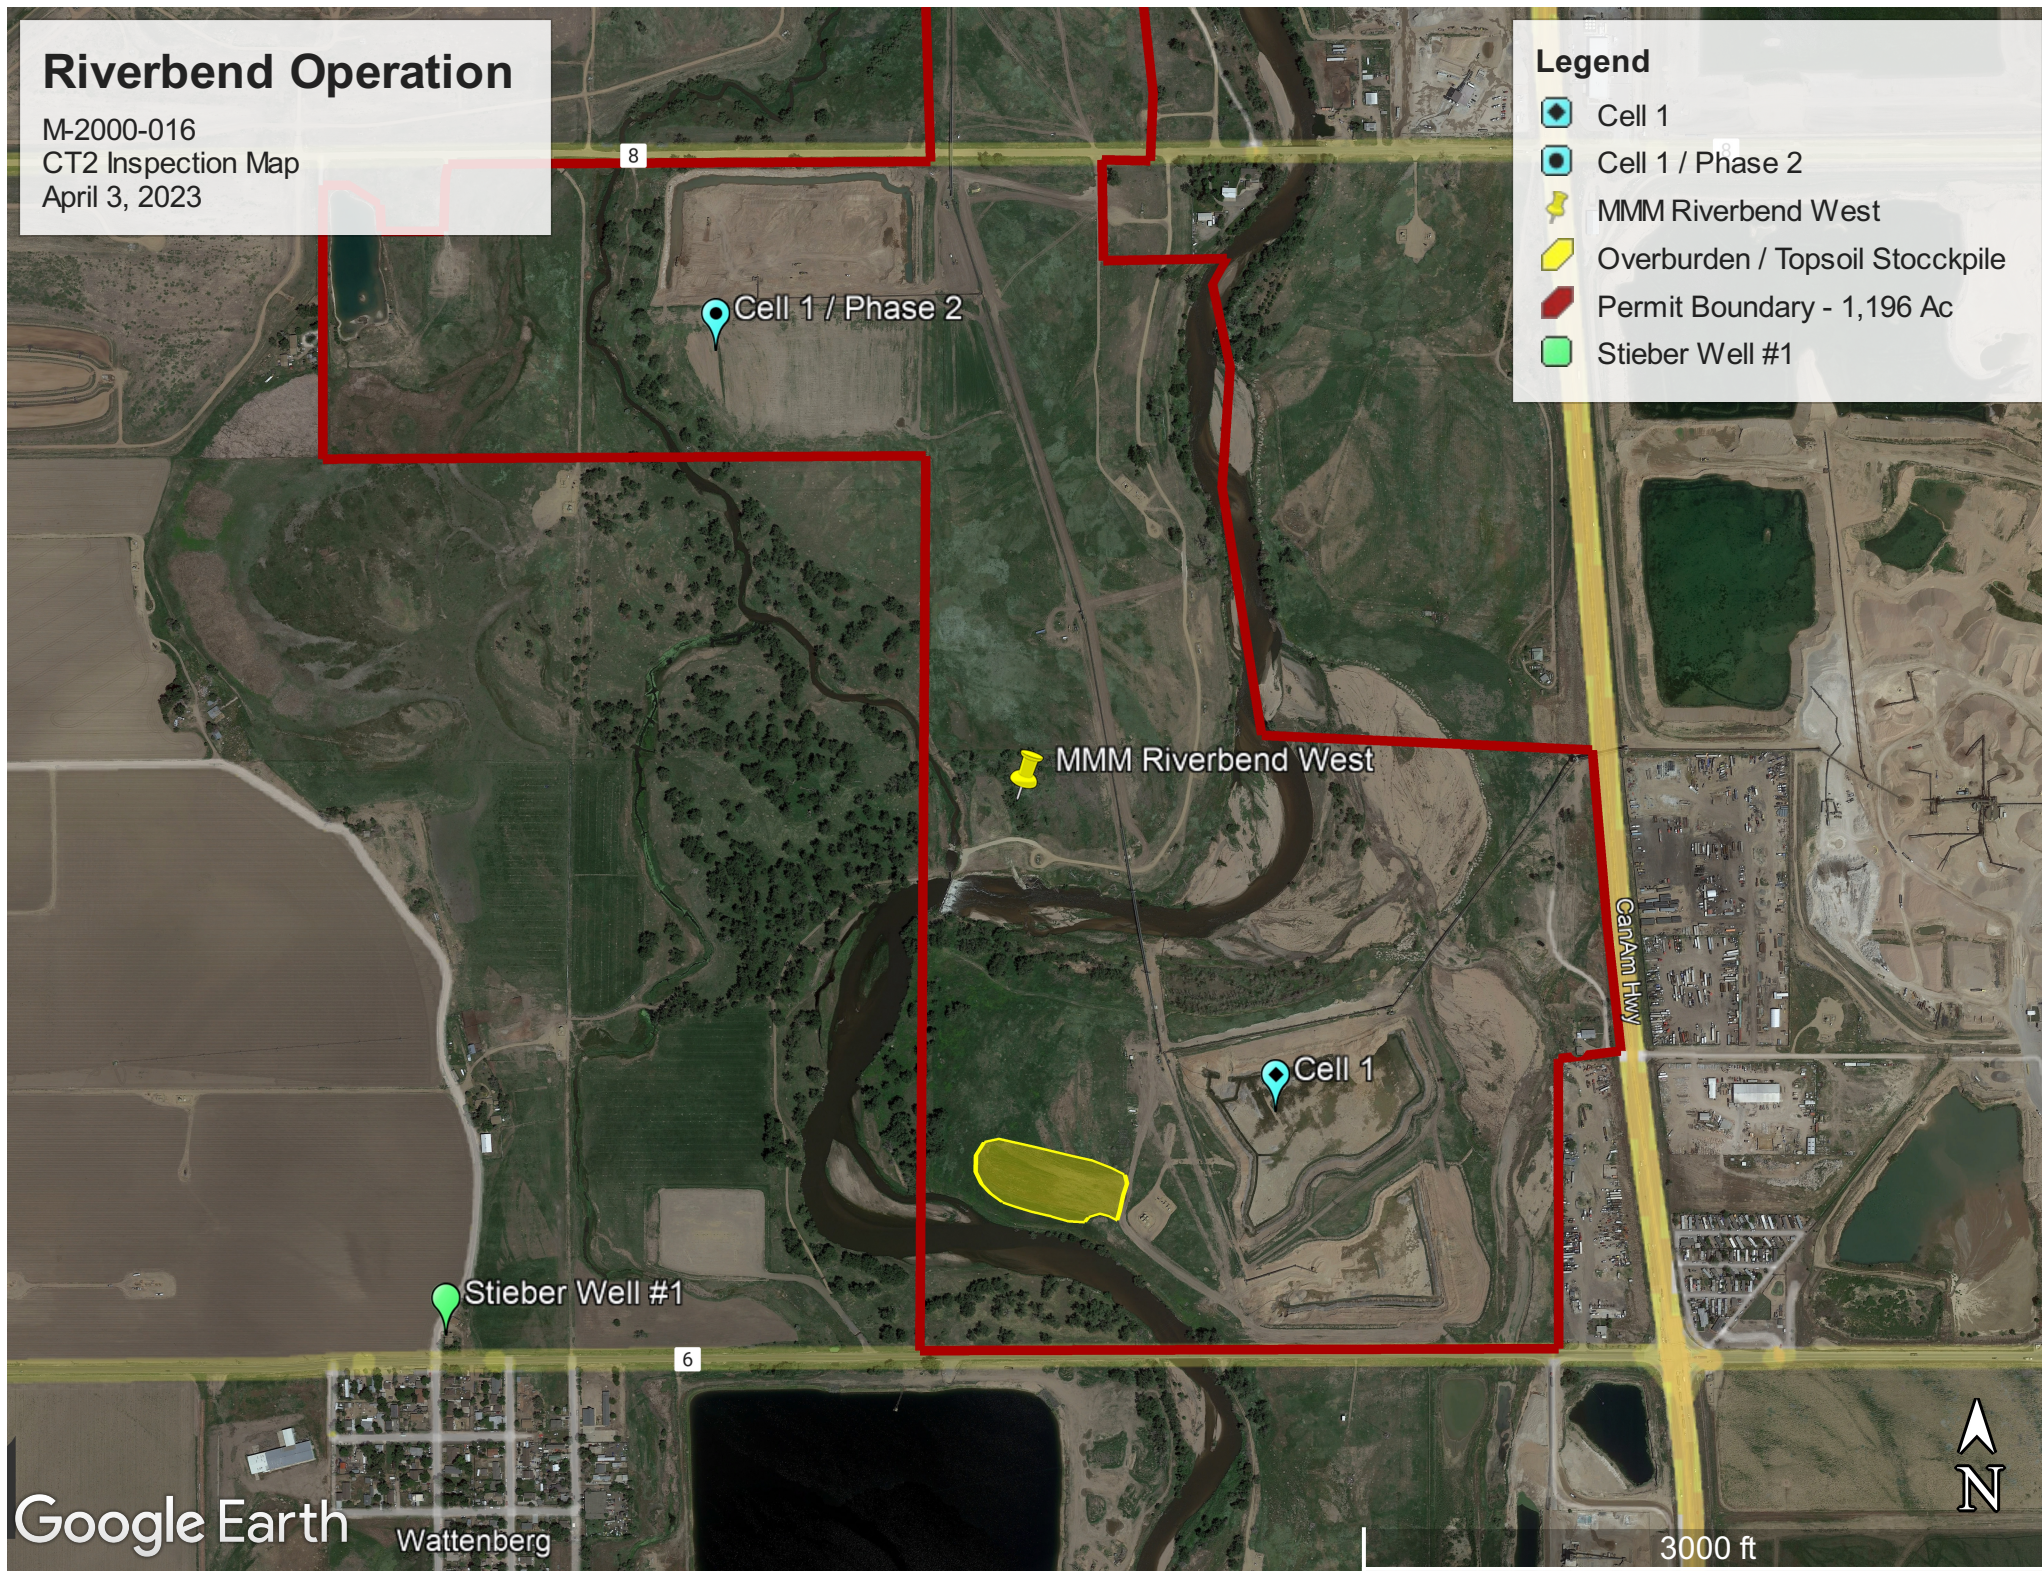
Stieber Well #1

The Stieber well is located approximately 0.50 miles west of Cell 1 (Rittenhaus) and 0.75 miles southwest of Cell 1 / Phase 2 (Norden). The South Platte River is located between the well and Cell 1. The Fort Lupton Ditch is located between the well and Cell 1 / Phase 2. The other three (3) wells on the property were not reported to be dry by the landowner. The remaining three wells were not observed by the Division during the inspection.

The Division observed two (2) plastic cisterns during the inspection. The black cistern was empty and not being used because the tank contained mud. The second clear cistern contained water and was plumbed into the water well pump for the residence. The cisterns were placed on the ground north of the Stieber home. Mr. Stieber stated the cistern system was working properly and the residence had adequate water. Mr. Stieber and the Operator were arranging the water delivery frequency based on the actual water usage for the home.
