### PITCH RECLAMATION PROJECT COLORADO MINED LAND RECLAMATION BOARD 2022 ANNUAL RECLAMATION REPORT

**RECLAMATION PERMIT NUMBER M-1977-004**

April 2023

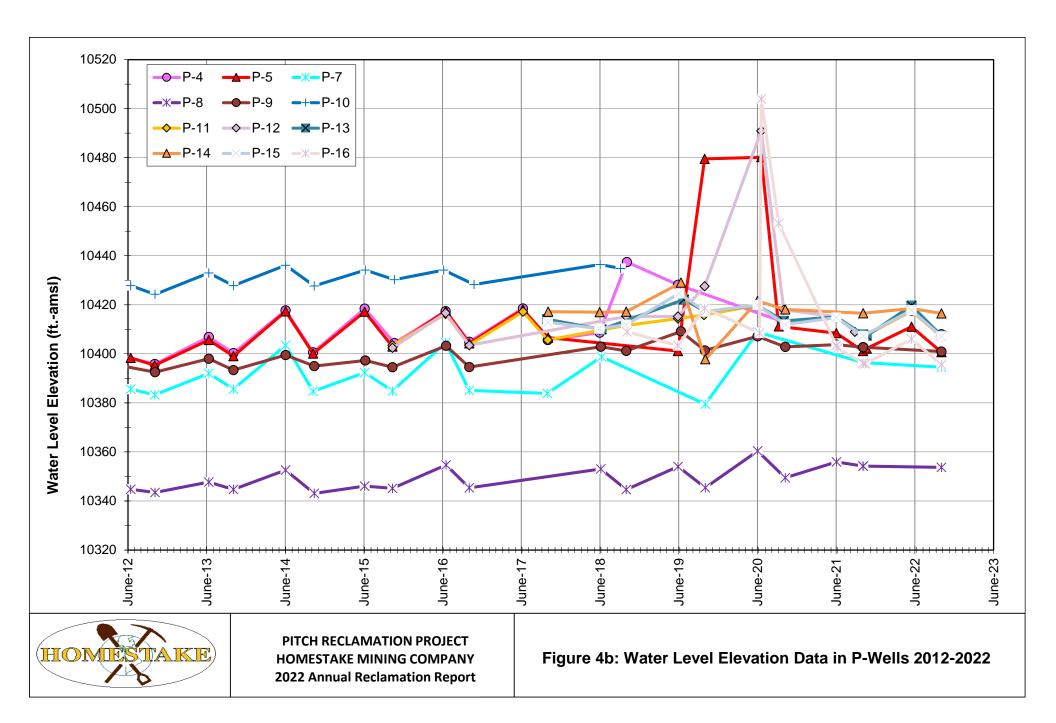
Figure 4a: Water Level Elevation Data in P - Wells 1995-2022

Water levels in the wells fluctuate seasonally, with the highest levels observed in late May or early June, coinciding with snowmelt (Figure 4a). During phosphate injection events, water levels fluctuated more strongly in response to active water recirculation. Water levels in Figure 4b represent the data obtained during low- and high-flow sampling events (i.e., not collected during active phosphate injection) from 2012 to 2022 to provide additional clarity. Spring and summertime water levels vary from year to year because of the magnitude and timing of snowmelt and heavy summer precipitation events; however, water levels under low-flow or "baseflow" conditions can be used to assess long-term trends. Overall, the baseflow water levels indicate a groundwater gradient to the north/northwest. This gradient is steepest on the southern end

- Water levels in wells P-4 and P-5, which are in direct hydraulic connection with the underground mine workings, have been very similar in low flow since 1997. Since the installation of wells P-11 and P-12 in 2015, the water levels in the wells have been comparable to each other and comparable to P-4 and P-5. Wells P-5 and P-12 exhibited higher water levels during summer months during the operation of the phosphate injection systems in 2015 through 2020; water levels in 2021 (without phosphate injections) were similar to water levels prior to the initiation of injections in 2017 (Figure 4a).

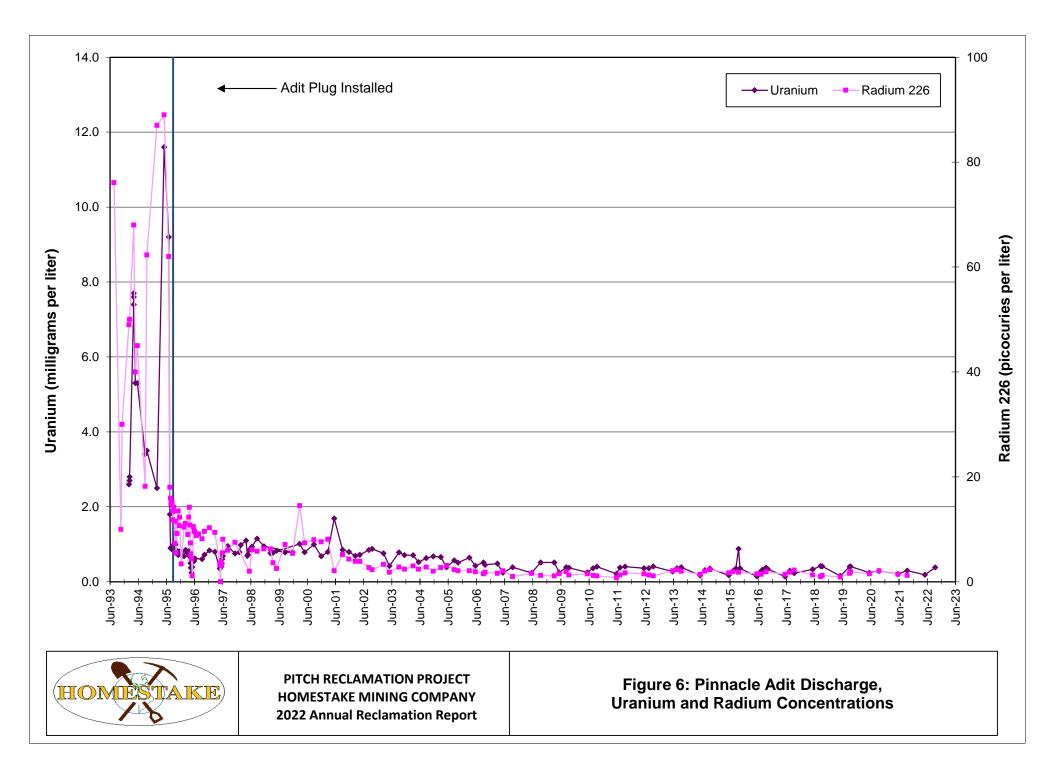
Figure 5: Hydrograph of Pinnacle Adit Discharge

The flow rate from the Pinnacle adit at PP-01 has been monitored since November 1993. The flow generally consists of a seasonal pattern of high flows during the short period of spring melt in late May or early June and stable flows of less than 10 gallons per minute throughout the year (Figure 5). The spike in flows observed at PP-01 each spring are a result of snowmelt and runoff, likely from sources originating between the Pinnacle plug and the PP-01 monitoring point. Once the snowmelt is over, the flow rate at PP-01 decreases and stabilizes at baseflow levels. In 2022, above average amounts of snowpack were observed, and flows at PP-01 remained similar to the flows since fall of 1999.

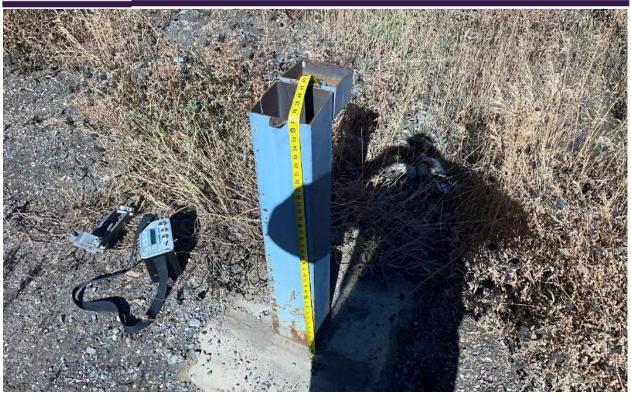
Photo 3: Stickup of casing, measured from concrete base

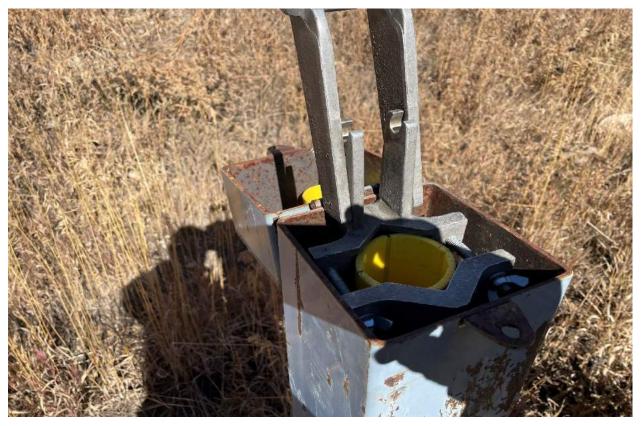
Photo 4: Pulley mechanism used for accessible casings

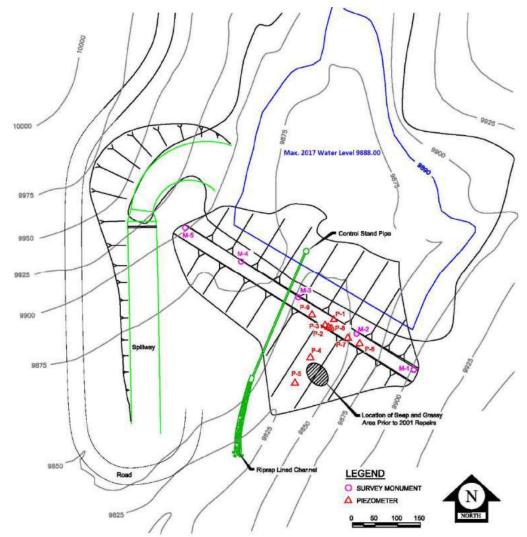
Figure 1-1. Monitoring station locations (Glasgow, 2002).

The survey monuments (M1 to M5) measure vertical displacement and are located near the upstream side of the embankment crest level, as shown on **Figure 1-1**. The five permanent survey monuments have been surveyed annually since 1981.
