**MINERALS PROGRAM INSPECTION REPORT**  
**PHONE: (303) 866-3567**

<b>MINE NAME:</b> Two Rivers	<b>MINE/PROSPECTING ID#:</b> M-1998-038	<b>MINERAL:</b> Gravel	<b>COUNTY:</b> Pueblo
<b>INSPECTION TYPE:</b> Monitoring	<b>WEATHER:</b> Clear	<b>INSP. DATE:</b> April 5, 2023	<b>INSP. TIME:</b> 12:00
<b>OPERATOR:</b> Kirkland Construction, R.L.L.P.	<b>OPERATOR REPRESENTATIVE:</b> Jodi Schreiber	<b>TYPE OF OPERATION:</b> 112c - Construction Regular Operation	
<b>REASON FOR INSPECTION:</b> Surety Related	<b>BOND CALCULATION TYPE:</b> Complete Bond	<b>BOND AMOUNT:</b> No Bond Held	
<b>DATE OF COMPLAINT:</b> NA	<b>POST INSP. CONTACTS:</b> None	<b>JOINT INSP. AGENCY:</b> None	
<b>INSPECTOR(S):</b> Amber Michels	<b>INSPECTOR'S SIGNATURE:</b>

**INSPECTION TOPIC:** Backfilling & Grading

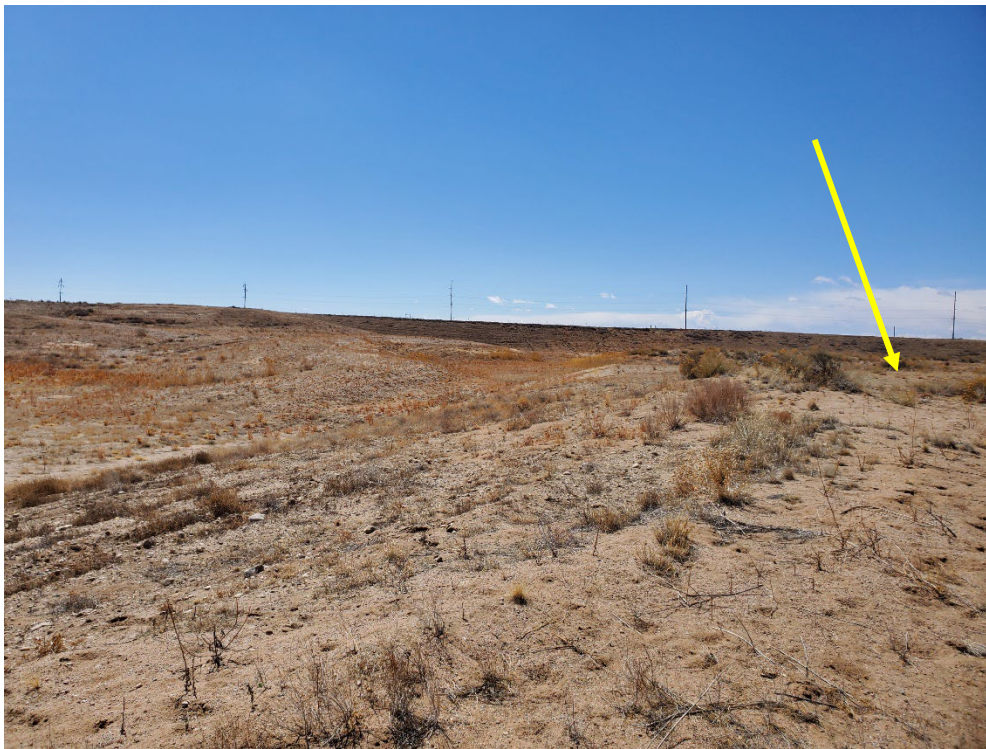
**Photo 12:** Standing on the western edge of the Phase 1 area, looking south at regraded slopes. The yellow arrow points to the south-east corner of Phase 2 that was inspected during part one of this SO1 inspection series.

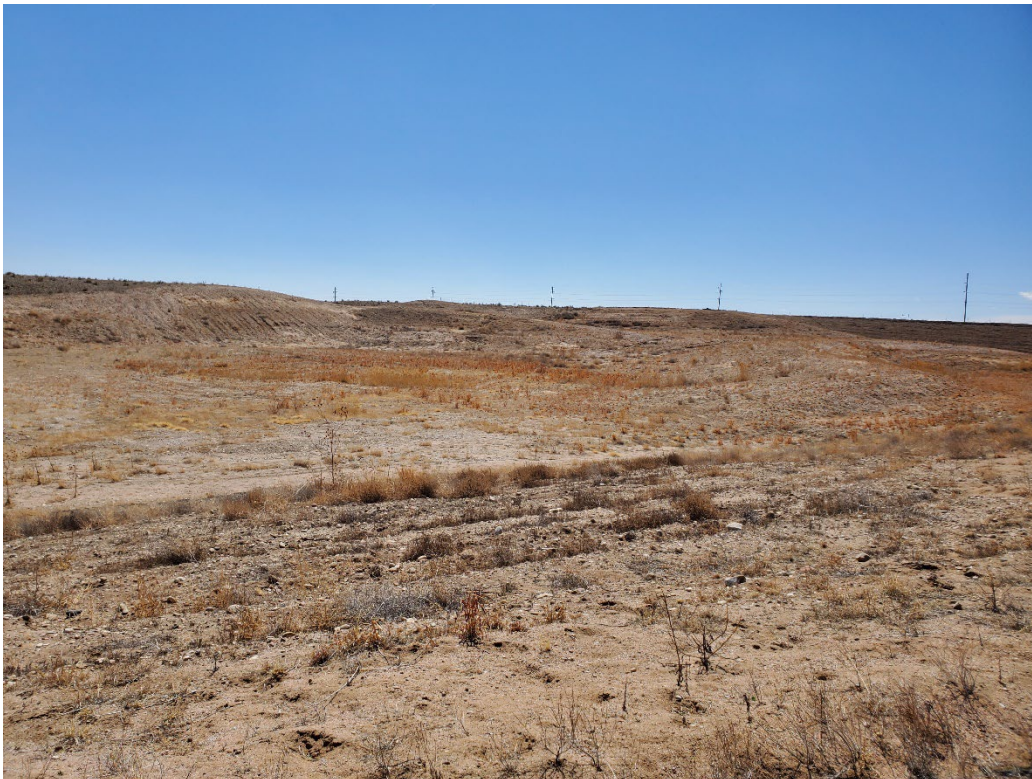
The highwalls located in the Phase I area cited in the Division's January 2020 inspection and reported to have been reclaimed (mentioned in Part One of the 2023 inspection series), were observed during this inspection. The highwalls in the Phase I area have been returned to 3H:1V slopes. The slopes on the west side of the Phase I area appears to have been seeded, and are growing sparse vegetation (Photos 24 and 25). The slopes on the east side of the Phase I area possess rills, and have very little vegetation established on them (Photos 14-17). It is difficult to determine whether or not they have been seeded. Along the northern border of the Phase I pit, there is an earthen berm that stretches from west to east. Near the center of this berm (see Marker 3 on Map 1), there is a deep erosional feature (Photos 18-20, and 22). There is vegetation growing within this eroded section, and it does not appear to be affecting the area downslope and to the north.

**Photo 14:** Standing on the western edge of the Phase 1 area, looking south-east at regraded slopes.

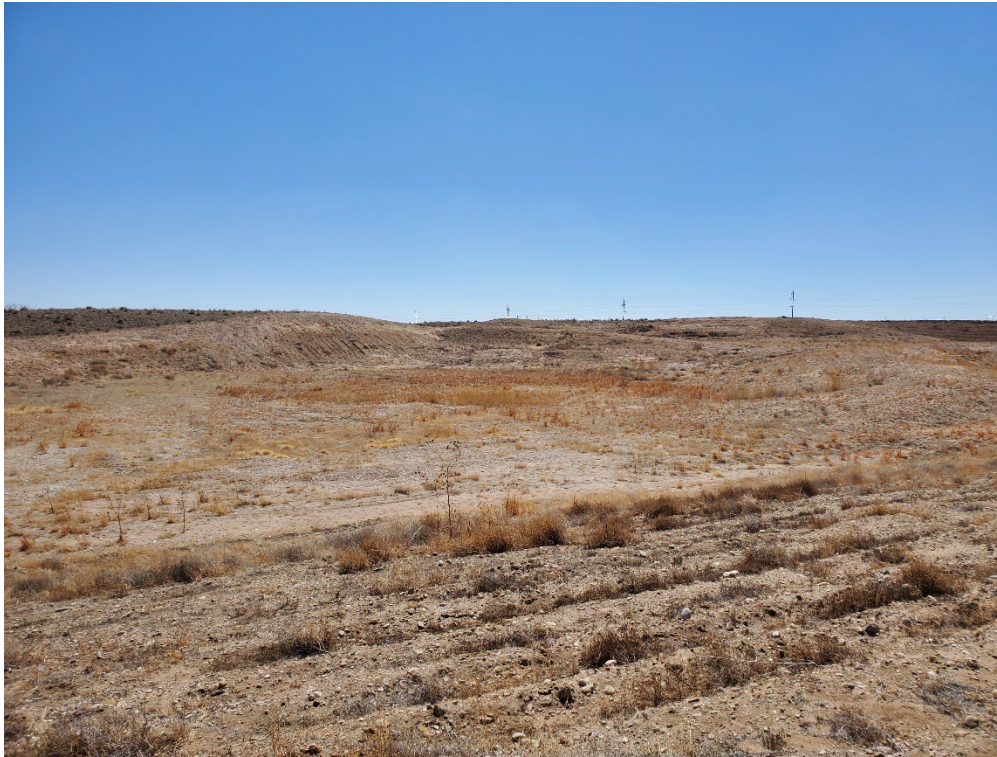
**Photo 17:** Looking south from the eastern facing side of the western slope of the Phase 1 area.

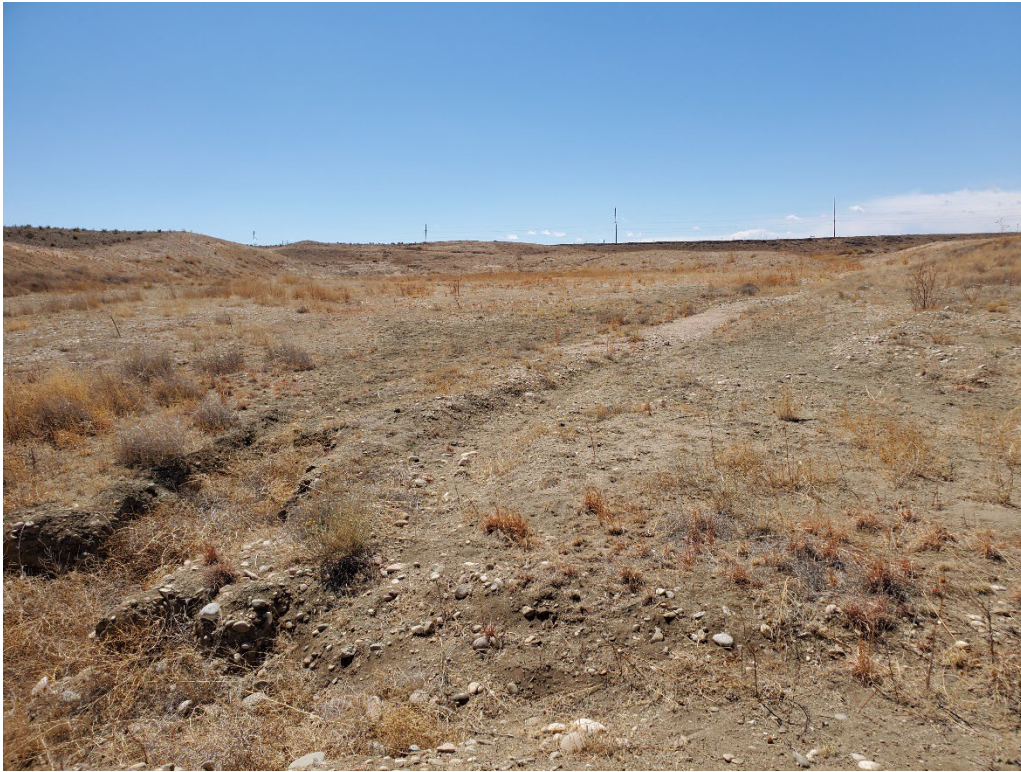
A problem has been cited above for the deep erosional feature, or gully, located in the earthen berm at the northern border of the pit in Phase 1. Because the berm separates Phase I from the lowland area to the north that is currently not approved to be affected by mining, the prospective Successor will be responsible for repairing the gully by the corrective action date. The prospective Successor is also advised to monitor the rills observed on the highwalls in the Phase I area through ensuring that they remain stable and that they do not deepen or subsequently cause substantial erosion to occur.

**Photo 23:** Standing on eroded berm in the north portion of Phase I, looking south across the reclaimed pit.

**CORRECTIVE ACTIONS:** The operator shall provide photo documentation to the Division verifying the erosion gully has been repaired, and that the site has have been reconstructed and stabilized to prevent erosion damage by the corrective action date.

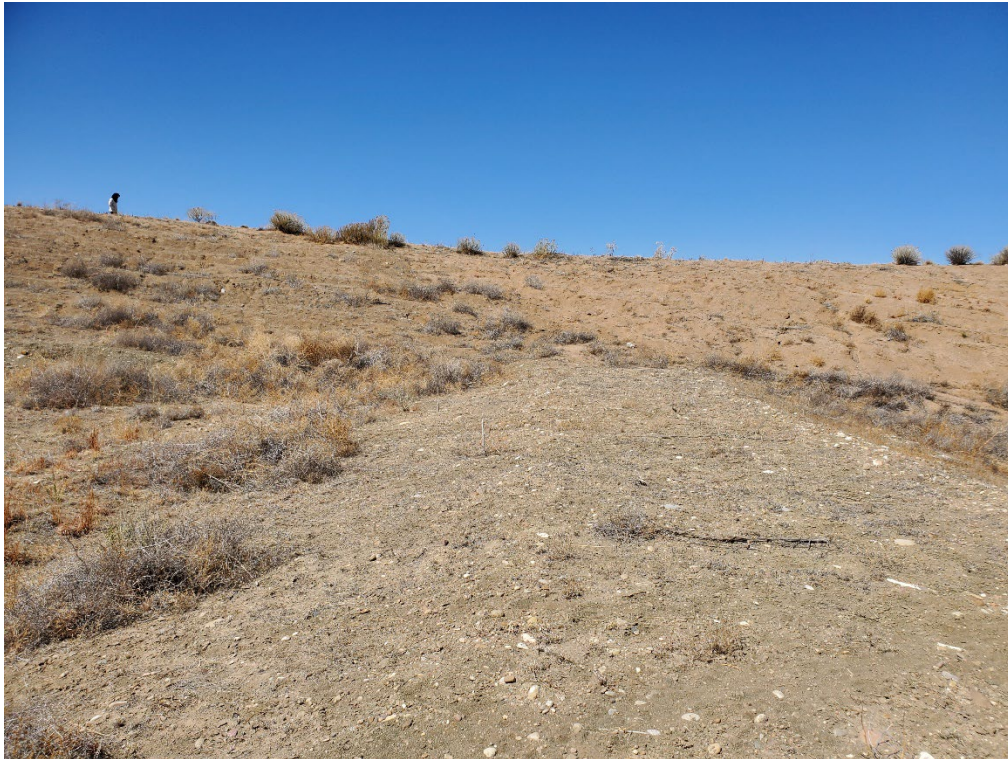
**Photo 25:** Standing on the berm in the north portion of Phase 1, facing west.
