**MINERALS PROGRAM INSPECTION REPORT**  
**PHONE: (303) 866-3567**

<b>MINE NAME:</b> Rifle Gravel Pit #1	<b>MINE/PROSPECTING ID#:</b> M-2021-052	<b>MINERAL:</b> Gravel and sand	<b>COUNTY:</b> Garfield
<b>INSPECTION TYPE:</b> Preoperation Inspection	<b>WEATHER:</b> Cloudy	<b>INSP. DATE:</b> April 12, 2023	<b>INSP. TIME:</b> 15:00
<b>OPERATOR:</b> IHC Scott, Inc.	<b>OPERATOR REPRESENTATIVE:</b> Chris Adrian	<b>TYPE OF OPERATION:</b> 112c - Construction Regular Operation	
<b>REASON FOR INSPECTION:</b> Preoperation Inspection	<b>BOND CALCULATION TYPE:</b> None	<b>BOND AMOUNT:</b> \$0.00	
<b>DATE OF COMPLAINT:</b> NA	<b>POST INSP. CONTACTS:</b> DRMS	<b>JOINT INSP. AGENCY:</b> None	
<b>INSPECTOR(S):</b> Amy Yeldell	<b>INSPECTOR'S SIGNATURE:</b>

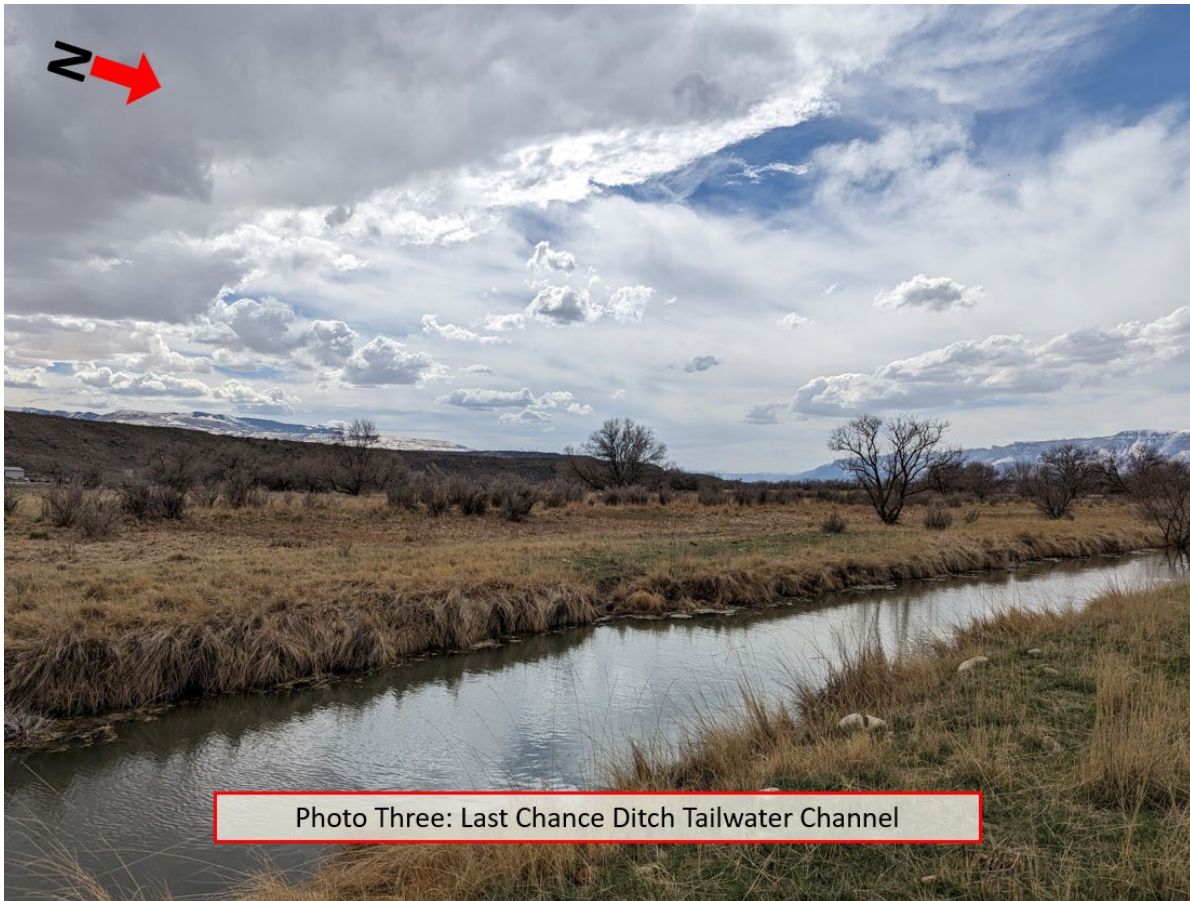
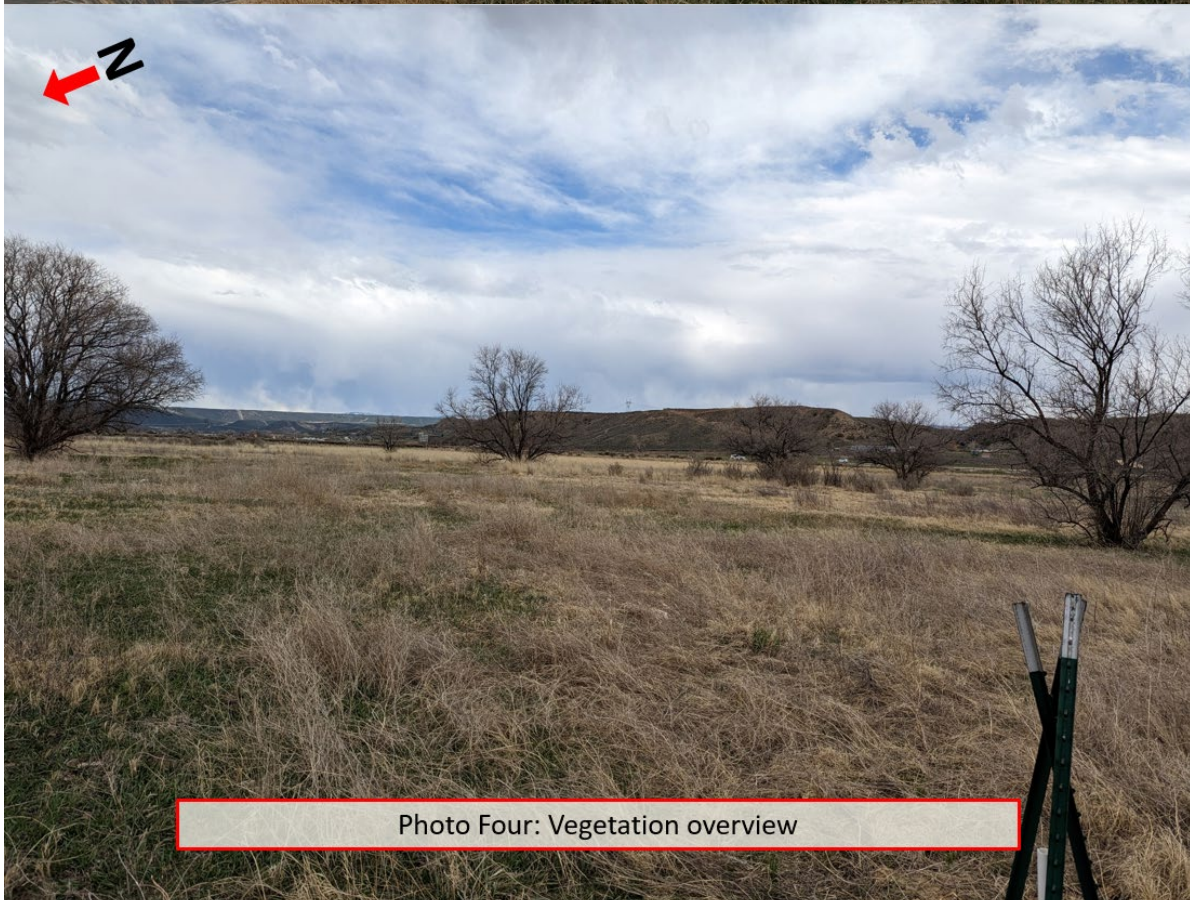
Revegetation: Vegetation varies greatly throughout the site based on groundwater levels (Photos Four to Eleven). The proposed pit area is largely pastureland and wetland fringe. Both irrigated and non-irrigated pastureland species were noted in addition to some woody shrubs and trees. The inspection occurred early in the
