MINERALS PROGRAM INSPECTION REPORT
PHONE: (303) 866-3567

MINE NAME: Logan Wash	MINE/PROSPECTING ID#: M-1977-424	MINERAL: Oil shale	COUNTY: Garfield
INSPECTION TYPE: Monitoring	WEATHER: Clear	INSP. DATE: April 21, 2023	INSP. TIME: 13:30
OPERATOR: Occidental Oil Shale, Inc.	OPERATOR REPRESENTATIVE: Bruce Smith	TYPE OF OPERATION: 112 - Hard Rock Regular Operation	
REASON FOR INSPECTION: High Priority	BOND CALCULATION TYPE: None	BOND AMOUNT: \$570,428.00	
DATE OF COMPLAINT: NA	POST INSP. CONTACTS: None	JOINT INSP. AGENCY: None	
INSPECTOR(S): Amy Yeldell	INSPECTOR'S SIGNATURE:

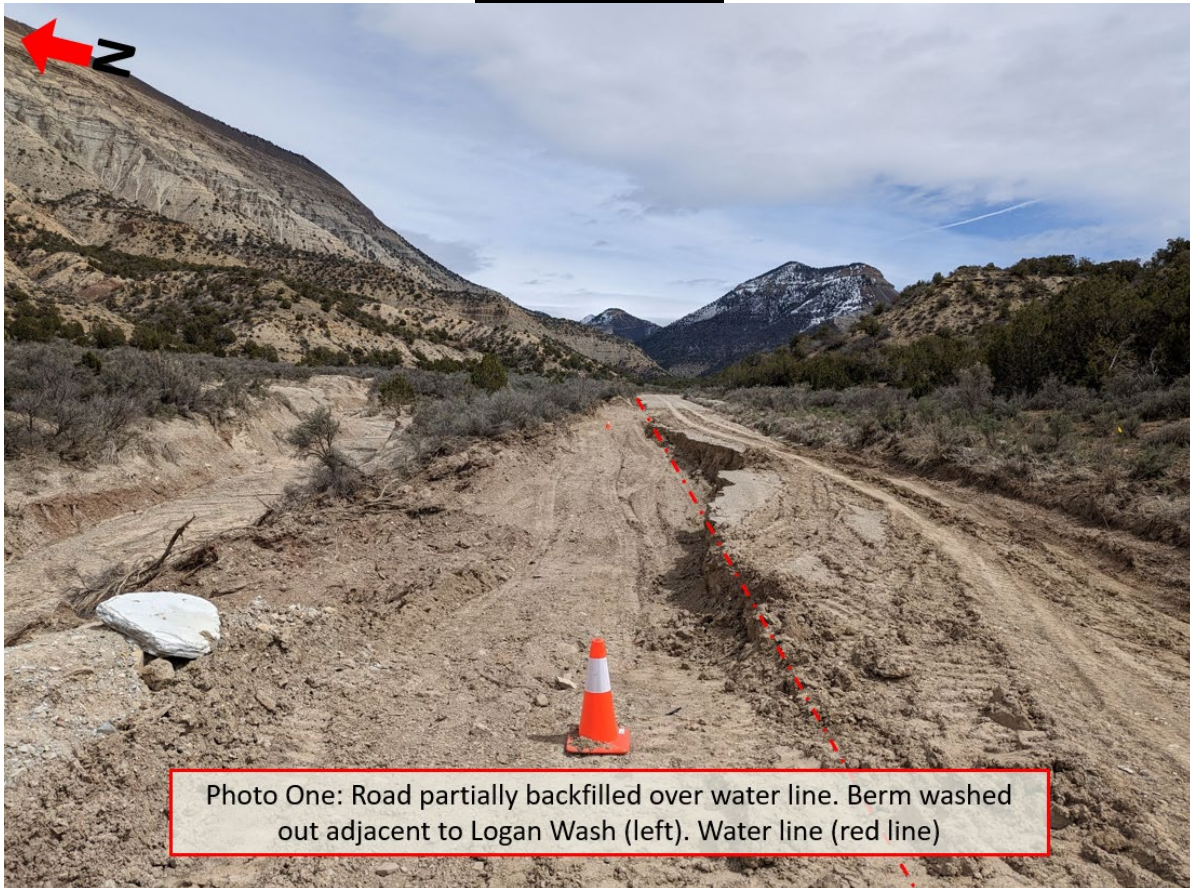
The duration and volume of spill is unknown. According to Mr. Smith the road had been scoured away by stormwater approximately 7 feet deep and the road was barely passable. Mr. Smith coordinated with contractors to get the pipe repaired that day and the water line is no longer leaking from the identified location. The eroded water line area was also temporarily backfilled. The estimated flow at the time of the repair was 2.1 GPM. During the repair, samples were taken of the retort water, soil sample downstream and an upstream reference soil sample. Flags were placed at the sample locations. Results had not been received back from the lab at the time of the inspection.

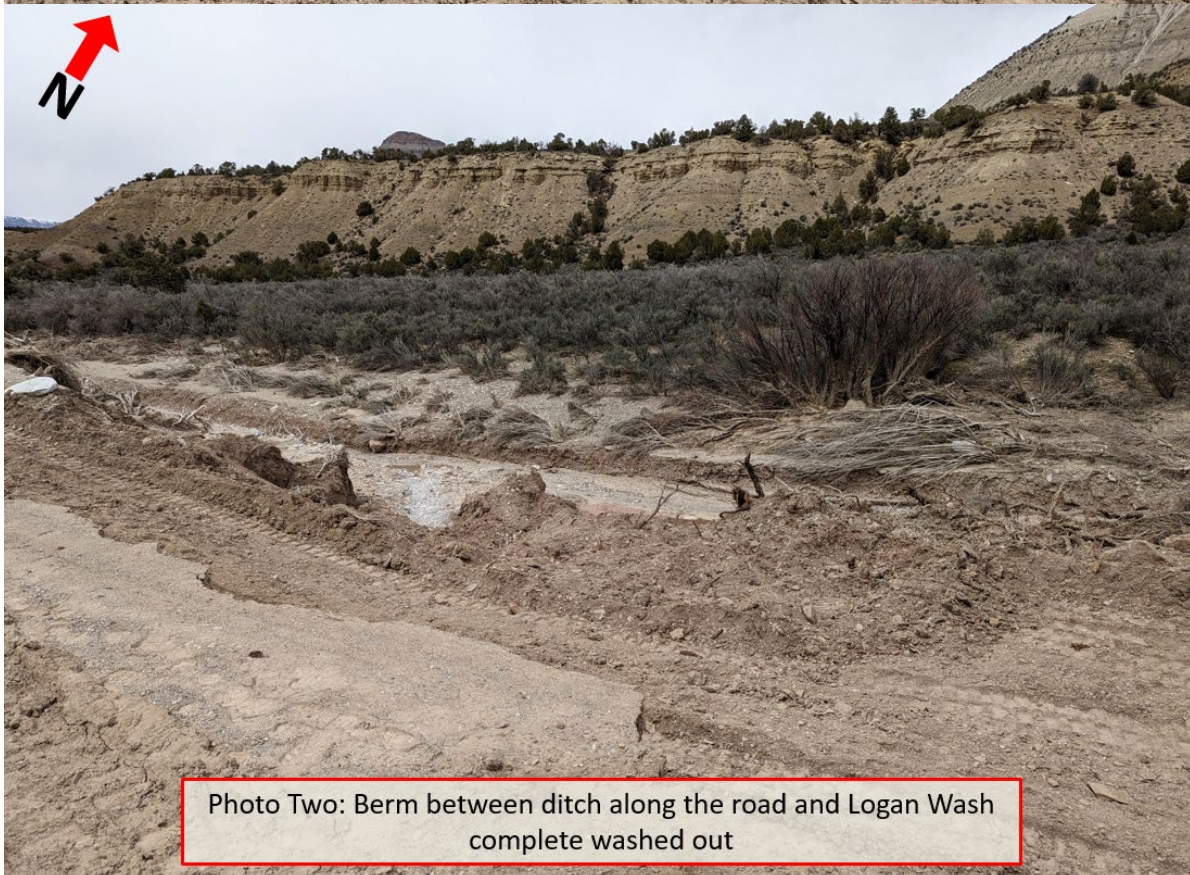
Access along Logan Wash Road is extremely rough due to stormwater eroding and/or depositing sediment throughout the road. The Logan Wash Road has stormwater ditches on either side of the road, as well as a berm to keep water in Logan Wash and off of the road at times of high flows. These BMPs have failed to maintain

stormwater effectively and were likely a contributing factor to the conditions that resulted in the water line break. Also observed during this inspection were culverts further up the Logan Wash Road which had become plugged with sediment and rocks. The plugged 36" twin culverts are designed to direct Logan wash from the south side of the road to the north side. Without these culverts functioning stormwater is flowing across and down Logan Wash Road. Excessive amounts of sediment have been deposited on the road and shoulders.

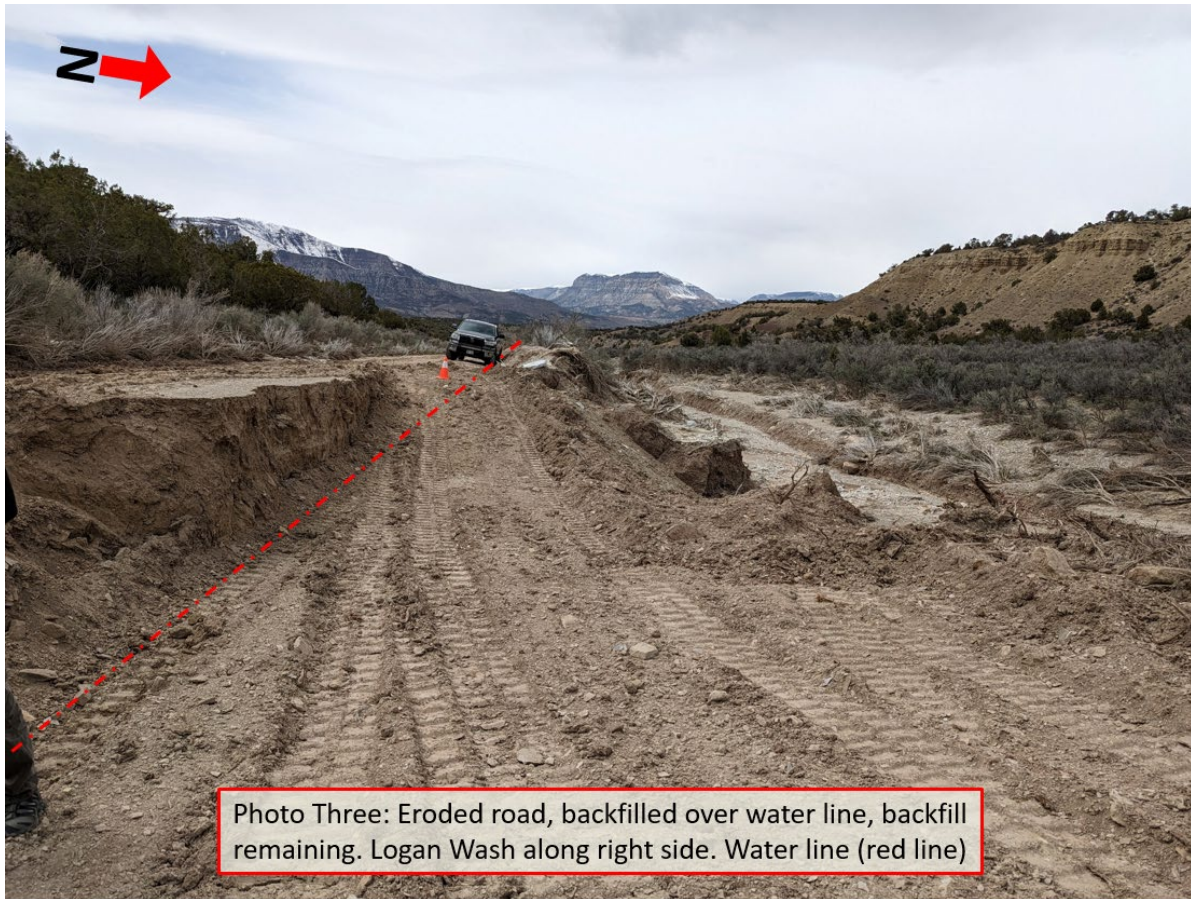
As a result of this event the inspection frequency conducted by the Operator has been increased to weekly to monitor for any future spring stormwater issues. Temporary repairs to the roads and ditches have been made. Contractors have been scheduled to finish repairing the road. The eroded area still requires an additional five feet or so of backfill to bring back to grade. Material will be imported and sufficiently packed to the repair road without damaging water line. The Operator as well as other road users are coordinating the maintenance of the stormwater ditches along the entire length of Logan Wash Road. A redesign or replacement of the plugged culvert area is also being discussed to prevent future maintenance problems. Utilities along Logan Wash Road have been marked by flags, indicating repairs are imminent.
