MINERALS PROGRAM INSPECTION REPORT
PHONE: (303) 866-3567

MINE NAME: Cortner Pit	MINE/PROSPECTING ID#: M-1986-159	MINERAL: Sand and gravel	COUNTY: Pueblo
INSPECTION TYPE: Illegal(Unpermitted Operation)	WEATHER: Clear	INSP. DATE: April 5, 2023	INSP. TIME: 09:30
OPERATOR: Martin Marietta Materials, Inc.	OPERATOR REPRESENTATIVE: Julie Mikulas	TYPE OF OPERATION: 112c - Construction Regular Operation	
REASON FOR INSPECTION: Normal I&E Program		BOND CALCULATION TYPE: Complete Bond	BOND AMOUNT: \$73,556.00
DATE OF COMPLAINT: NA		POST INSP. CONTACTS: None	JOINT INSP. AGENCY: None
INSPECTOR(S): Amber Michels	INSPECTOR'S SIGNATURE:

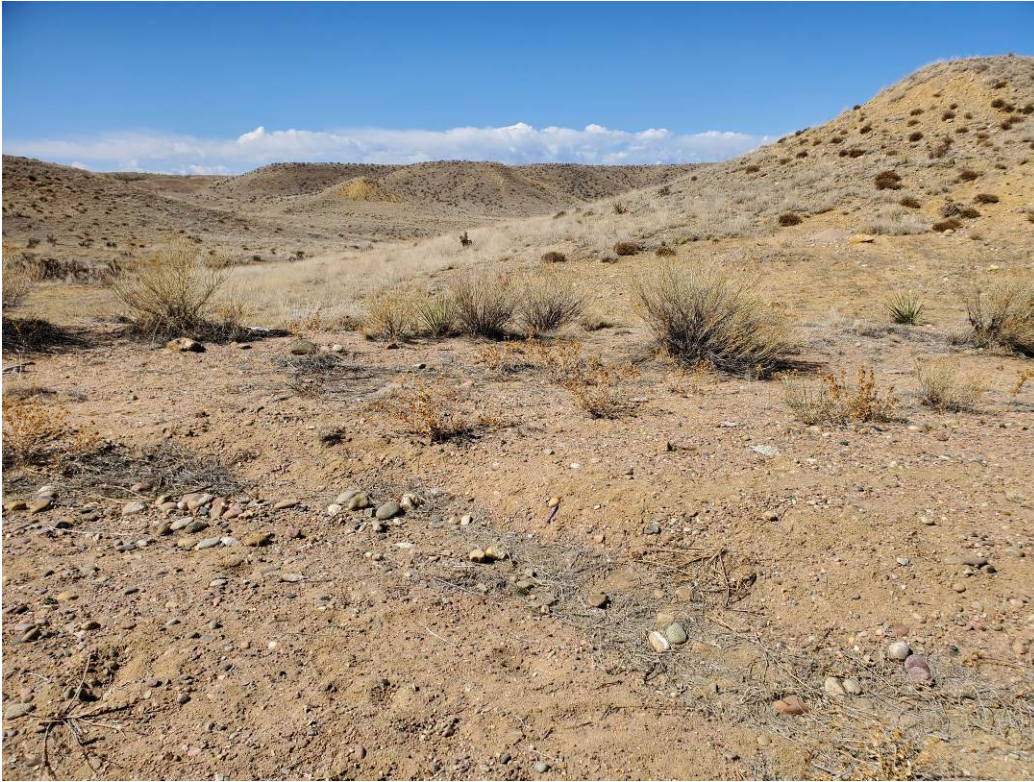
Photo 3: Taken from outside of the permit boundary, on the north fork of the access road, looking south-west.

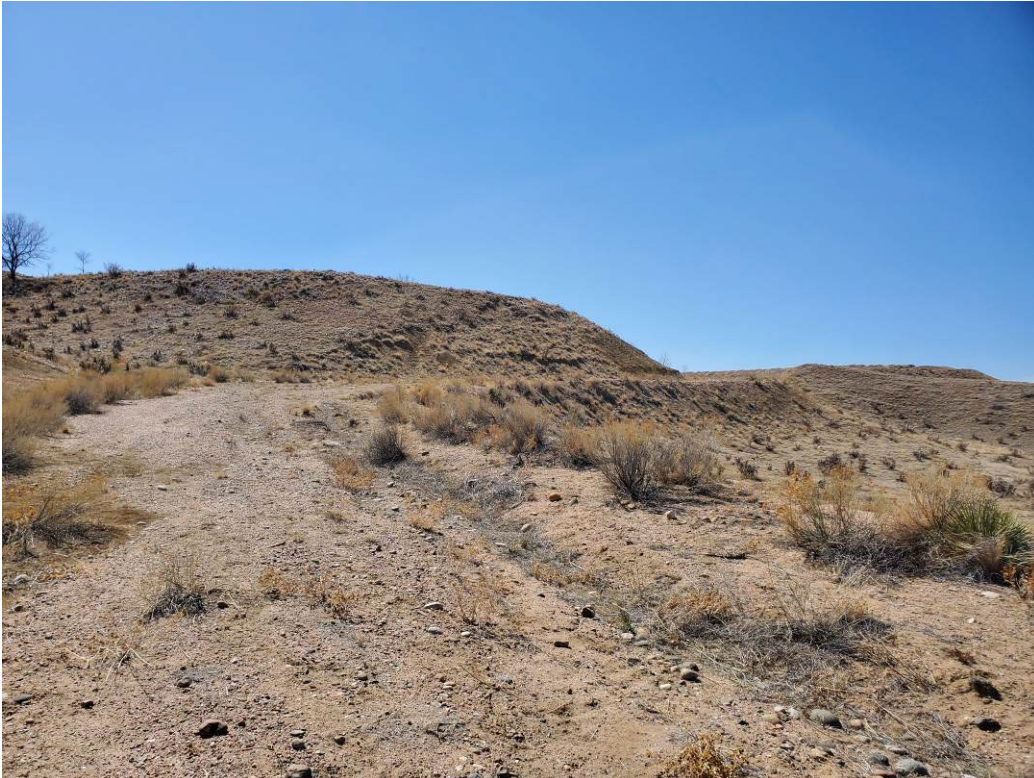
Photo 4: Taken from outside of the permit boundary, on the north fork of the access road, looking south-east.

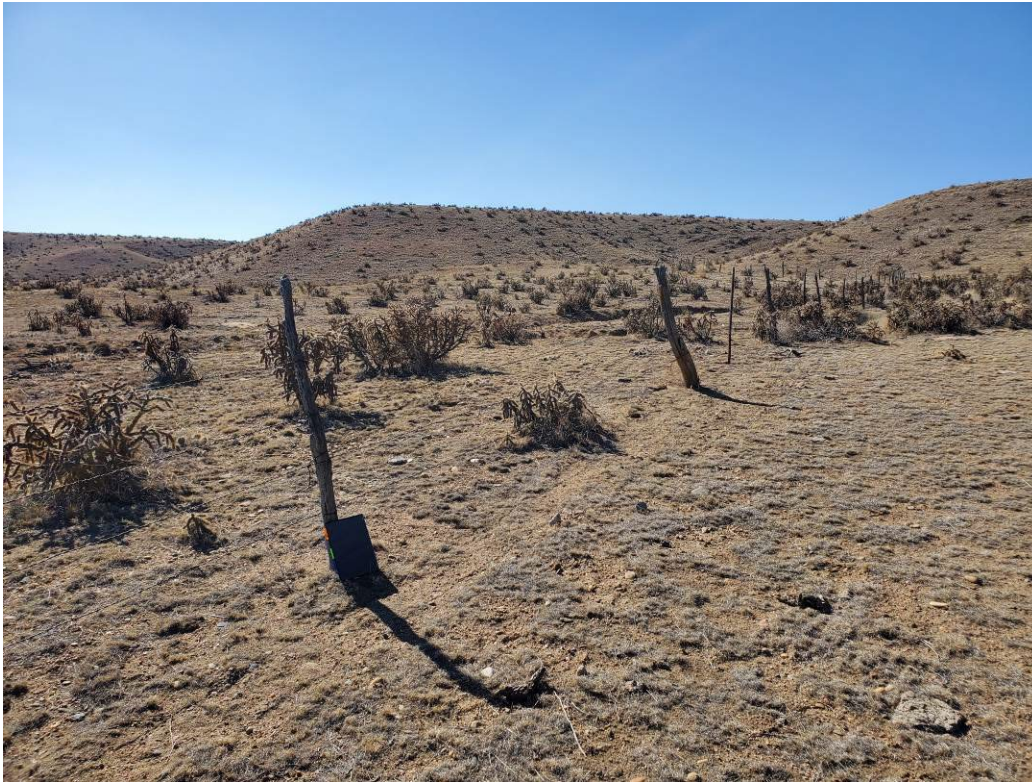
Photo 5: Looking west at the approximate extent of the fence located just west of the northwest corner of the permit boundary indicated by the binder.

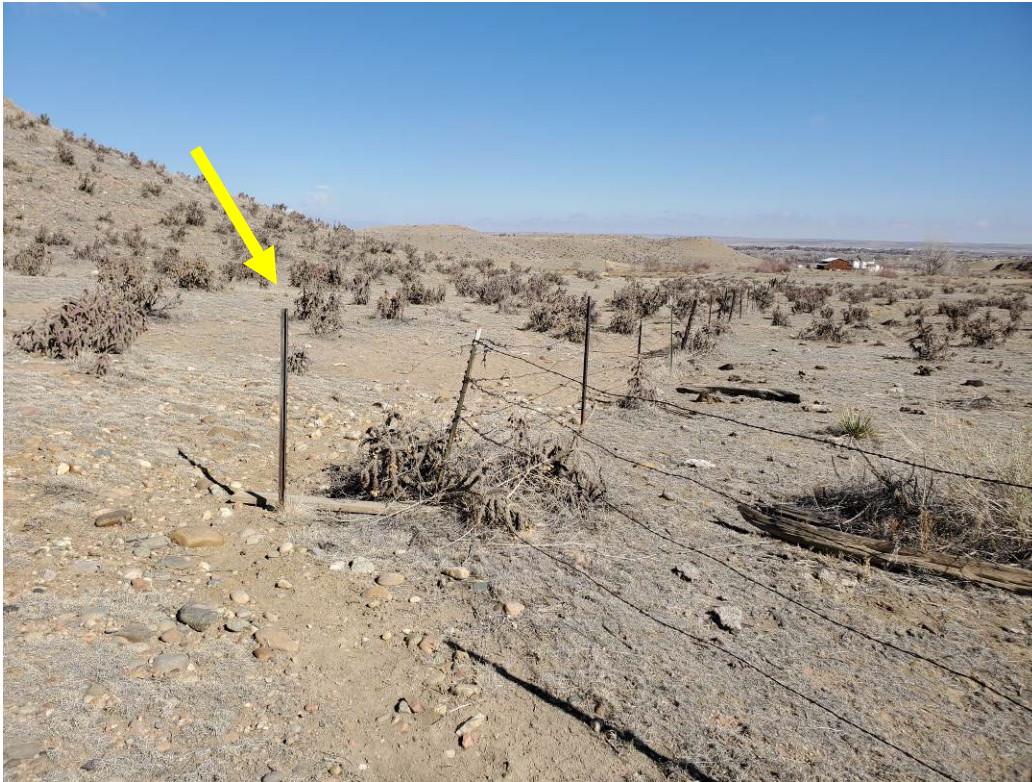
Photo 7: Looking north at the fence pole that is within the permit boundary (indicated by the yellow arrow), and the portion of the fence that is not (see Map 3)

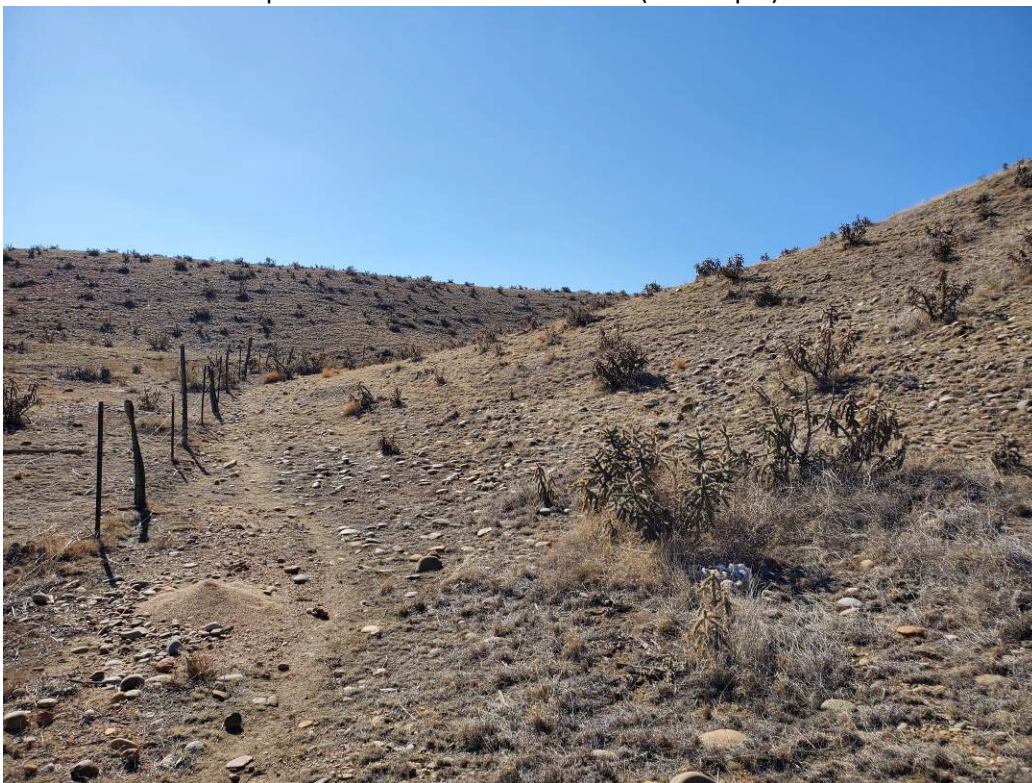
Photo 8: Looking south at fence line within the permit boundary along the north-west border.

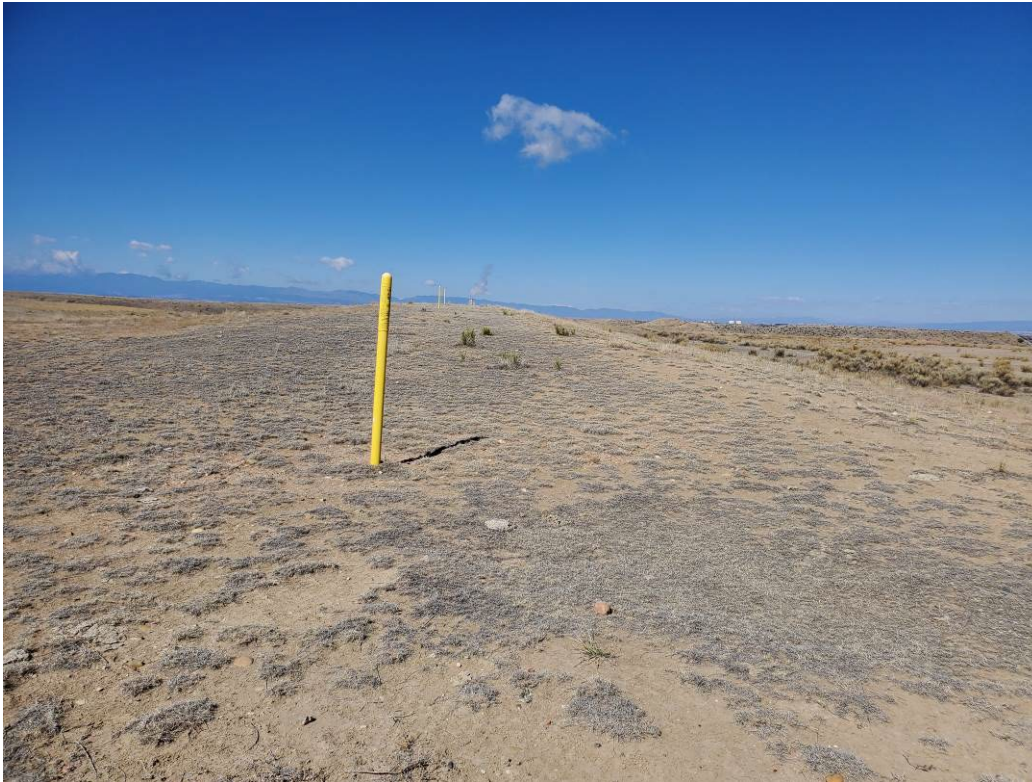
Photo 13: Looking west along the pipe line that dissects the permit area, separating Phases II and III.

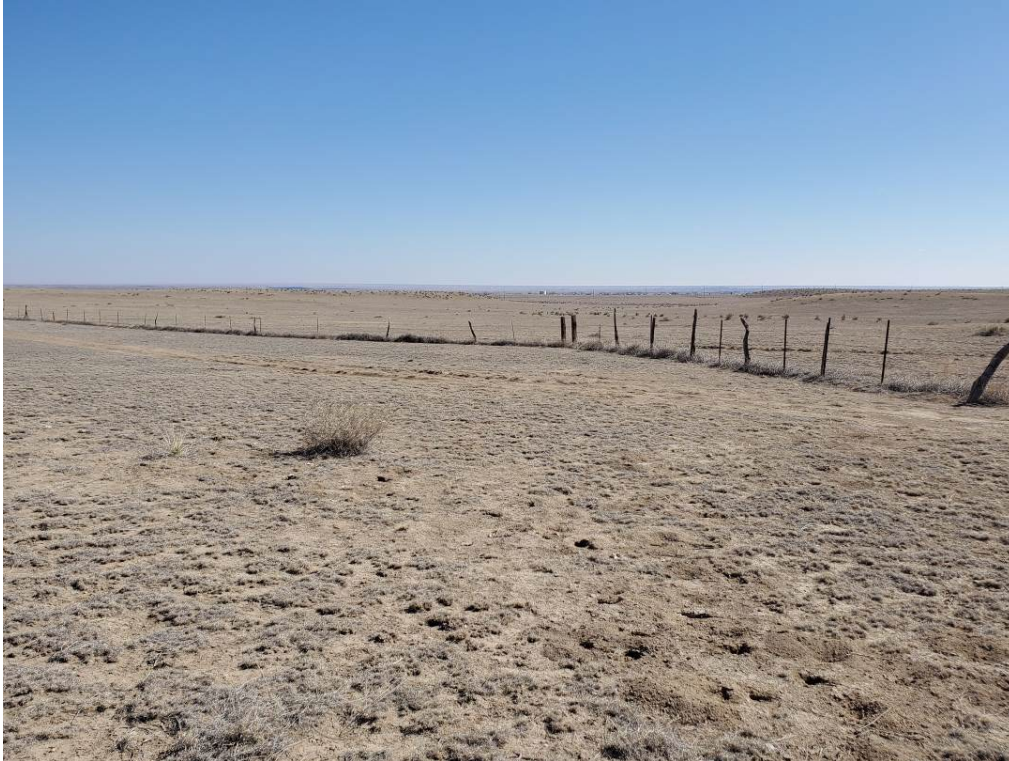
Photo 15: Looking east at the bend in the fence near the estimated east permit boundary.

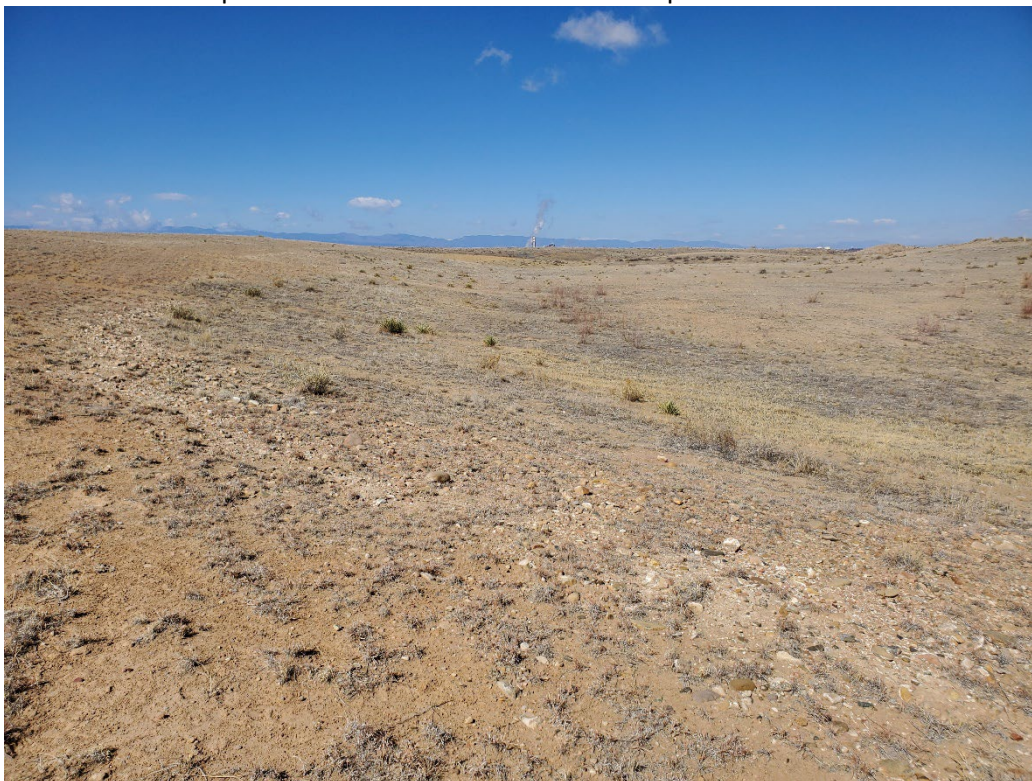
PROBLEM: Tamarisk (salt cedar) trees are present within or have volunteered into the permit area and are becoming established. This is a problem for failure to employ weed control methods for a state listed noxious weed species within the permitted area, and to reduce the spread of weeds to nearby areas as required by Section 3.1.10 (6) of the rule.

Photo 21: Looking north at the re-establishment of tamarisk plants (circled in yellow) within the flat area.

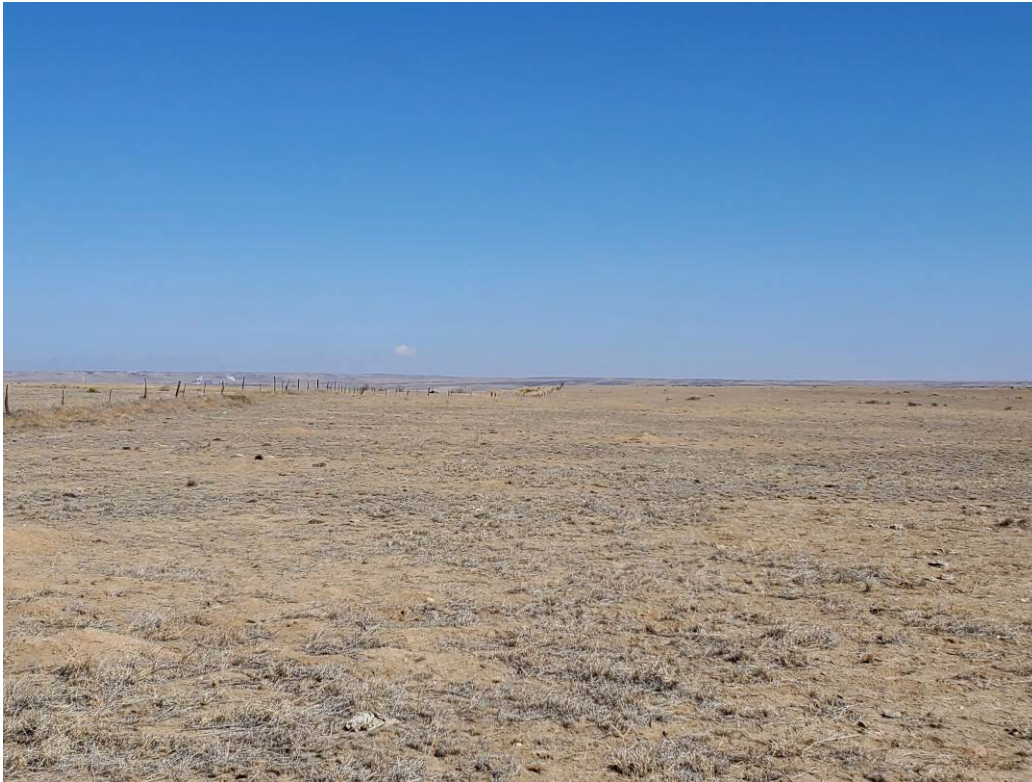
The Operator asked if they could request a release for the central area (Phase III) at the same time as requesting an acreage reduction for the Phase V area. Upon inspection, the central area has well vegetated slopes and vegetation density and composition that reflects that of the surrounding unaffected areas, with the exception of the lowland spot south of where a pipeline dissects the permit area (Photo 13). The Operator stated that this flat area has been seeded and re-seeded with little to no success, partially as a result of this area being accessible to cattle (Photos 17 through 22). Within this area, the Division also noticed the establishment of the state listed noxious weed, tamarisk. A **problem** has been cited for the presence of tamarisk in this area. Upon review of past inspection reports, this has been a recurring issue. The tamarisk will need to be eradicated before this area would be eligible for bond release.

Photo 22: Looking north-west across the flat area that has been unable to sustain vegetation. Cattle prints were observed throughout the area, as well as the re-establishment of tamarisk around its borders.

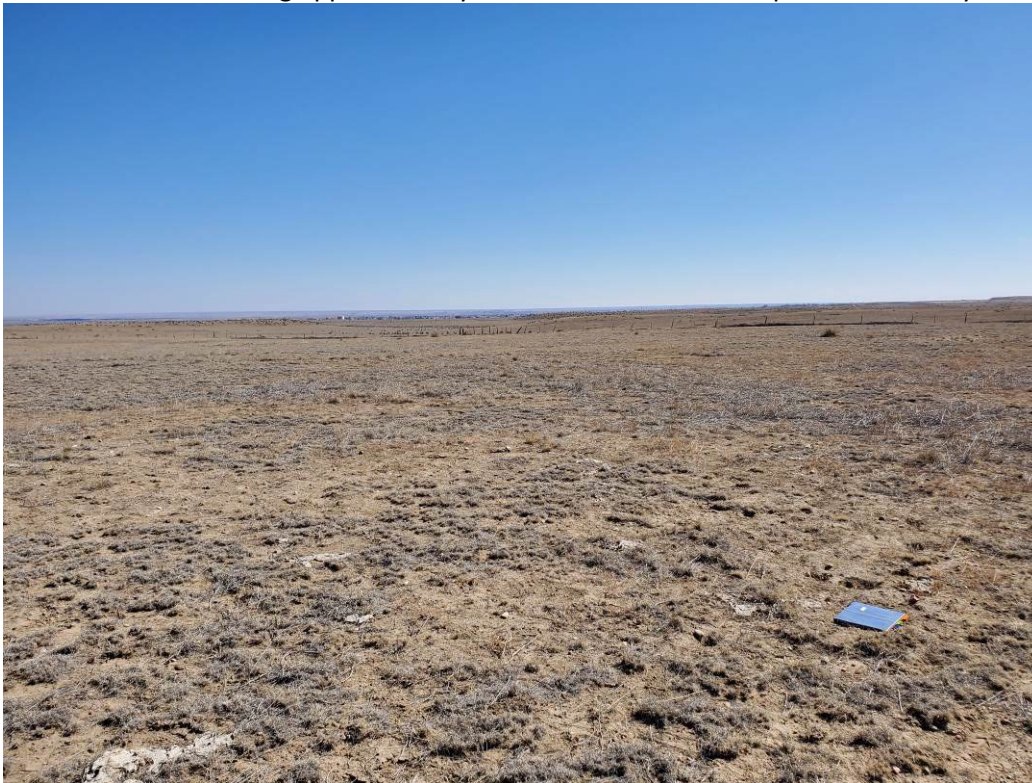
Photo 23: Standing approximately at the south-east corner permit boundary.

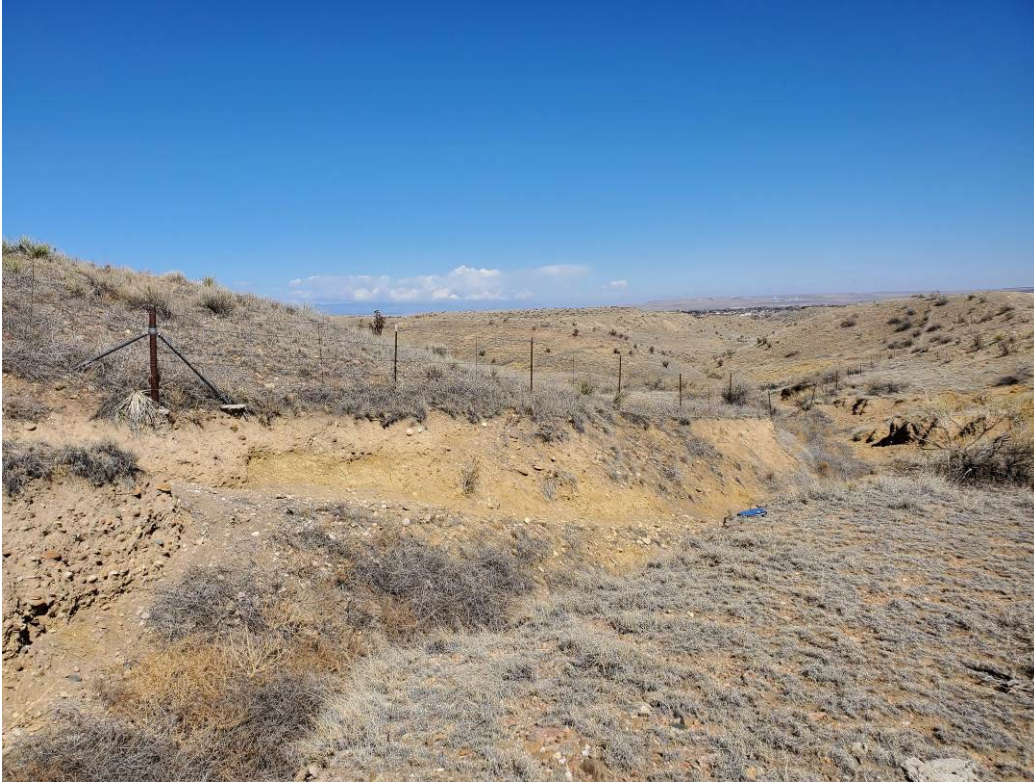
PROBLEM: The affected area boundary markers are missing or incorrectly placed. This is a problem for failure to maintain boundary markers around the affected area as required by Section 3.1.12(2) of the rule.

No boundary markers were observed onsite, except one located in the north-east corner (Photo 6). The Operator stated that this is due to the discrepancy in the permitted acreage and the 86.12 acres that the approved permit boundary reflects. They stated that they have had a survey done and intended to ask the Division about this before verifying their markers prior to requesting a release of the southern Phase V area. The Division took GPS points around the site using Esri Field Maps to find approximately where the permit boundary should be (Map 3), as well as to link photos taken around the pit to show the land from the various directions georeferenced in Map 1. A **problem** was cited above for failure to maintain boundary markers. The Operator will need to provide evidence that this has been abated and that the boundary markers reflect the approved affected acreage by the corrective action date.

Photo 26: Looking west at one of the approximate south-western corners of the permit boundary.

CORRECTIVE ACTIONS: The Operator shall conduct a survey and replace the boundary markers in the correct location(s). The Operator shall provide photo evidence to the Division that this has been done by the corrective action date.

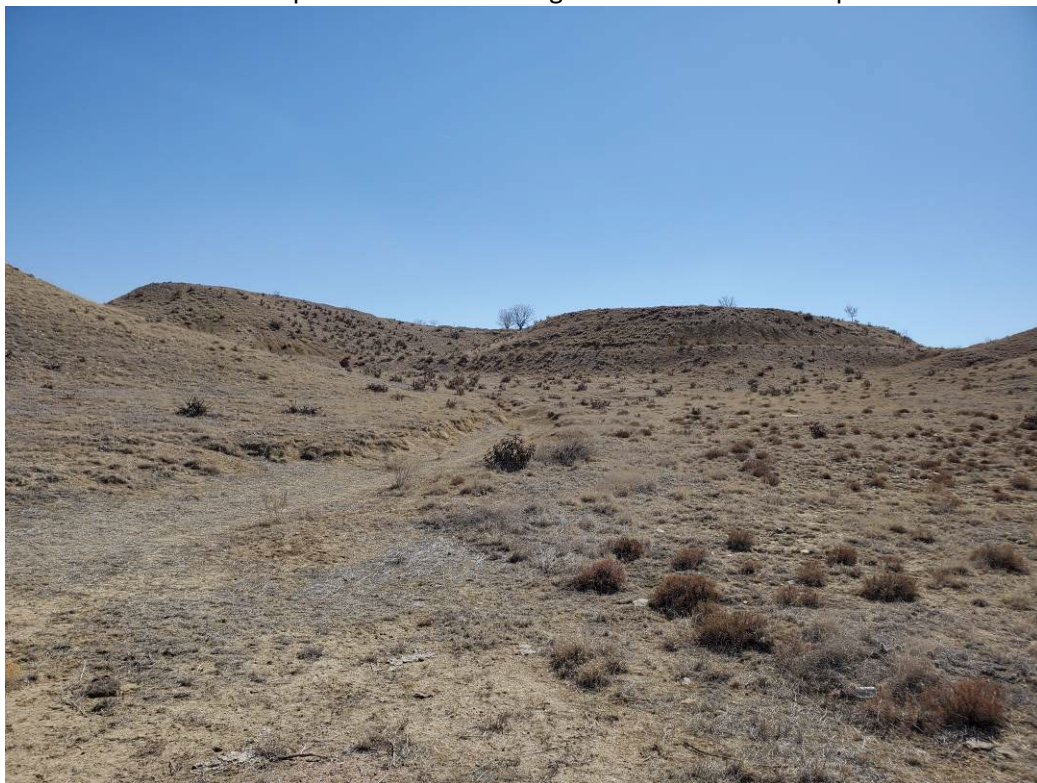
erosion that occurred from run-off on the access/haul road. The check dams in this area have since been reclaimed and re-vegetated (Photos 28 and 29). West of this area, seemingly outside of the permit boundary, check dams and an earthen dam beyond them are still in place (Photos 30 through 33). When the Division stated the presence of these may be a problem, the Operator insisted that they were instructed to install these by the Division as a result of a previous inspection. The Division's 2012 inspection instructed the Operators to correct the erosion observed to the west of the Phase III area, as well as stabilize the areas adjacent to the haul roads, therefore, this appears to have been complied with as instructed. The remaining check dams and earthen dam appear to be stable, and no additional erosion was observed on or adjacent to the haul road.

Photo 33: Looking south-east outside of the permit area to the west of the haul road at the check dams created as a result of an inspection citation during the Division's 2012 inspection.
