File: April 2023 Monitoring Summary

Date: May 31, 2023

**Reference: April 2023 Geotechnical Monitoring Summary Pikeview Quarry**

PIKEVIEW QUARRY SLOPE  
MONITORING

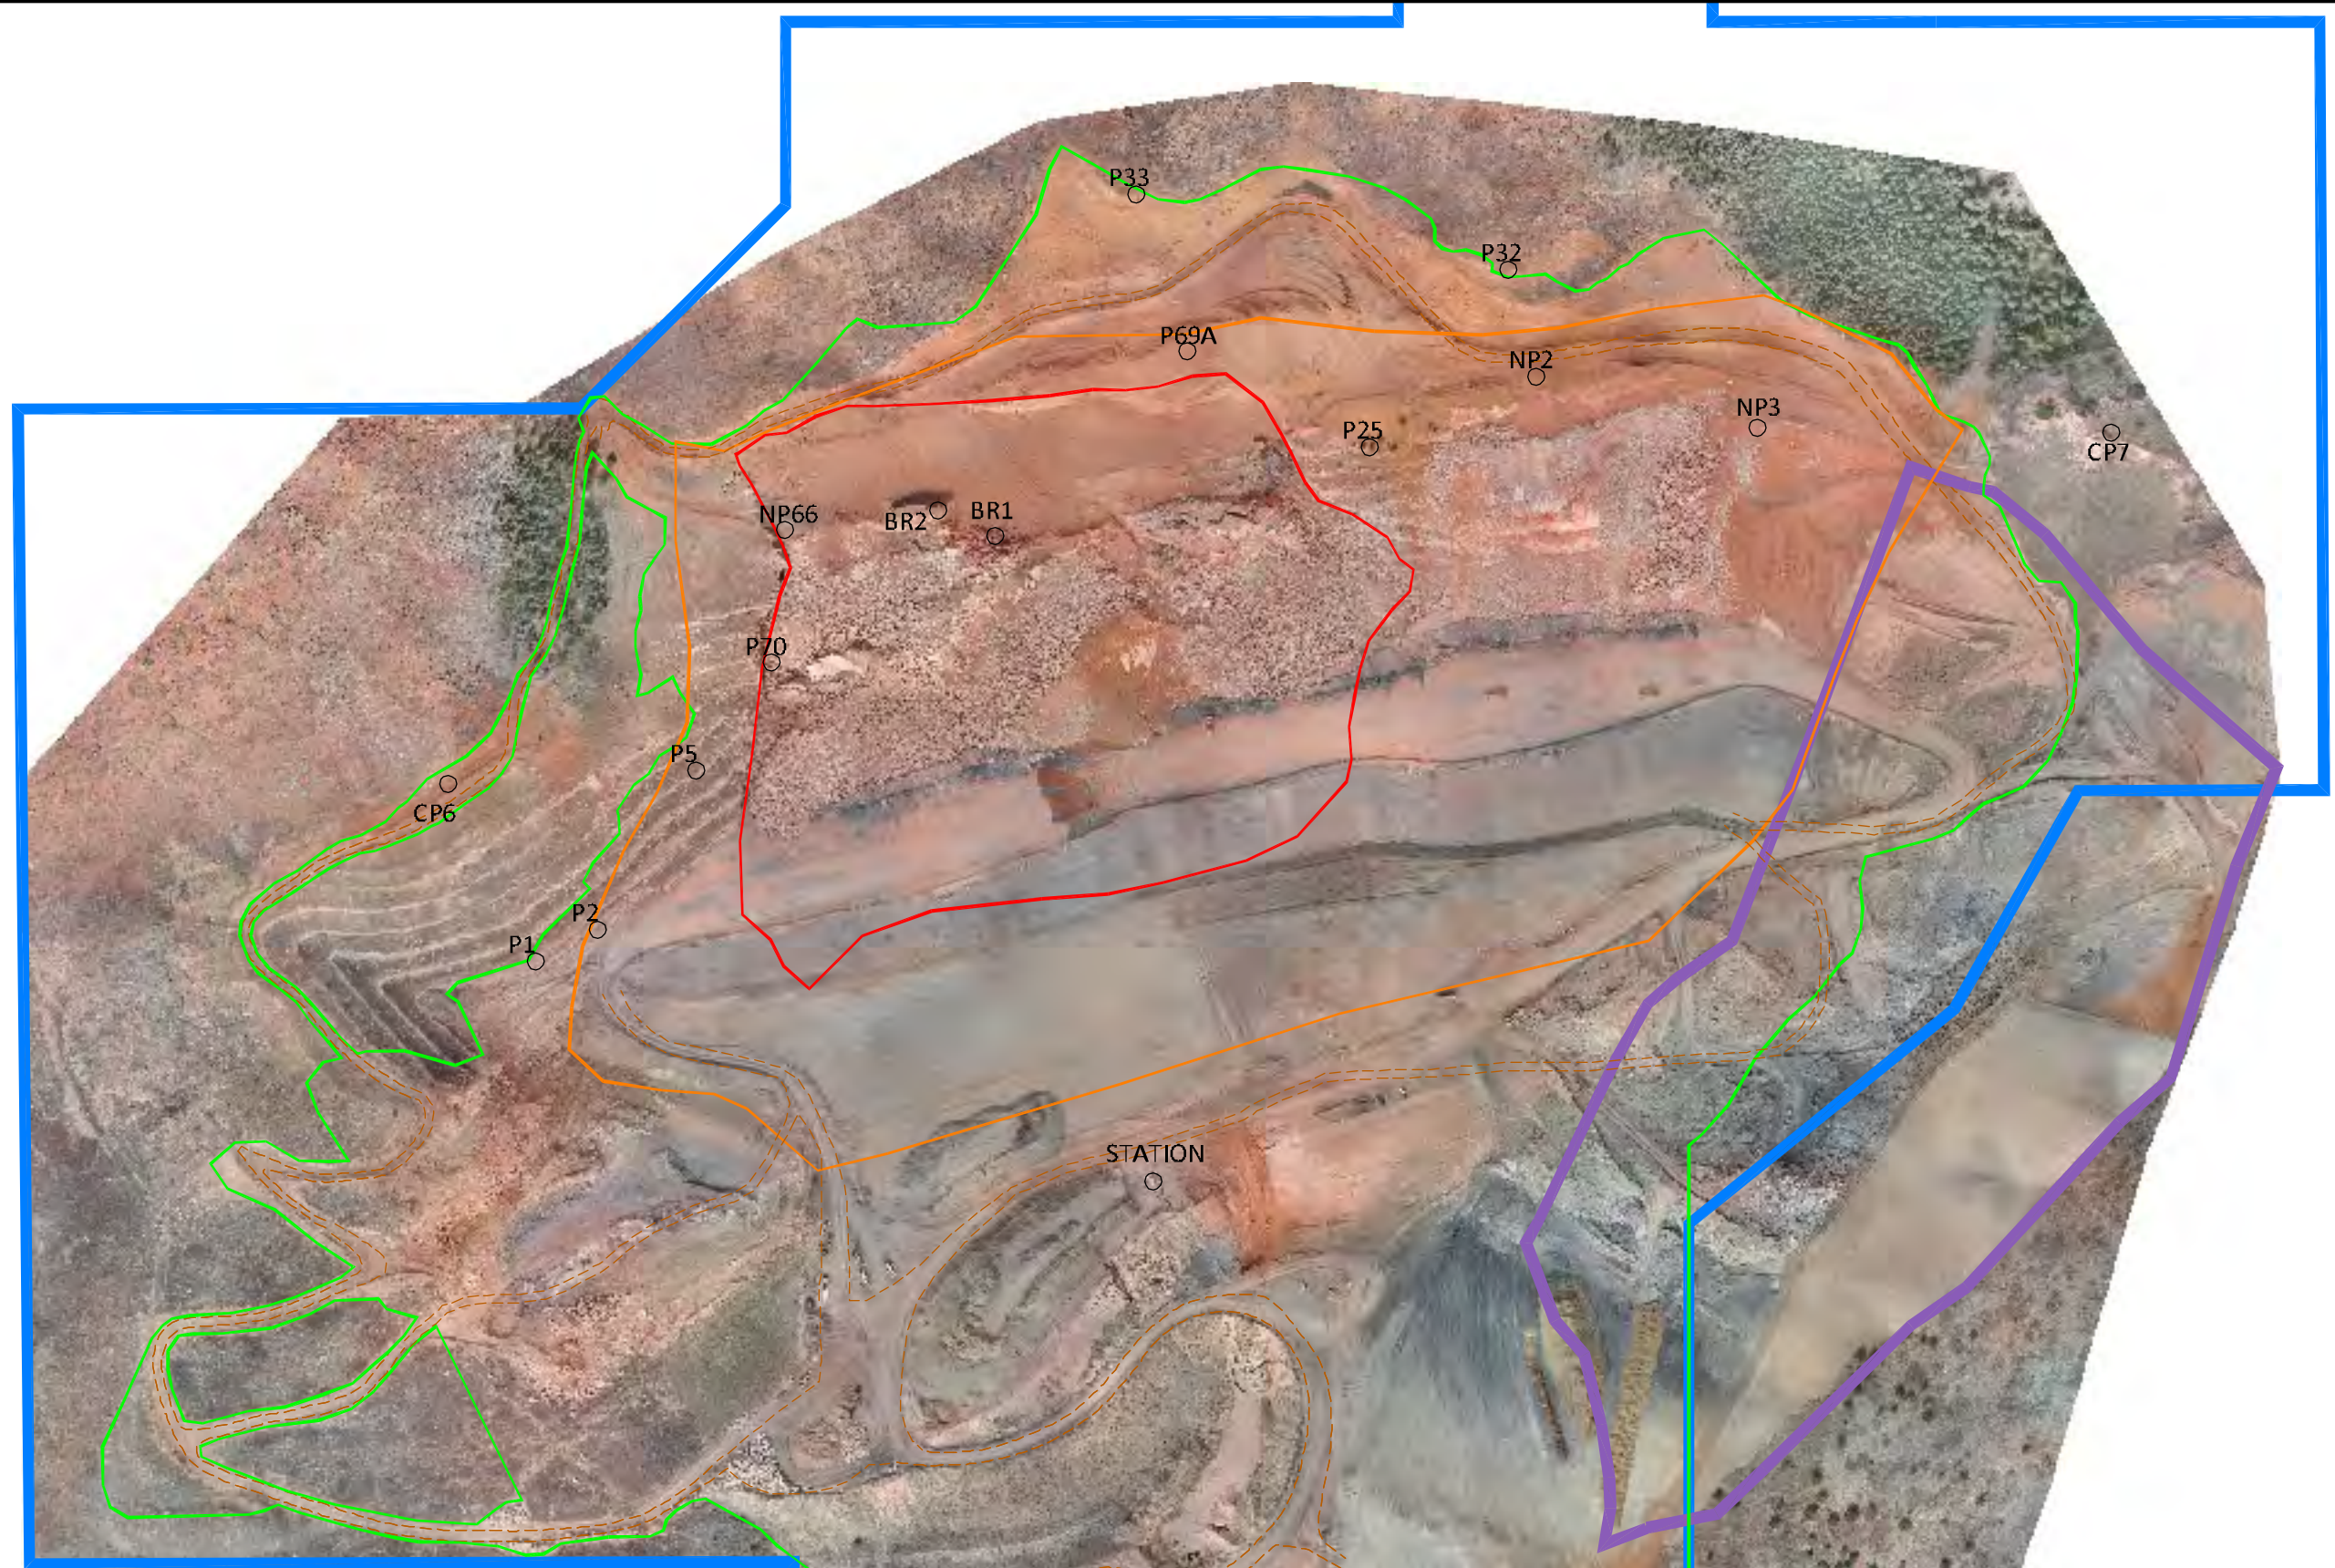
Revision #  
Date  
2023.05.31  
Drawn By  
PK  
Figure No.  
1

Major components of the instrumentation monitoring program are listed in Table 1 and shown on Figure 1.

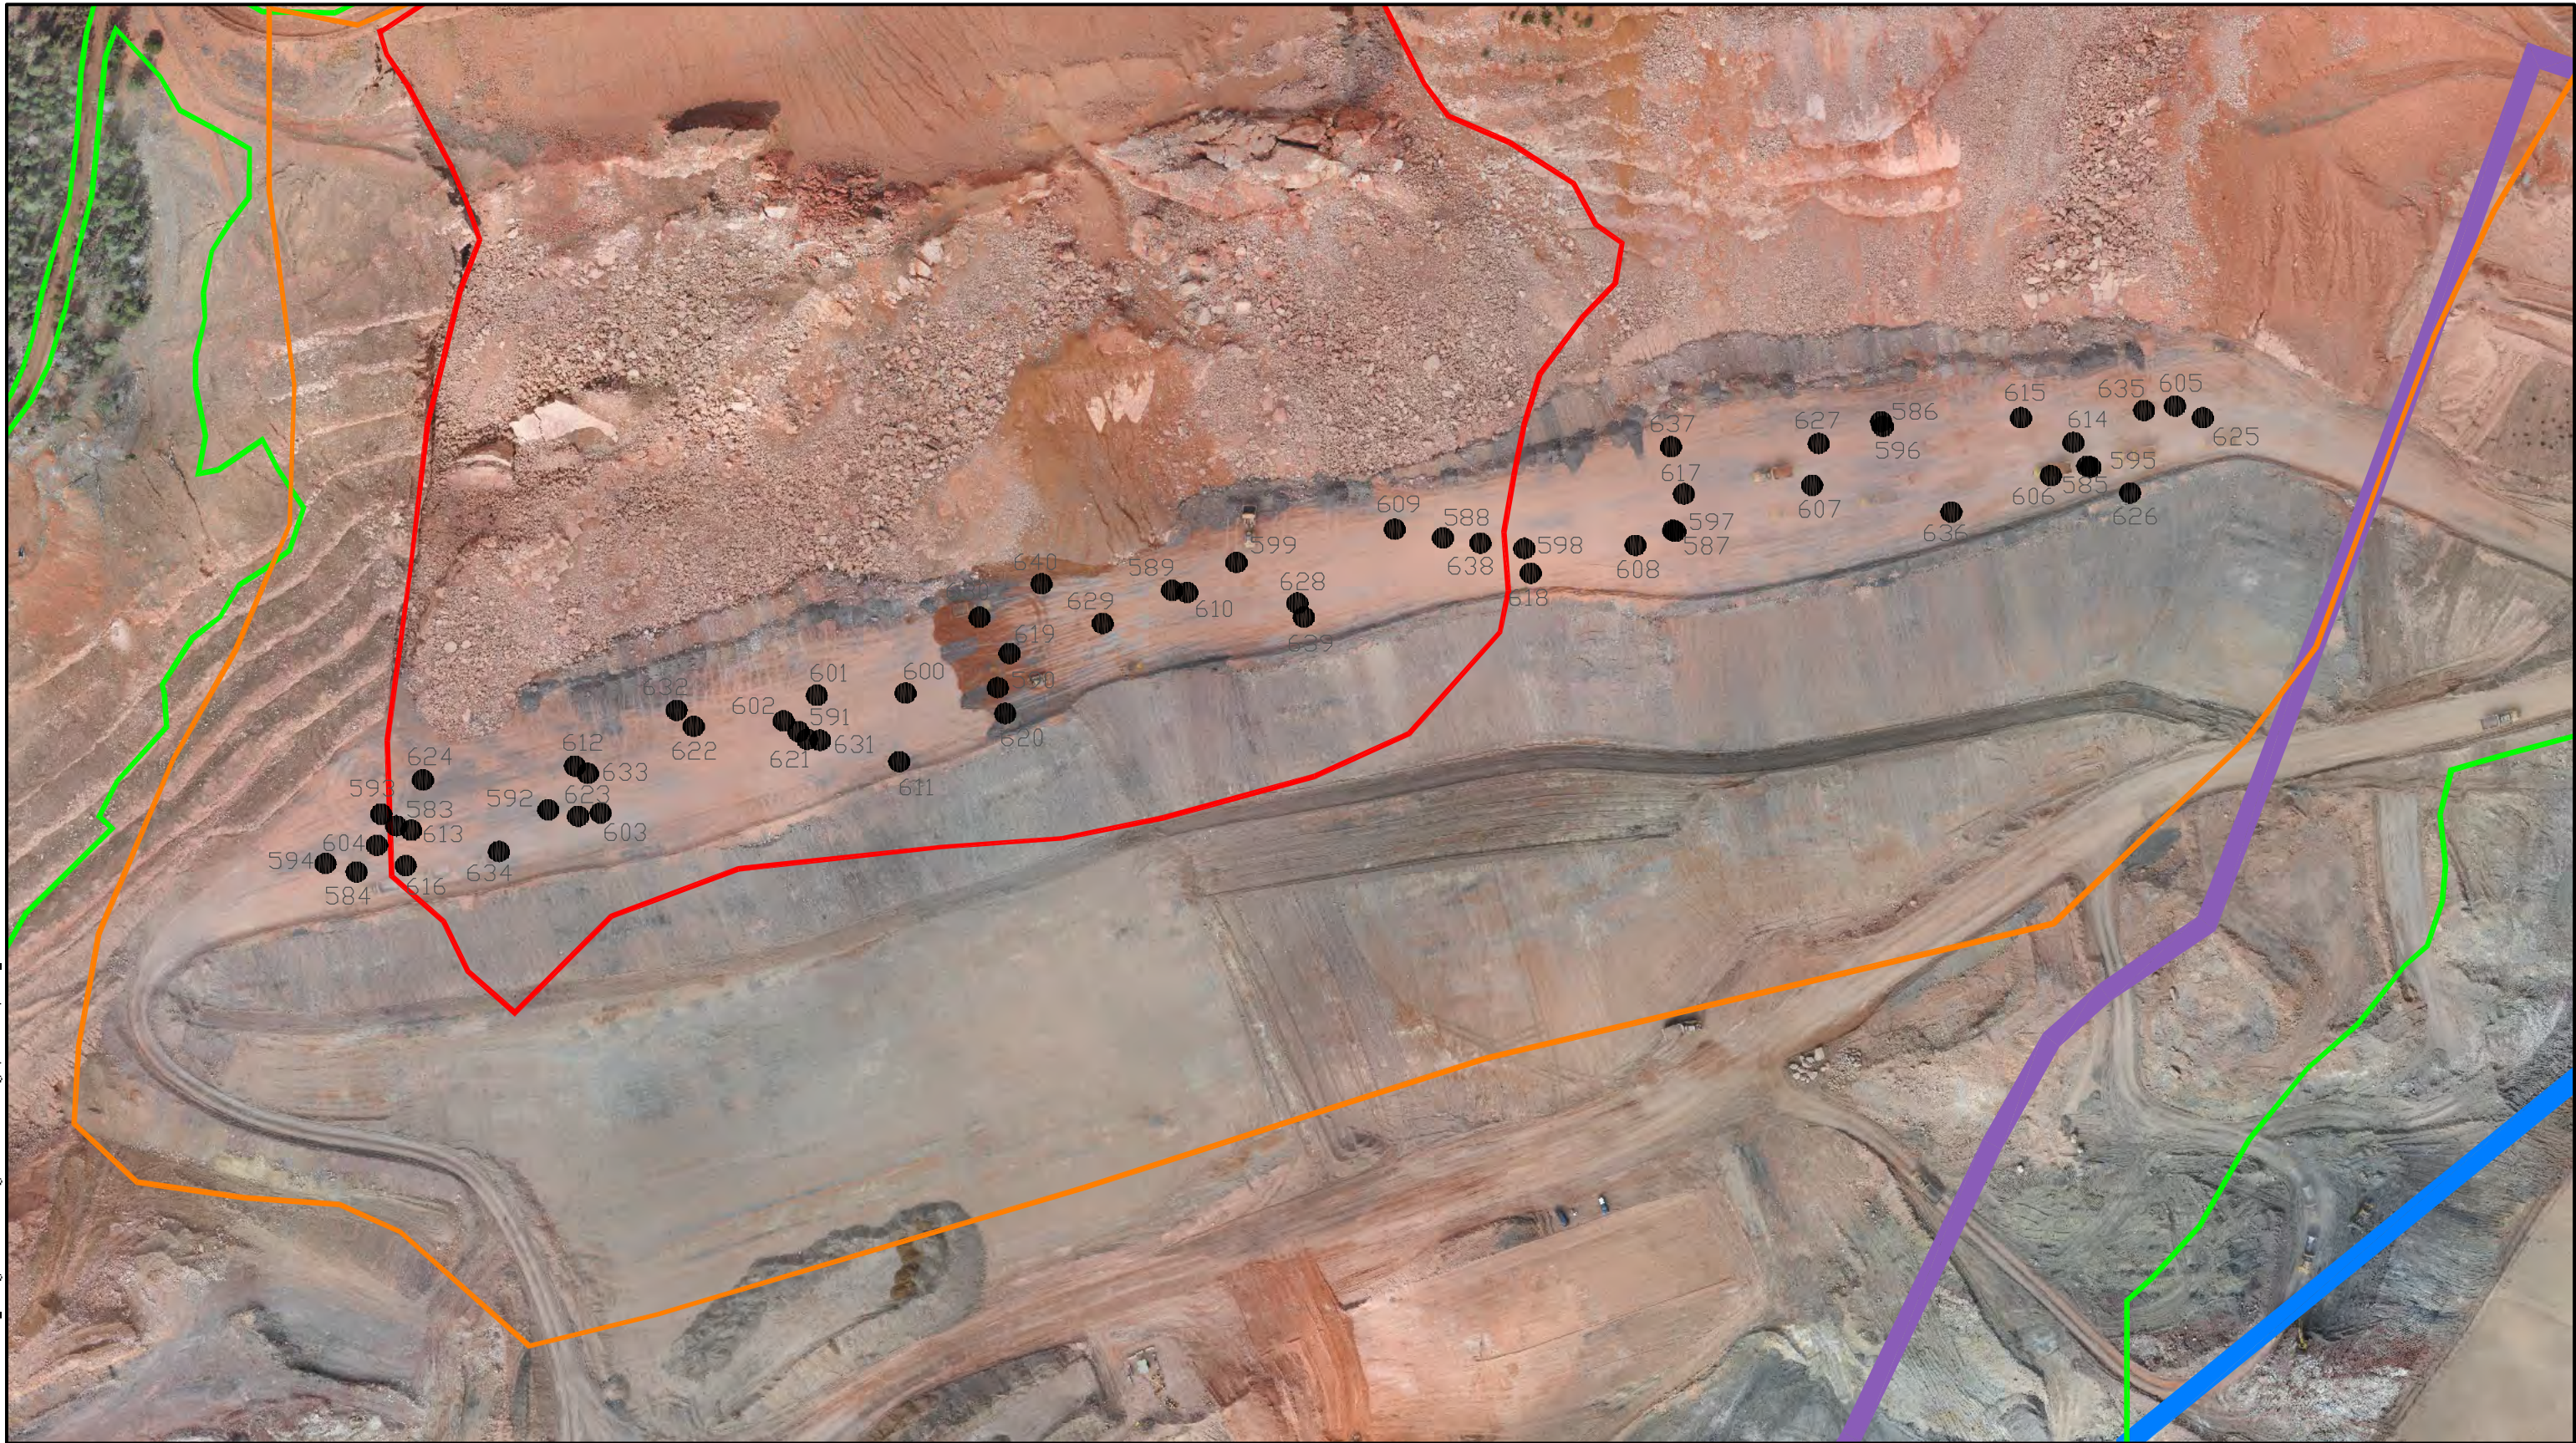
Fill placement started on February 25, 2022 and continued throughout April 2023. Fill was excavated from the Shop, Lower, and North Borrow Areas and placed in the buttress and buffer zones. All fill is moisture conditioned as necessary and then compacted. Compaction testing began April 2022 and occurs at the rate of at least one test per 5,000 yd<sup>3</sup> placed. During April, approximately 103,000 yd<sup>3</sup> was placed and compacted. This volume placed in the buttress zone required at least 21 compaction tests. There were 58 compaction tests taken in April. As of April 30, 2022, a total of approximately 2,409,000 yd<sup>3</sup> had been placed and compacted. This required at least 482 compaction tests, and 859 tests have been taken. There were no failing tests in April; all tests met the minimum compaction requirement of 90%. The compaction testing results are summarized in Appendix D, and the testing locations are shown on Figure 6.
