MINERALS PROGRAM INSPECTION REPORT
PHONE: (303) 866-3567

MINE NAME: Nahcolite Project	MINE/PROSPECTING ID#: M-1983-194	MINERAL: Carbonates	COUNTY: Rio Blanco
INSPECTION TYPE: Monitoring	WEATHER: Cloudy, Raining intermittently	INSP. DATE: June 5, 2023	INSP. TIME: 11:30
OPERATOR: Natural Soda LLC	OPERATOR REPRESENTATIVE: Kirk Dealing	TYPE OF OPERATION: 112d-3 - Designated Mining Operation	
REASON FOR INSPECTION: Normal I&E Program	BOND CALCULATION TYPE: None	BOND AMOUNT: \$4,433,331.00	
DATE OF COMPLAINT: NA	POST INSP. CONTACTS: DRMS	JOINT INSP. AGENCY: U.S.BLM	
INSPECTOR(S): Amy Yeldell Todd Jesse	INSPECTOR'S SIGNATURE:

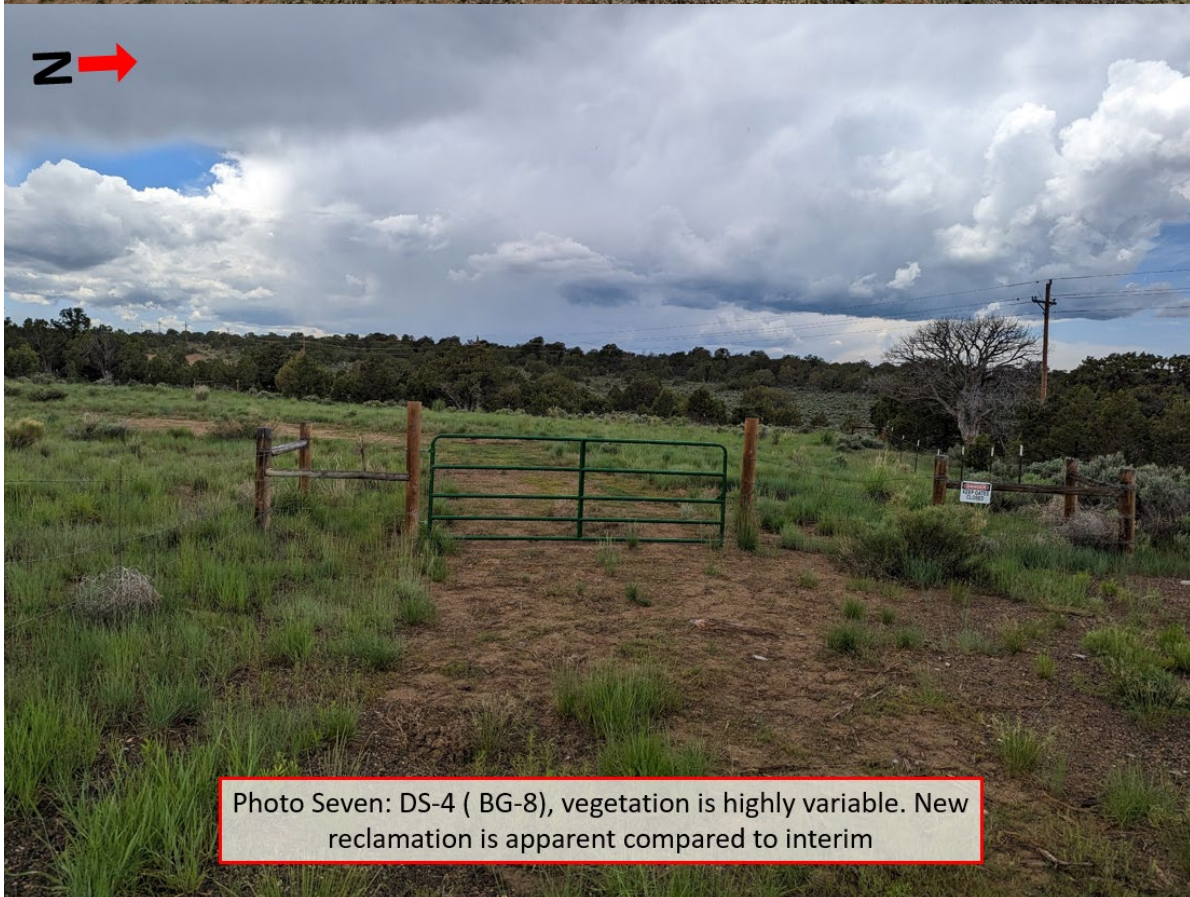
The access road to DS-4 (BG-8) is varied (Photo Seven). Vegetation in some areas is well established with desirable species or pockets of completely bare ground. Conditions within the pad were similar. The interim areas have well established perennial grasses with a few shrubs and minimal cheatgrass infestation (Photo Eight). While the recently reclaimed areas are nearly bare. This pad may have some soil quality issues given the distinct difference in reclamation success. The pad within the fence should be reseeded this fall. Soil sampling

to see if a larger problem is to blame for the failure also is recommended.
