**PERMIT INFORMATION**

<b>Permit Number:</b> C1981033 <b>Mine Name:</b> Bear Mine <b>Operator:</b> N/A <b>Operator Address:</b> N/A	<b>County:</b> Gunnison <b>Operation Type:</b> Underground <b>Permit Status:</b> Revoked <b>Ownership:</b> Private
	<b>Operator Representative Present:</b>  N/A
<b>Operator Representative Signature: (Field Issuance Only)</b>

<b>Inspection Start Date:</b> May 17, 2023 <b>Inspection Start Time:</b> 14:00 <b>Inspection End Date:</b> <b>Inspection End Time:</b>	<b>Inspection Type:</b> Coal Complete Inspection <b>Inspection Reason:</b> Normal I&E Program <b>Weather:</b> Clear
<b>Joint Inspection Agency:</b>  None	<b>Joint Inspection Contacts:</b>  
<b>Post Inspection Agency:</b>  None	<b>Post Inspection Contacts:</b>  
<b>Inspector(s):</b>  Leigh Simmons	<b>Inspector's Signature:</b>

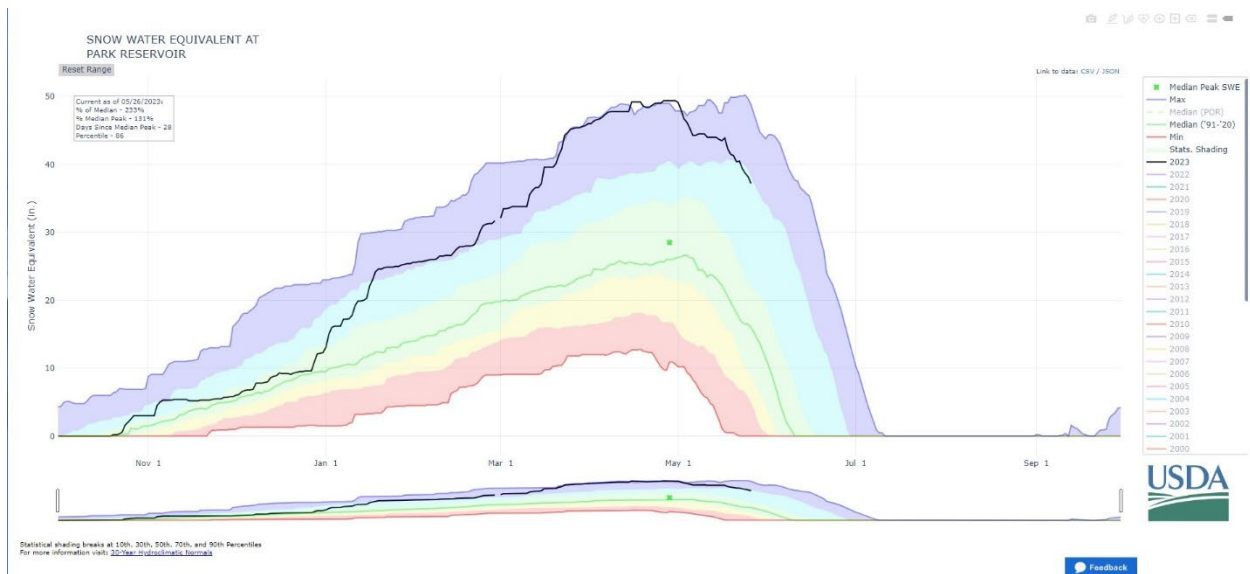
Figure 2: Snow water equivalent at Park Reservoir SNOTEL station

The area around the Bear Mine had been significantly impacted by the spring run-off of an unusually deep winter snowpack, exacerbated by a wetter than average spring. The Natural Resources Conservation Service (NRCS) of the United States Department of Agriculture maintains an automated system of 730 snowpack sensors across the Western United States called SNOTEL (SNOW TELemetry). Three SNOTEL stations are situated on the high ground north of the mine (from west to east, Park Reservoir, Overland Reservoir and McClure Pass), shown in Figure 1. The data from each of these stations show that the snow-water equivalent (which is a proxy for snowpack depth) in 2023 peaked close to, or above, the maximum recorded since 1990, and that there was a period of rapid melting around the beginning of May (see Figures 2-4).

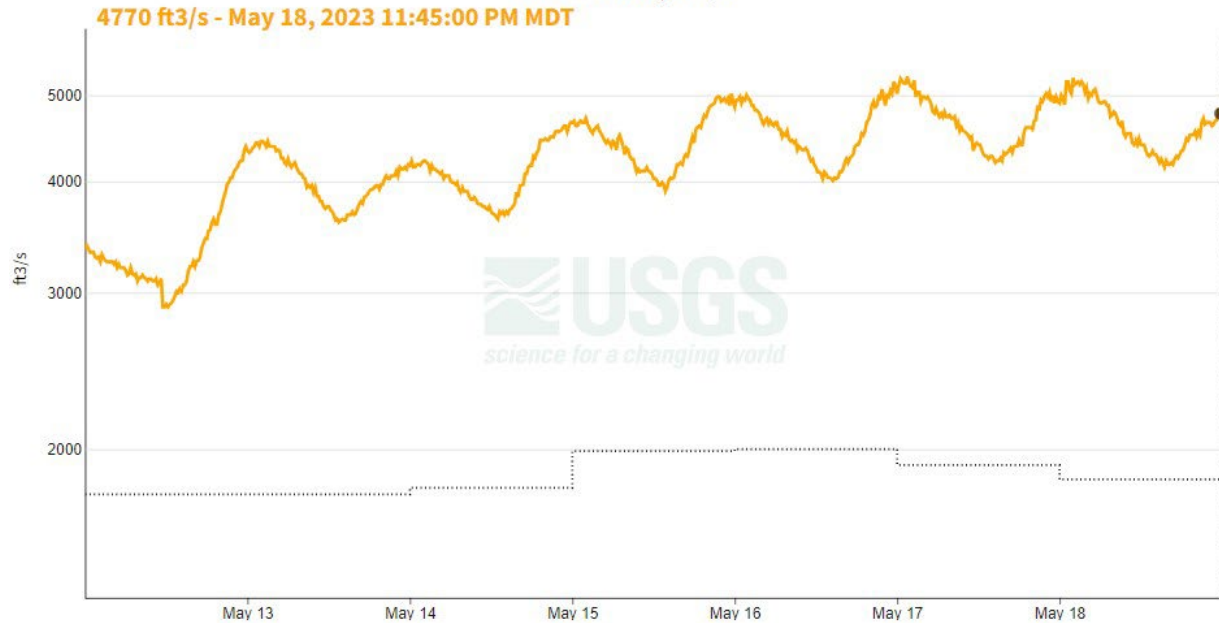
Figure 5: Streamflow data from USGS stream gage (median streamflow shown with dashed black line)
