File: May 2023 Monitoring Summary

Date: June 30, 2023

**Reference: May 2023 Geotechnical Monitoring Summary Pikeview Quarry**

PIKEVIEW QUARRY SLOPE  
MONITORING

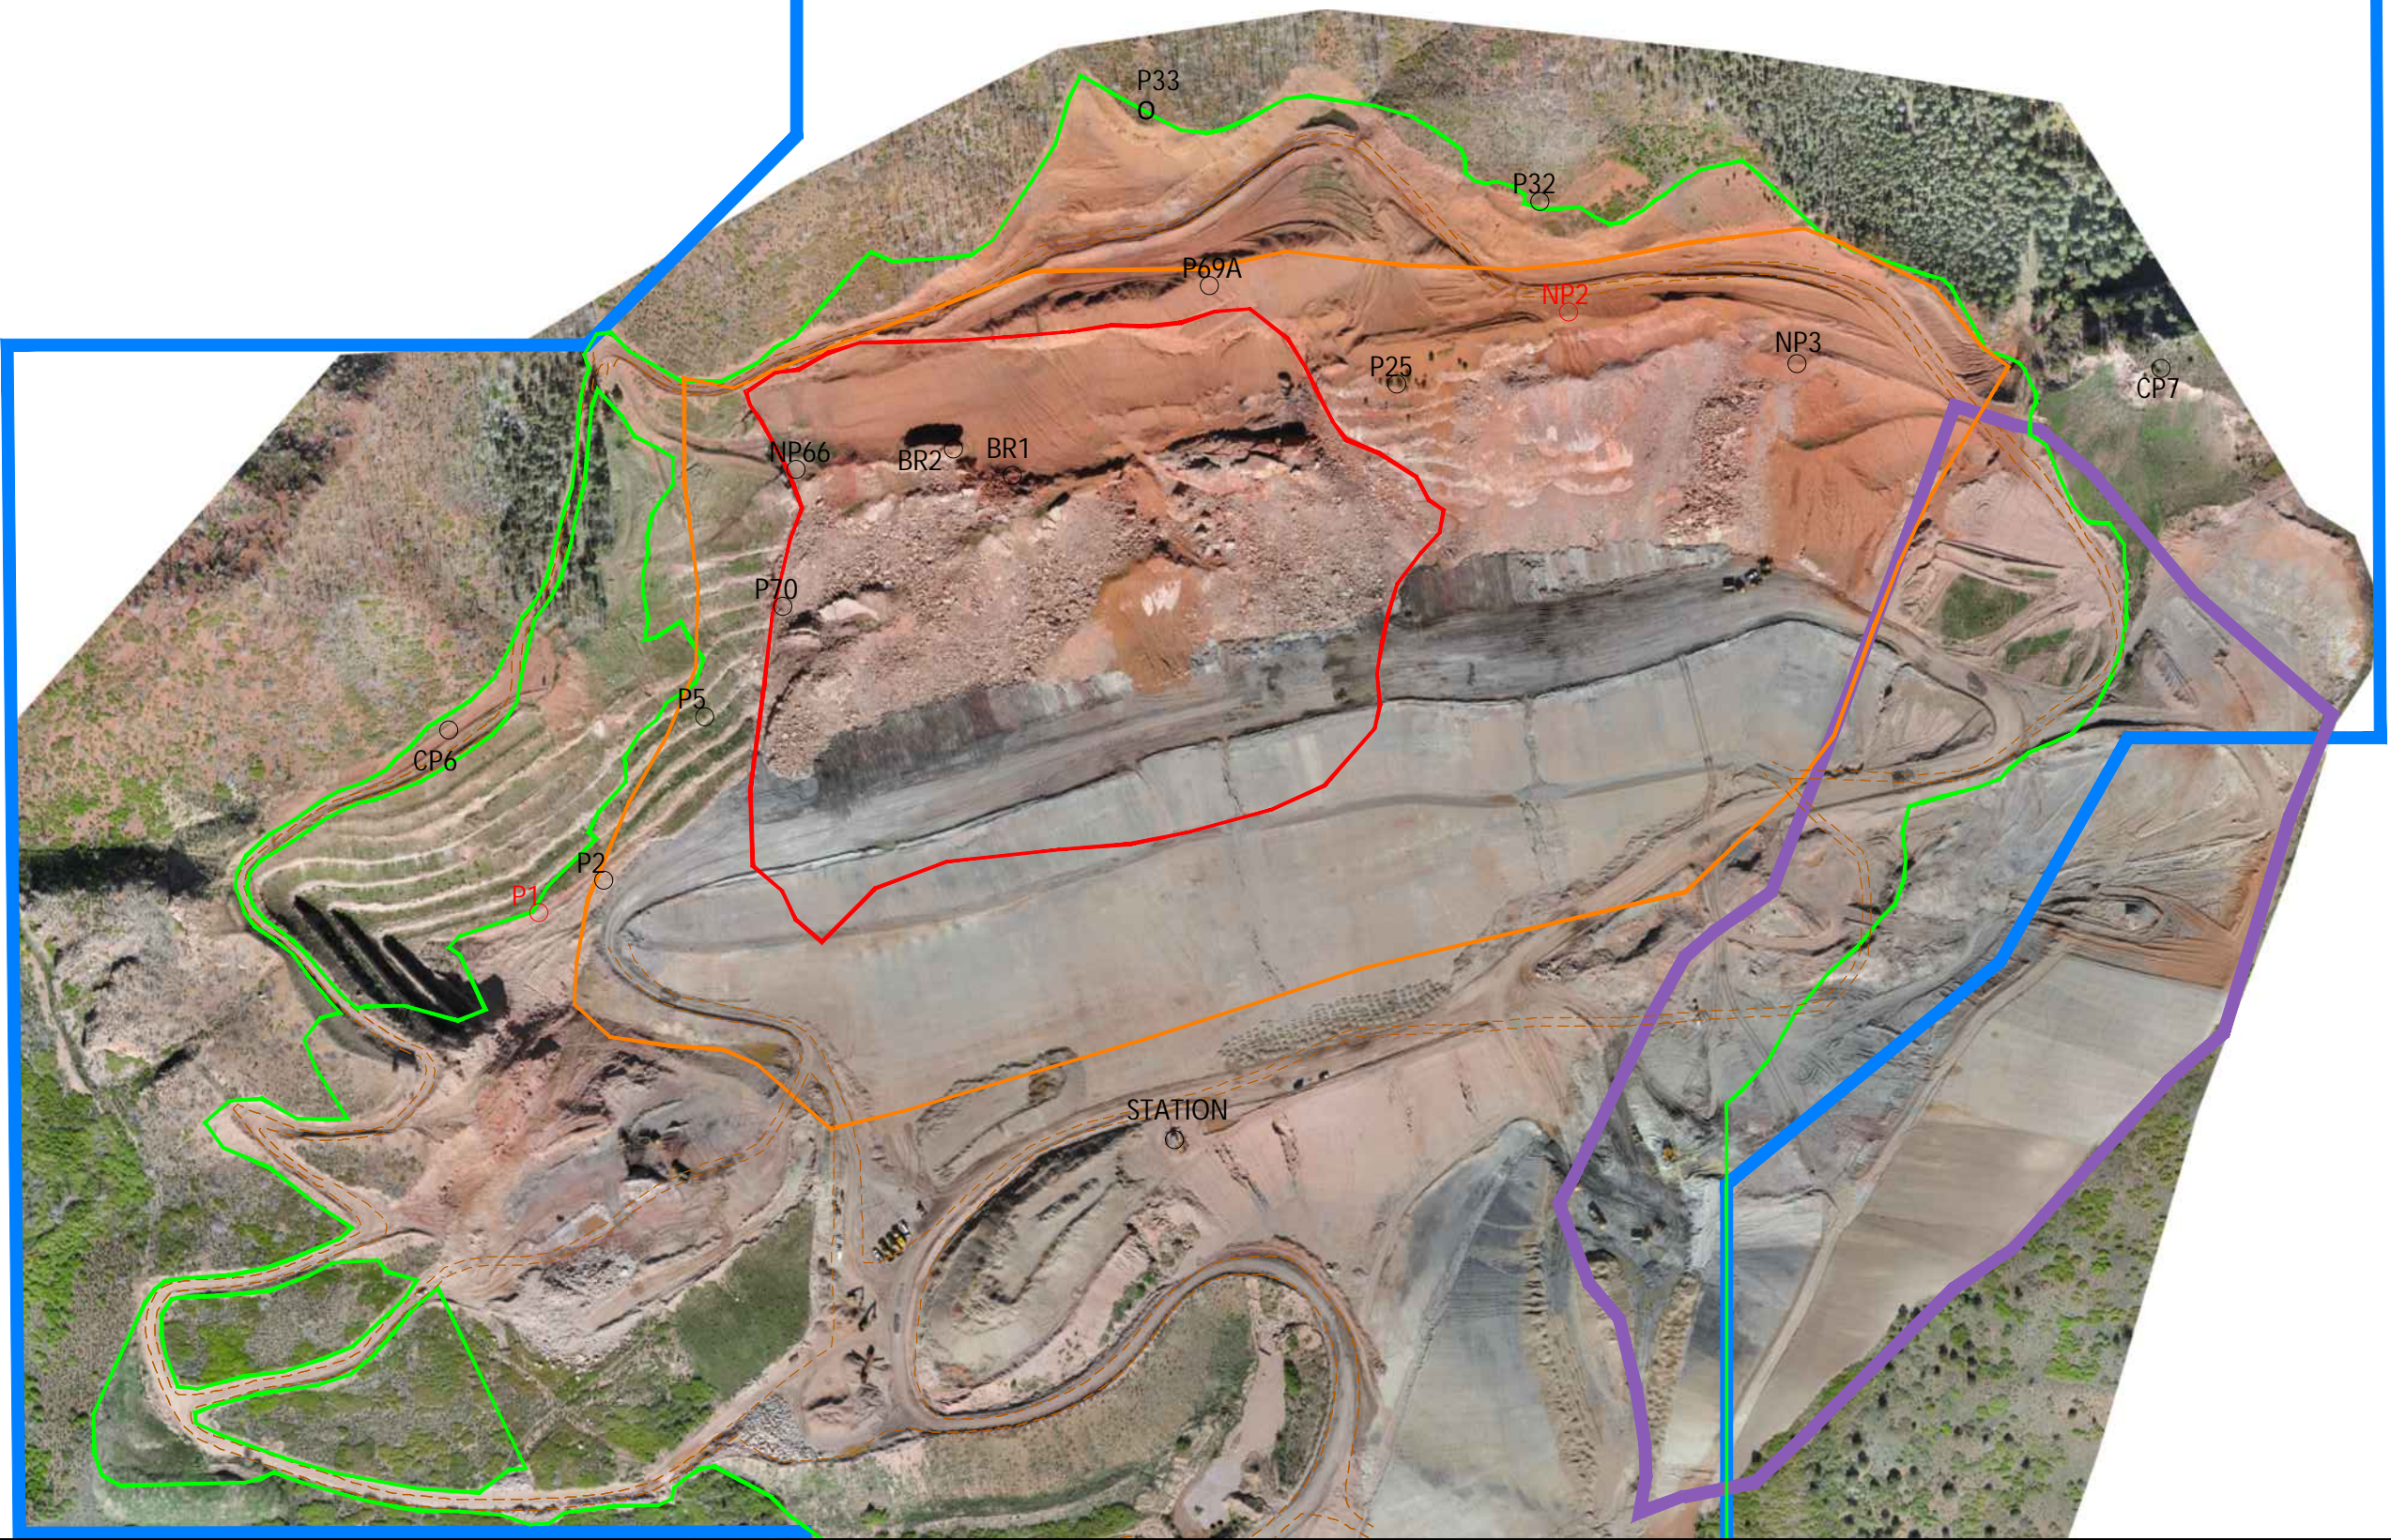
Revision #	Date
Drawn By PK	2023.06.30
	Figure No. 1

The data show stable conditions with no movements at 8 of 14 prisms with recorded displacements limited to data scatter and not actual movements. Prisms BR1, BR2, NP66, NP3, P69A, and P70 are located above the landslide, and these prisms recorded slope creep movements at slow velocity following the heavy rains in mid-May. This settlement was likely related to the landslide material consolidating under its own weight with the addition of excess water. At least one prism was located within an area where surficial slumping was observed, the prism, and these movements partially account for the recorded movements. These prisms were placed in areas where slope creep movements are likely to be recorded; therefore, slope creep movements being recorded at more locations is expected to occur. Plots of the transverse and height displacements for each prism are included in Appendix B.

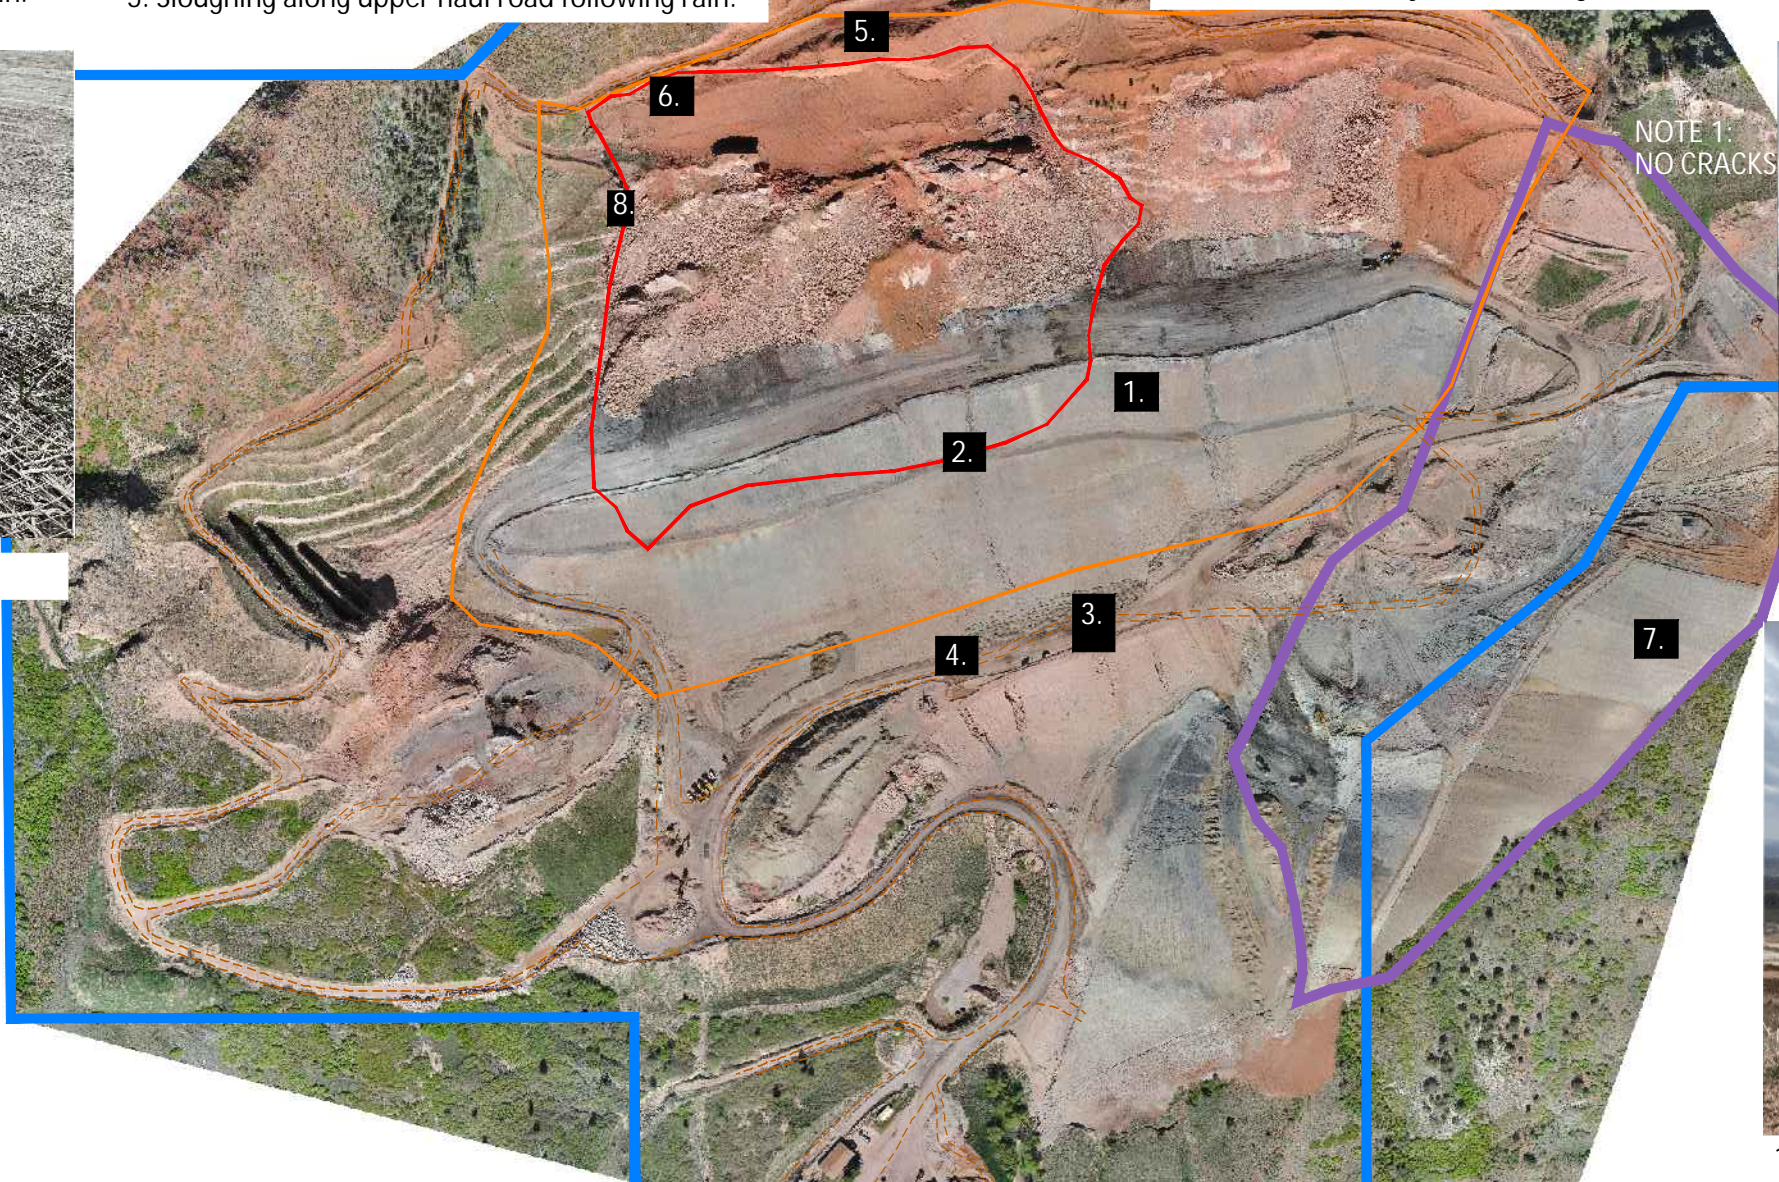
7. Vegetation growing within erosion blanket.

NOTE 1:  
NO CRACKS

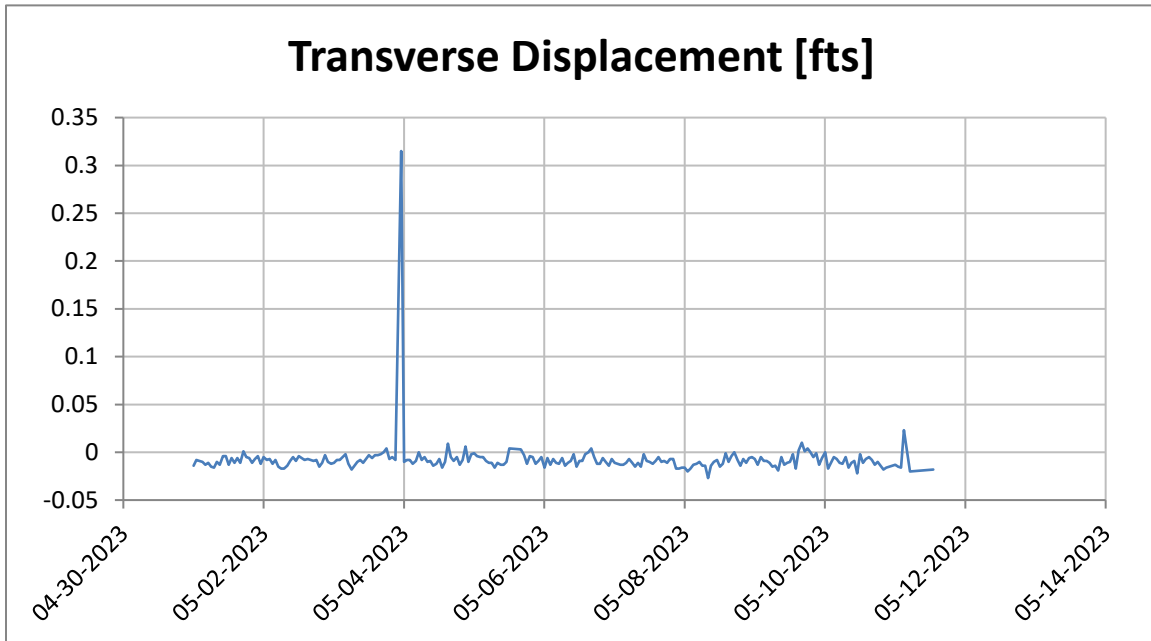
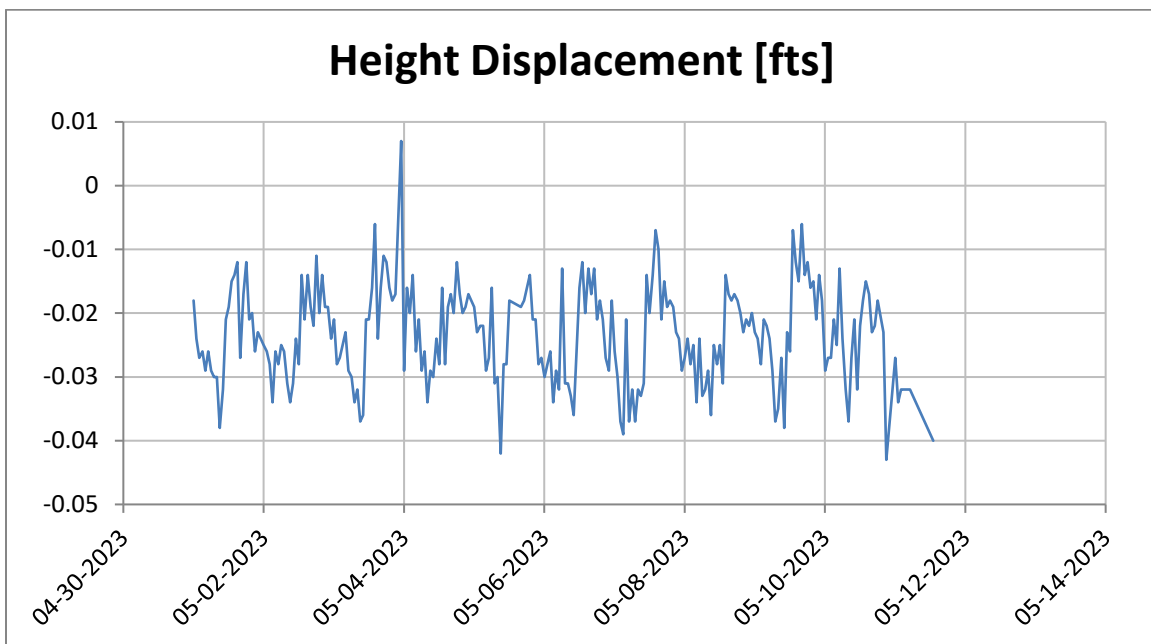
## Prism P1

4-May	P1 regression limits received	Multiple alerts in positive and negative directions. No work during alert. Prism inspected and no signs of movement.	4-May
4-May	P69A regression limits received	Multiple alerts. No work during alert. Prism inspected and no signs of movement.	4-May
5-May	No communication	Planned power outage during excavation near Leica building. Spotters in place during outage.	5-May
May 10 to May 12	Points not found	Rain, and fog. No work being performed at time of alerts.	10-May
11-May	P25 regression limits received	Rain and fog at time of alerts. No work during alert.	11-May
11-May	P69A regression limits received	Rain and fog at time of alerts. No work during alert.	11-May
11-May	P33 regression limits received	Rain and fog at time of alerts. No work during alert.	11-May
11-May	NP66 regression limits received	Rain and fog at time of alerts. No work during alert. Prism rotated as part of a surficial slump	11-May
