MINERALS PROGRAM INSPECTION REPORT
PHONE: (303) 866-3567

MINE NAME: Ensminger Pit	MINE/PROSPECTING ID#: M-2002-068	MINERAL: Gravel, sand and clay	COUNTY: Phillips
INSPECTION TYPE: Monitoring	WEATHER: Clear	INSP. DATE: May 25, 2023	INSP. TIME: 12:00
OPERATOR: Rick Ensminger	OPERATOR REPRESENTATIVE: Rick Ensminger	TYPE OF OPERATION: 110c - Construction Limited Impact	
REASON FOR INSPECTION: Normal I&E Program	BOND CALCULATION TYPE: Complete Bond	BOND AMOUNT: \$10,000.00	
DATE OF COMPLAINT: NA	POST INSP. CONTACTS: None	JOINT INSP. AGENCY: None	
INSPECTOR(S): Amber Michels	INSPECTOR'S SIGNATURE:

SIGNATURE DATE: July 17, 2023

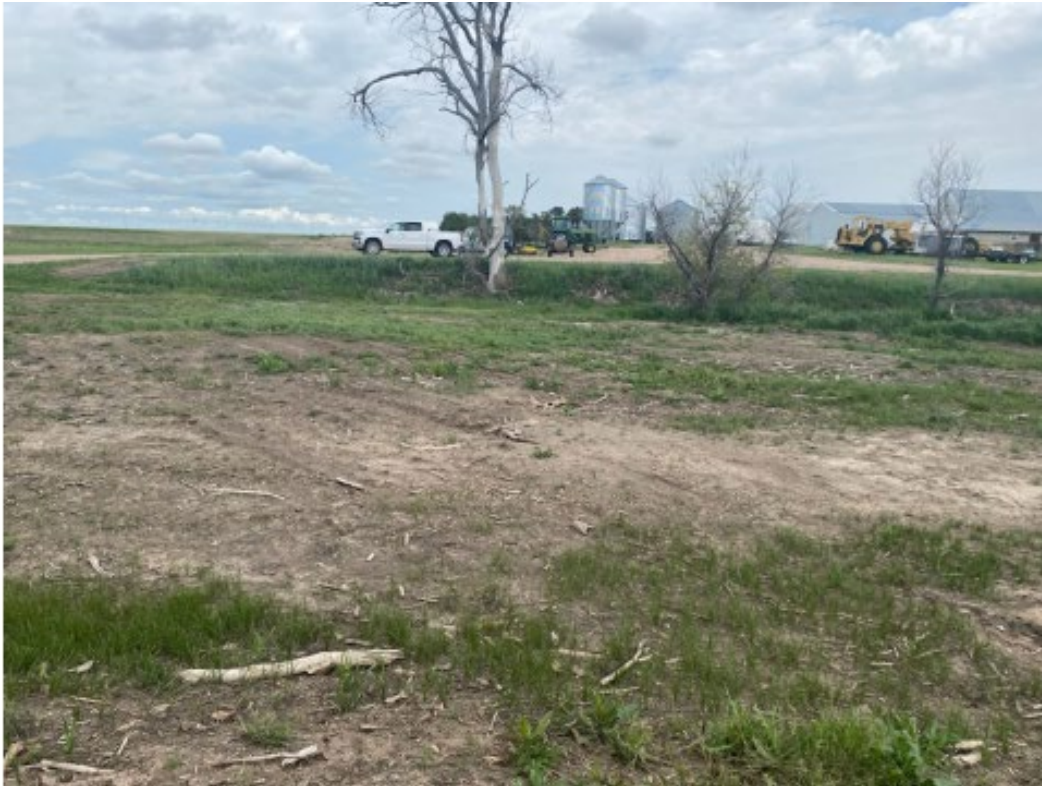
Only one boundary marker was observed on-site. The north-east corner t-post was placed next to the mine sign (Photo 20: Map 1). The Operator also stated that there had been one marking the south-east corner just prior to the inspection, and that it had been knocked down. The Division took a photo from the location where the Operator stated the post had been (Photos 1 and 2: Map 1). The Operator also stated that there were t-posts for the northern boundaries prior to the inspection, but they were taken down to farm in these areas (see cropland north of active pit on Map 1, and Figures 1-2).

Photo 1: Looking north from the approximate location of the south-east corner marker.

A problem was cited above for failure to maintain boundary markers delineating the approved affected area in accordance with Rule 3.1.12(2)(a). The Operator shall conduct a survey to replace the missing boundary markers. The Operator must submit photo evidence and/or GPS coordinates that indicates that boundary markers have been installed.

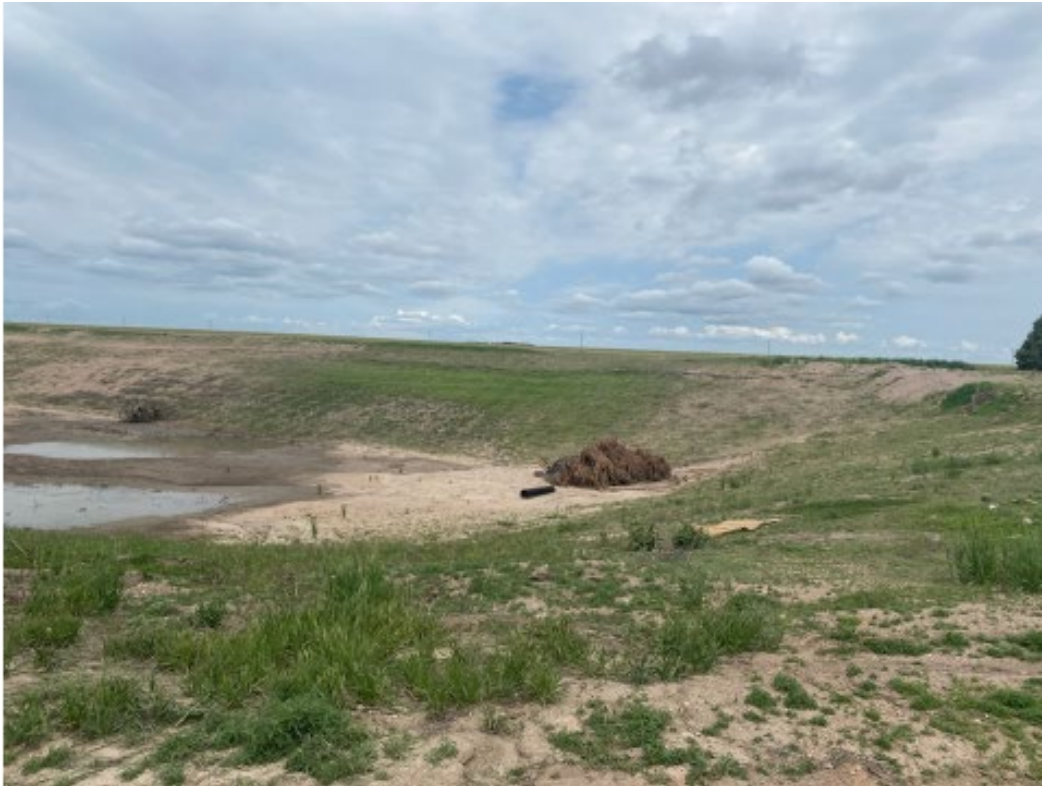
The Division did not observe excess sediment entering the creek bed. However, in the north east corner of the northern pit, there is an erosion gully that appears to have been caused from the run-off from the Operator's shop area running downslope into the pit (Photo 19: Map 1). **A problem has been cited** for erosion. The Operator will need to repair the erosion in this corner, and submit photo evidence that this has been completed by the corrective action date.

Photo 7: Looking north at the north-eastern corner of the northern pit.

CORRECTIVE ACTIONS: The Operator shall provide photo documentation to the Division verifying erosion the gully has been repaired, and that the site has have been reconstructed and stabilized to prevent erosion damage by the corrective action date.

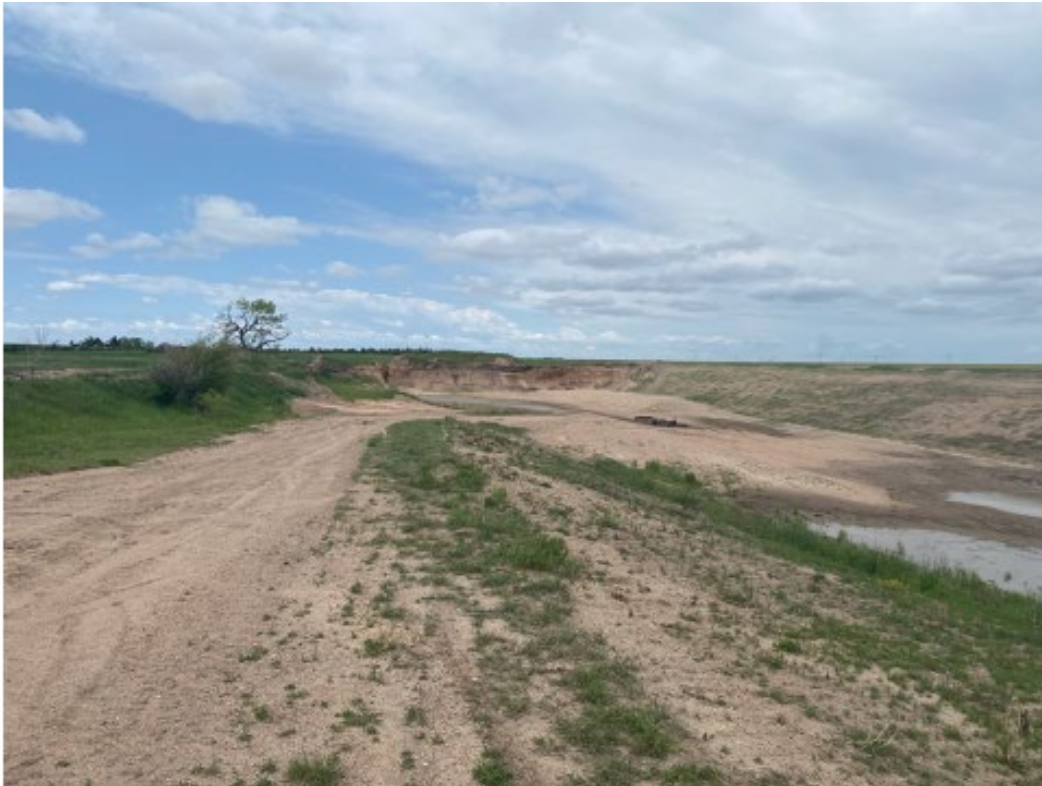
The Operator stated that they plan to reclaim the highwall along the western border this summer. The Division reminds the Operator that the approved grade for the east and west slopes according to the current reclamation plan is a 4H:1V slope. The Operator has conducted reclamation of the northern boundary of the pit within the past few years and stated that it was seeded a few years ago. The northern boundary has been graded at a 3H:1V slope, pursuant to the approved reclamation plan. The vegetation planted on the slope has begun to grow and is becoming established. There is a shallow scarp that extends from the east to the west side of the slope (Photos 16 and 17). The Division expressed concern about slope failure but the Operator stated that they believe the slope has settled and will not continue to erode. The Division cautions the Operator to monitor the scarp to ensure that it doesn't grow. If the scarp continues to erode, the Operator will need to regrade and re-seed the slope in compliance with Rule 3.1.9(5).

Photo 9: Looking west at the western boarder of the northern pit.

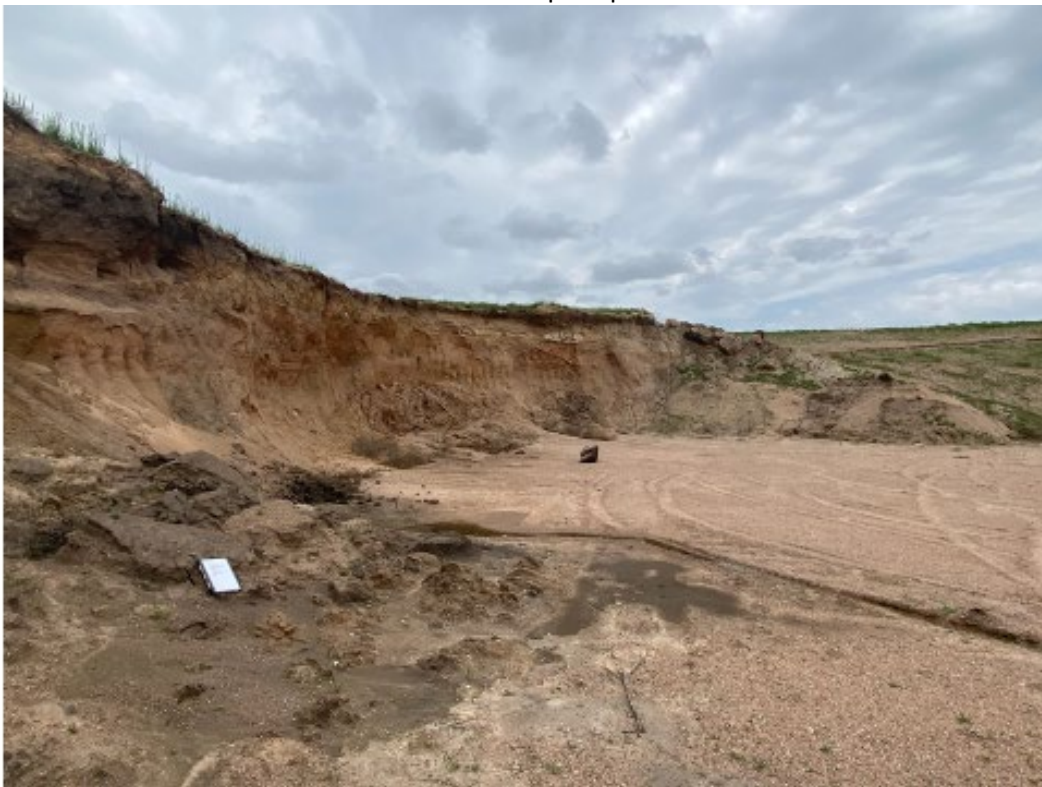
Photo 14: Looking north along the western border of the northern pit.

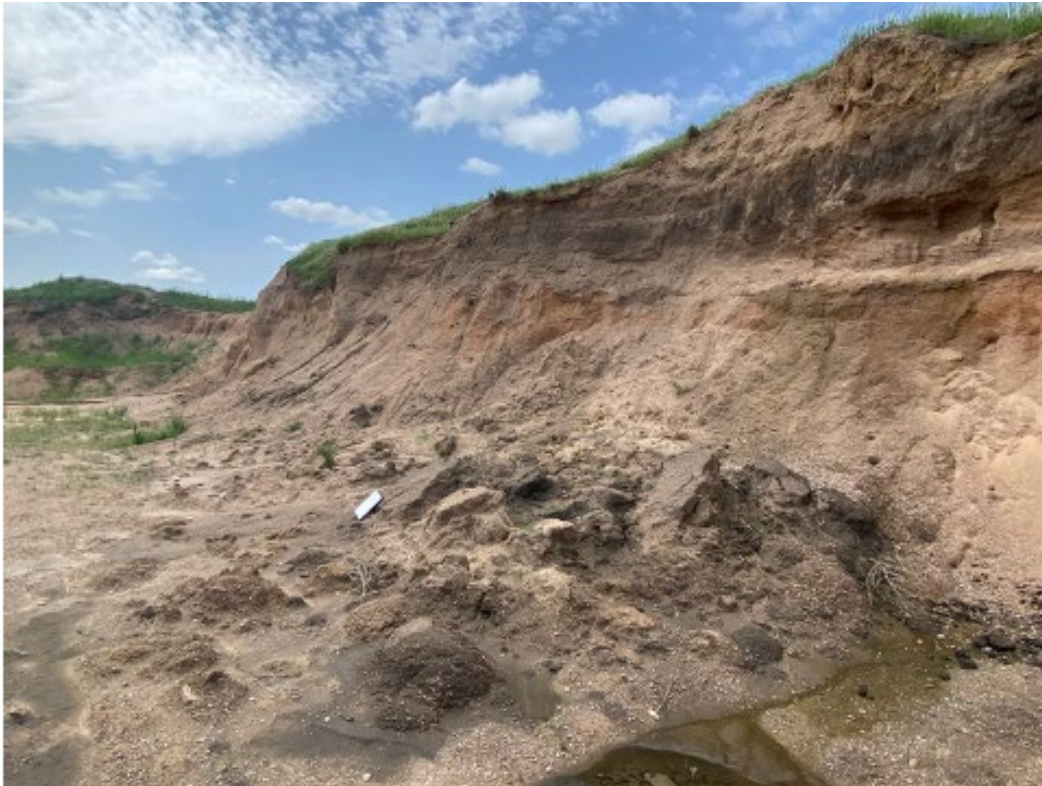
Photo 15: Looking south along the western border of the northern pit.

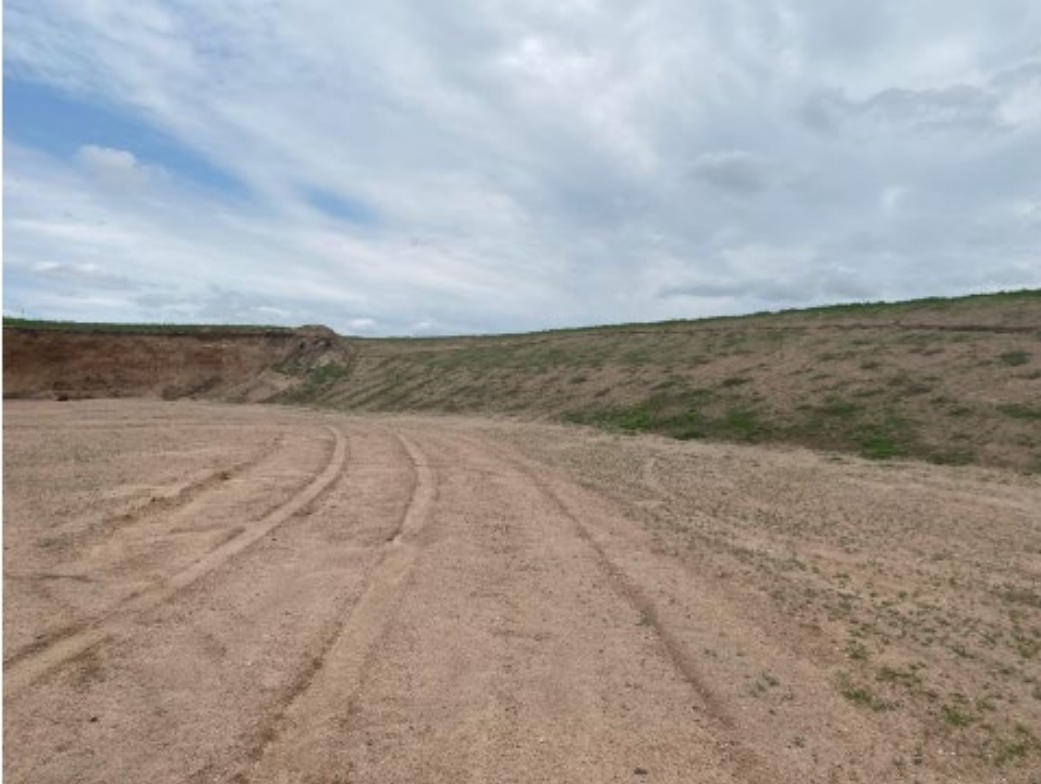
Photo 17: Looking north-west at the northern most corner of the northern pit.

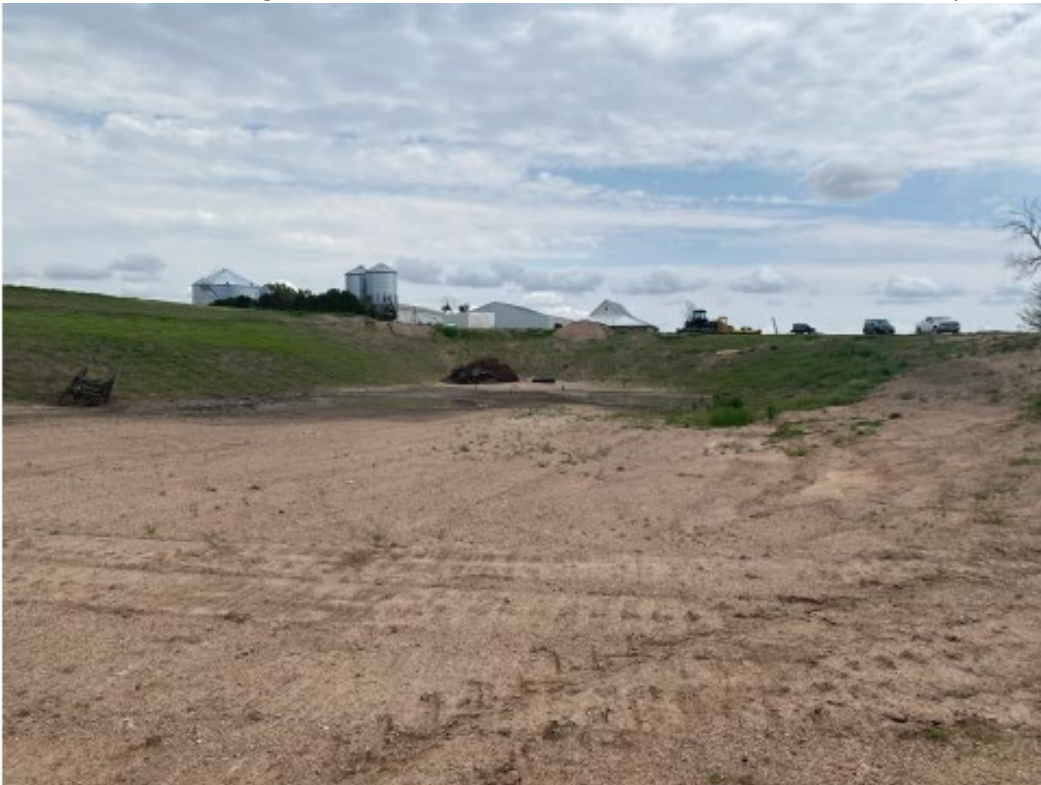
Photo 18: Looking at the north-east corner of the northern pit.

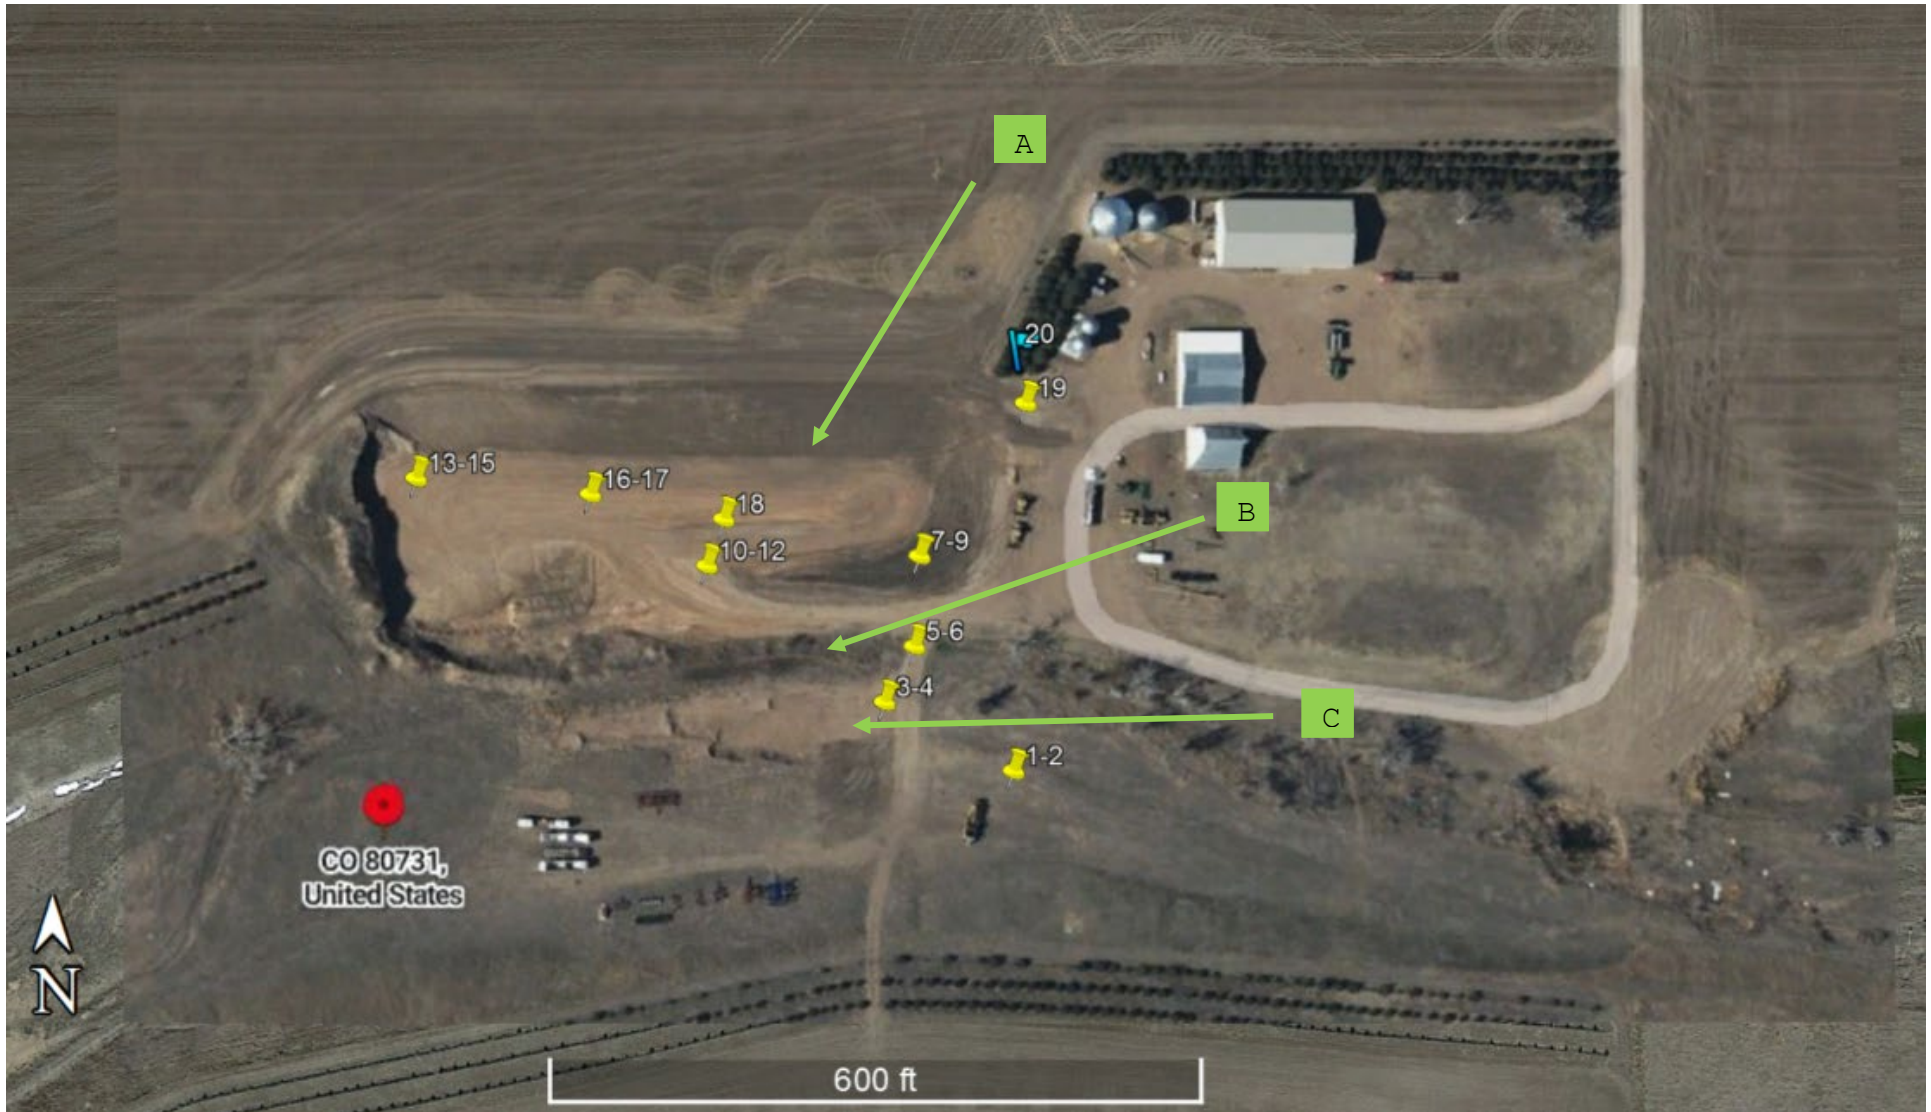
Standing water was observed onsite within the creek bed south of the main pit (Photos 2-6: Map 1(C)) and in shallow ponds within the north pit (Photos 8, 12, and 19: Map 1). As stated above, the Operator constructed a berm using clay materials to attempt to keep the water within the creek bed and out of the northern pit. The area of Haxtun, CO and surrounding areas had recently received high amounts of rainfall, and were experiencing an excess of water compared to average conditions. The Operator stated that he is aware that the water is to remain in the creek, and is actively attempting to find a solution to keep the northern pit dry.

Map 1: Map generated using a more recent (not dated) map image from Bing Maps in combination with the image overlay function in Google Earth Pro. The Bing Map provides a more representative image of the current site conditions than the most recent image on Google Earth Pro (most recent image is in G.E.P is from September 2016). The blue flag represents the location of the t-post boundary marker observed in place during the 2023 inspection, and corresponds with Photo 20 (see Figure 1). The yellow push pin icons represent the locations where the photos were taken during the 2023 inspection. The green arrows represent:

A) the northern pit, B) the clay berm separating the northern pit from the creek bed, C) the small southern pit within the creek bed of Frenchman Creek.
