**MINERALS PROGRAM INSPECTION REPORT**  
**PHONE: (303) 866-3567**

<b>MINE NAME:</b> Hartman Pit	<b>MINE/PROSPECTING ID#:</b> M-1997-087	<b>MINERAL:</b> Gravel	<b>COUNTY:</b> Pueblo
<b>INSPECTION TYPE:</b> Surety Release Inspection	<b>WEATHER:</b> Clear	<b>INSP. DATE:</b> June 29, 2023	<b>INSP. TIME:</b> 08:30
<b>OPERATOR:</b> Arnolds Custom Seeding, LLC	<b>OPERATOR REPRESENTATIVE:</b> Shawn Hesse	<b>TYPE OF OPERATION:</b> 112c - Construction Regular Operation	
<b>REASON FOR INSPECTION:</b> Surety Release Requested	<b>BOND CALCULATION TYPE:</b>	<b>BOND AMOUNT:</b> \$22,707.00	
<b>DATE OF COMPLAINT:</b> NA	<b>POST INSP. CONTACTS:</b> None	<b>JOINT INSP. AGENCY:</b> Colo. Land Board	
<b>INSPECTOR(S):</b> Amber Michels	<b>INSPECTOR'S SIGNATURE:</b>

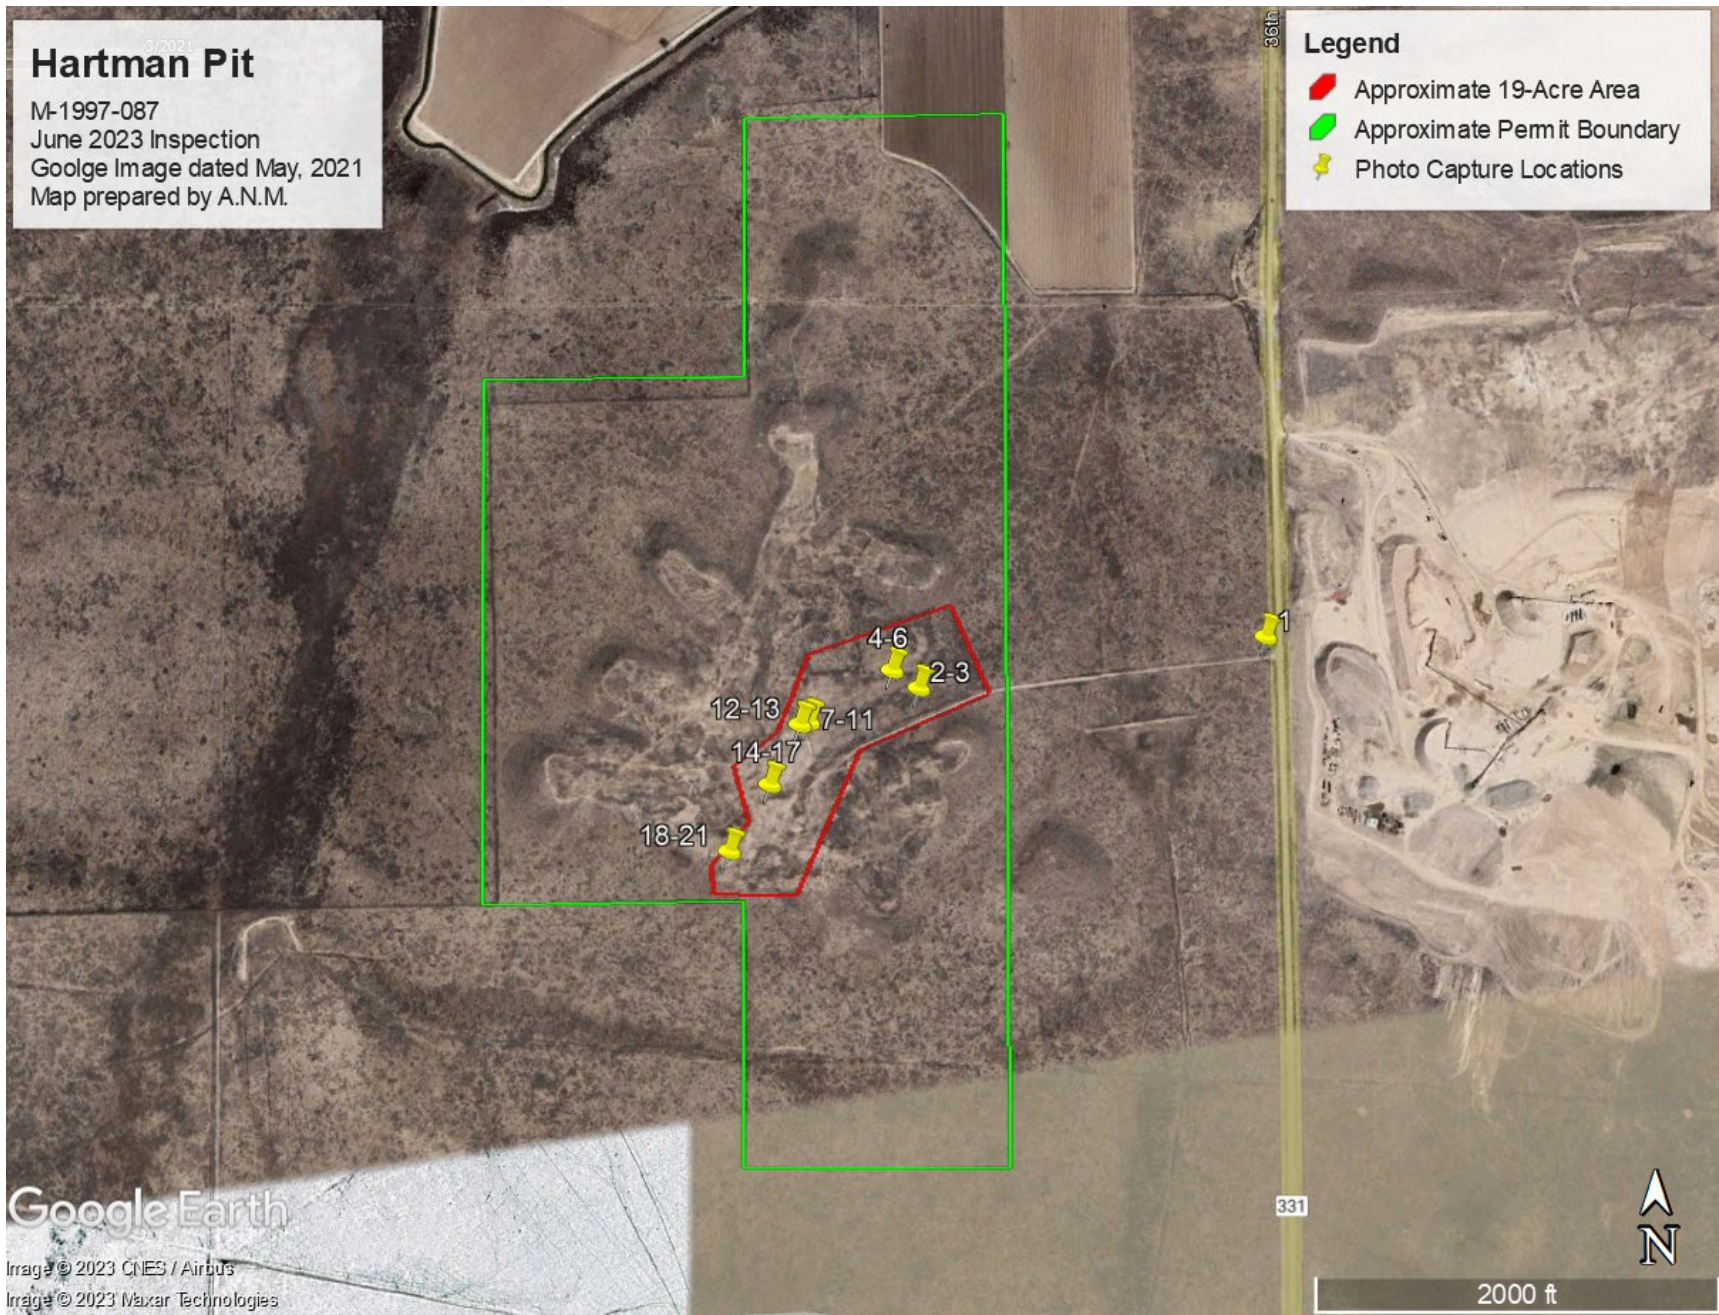
**Map 1:** Map generated in Google Earth Pro to display the entire permitted area. Photos taken during the inspection correlate with the yellow push-pins labeled 1-21.

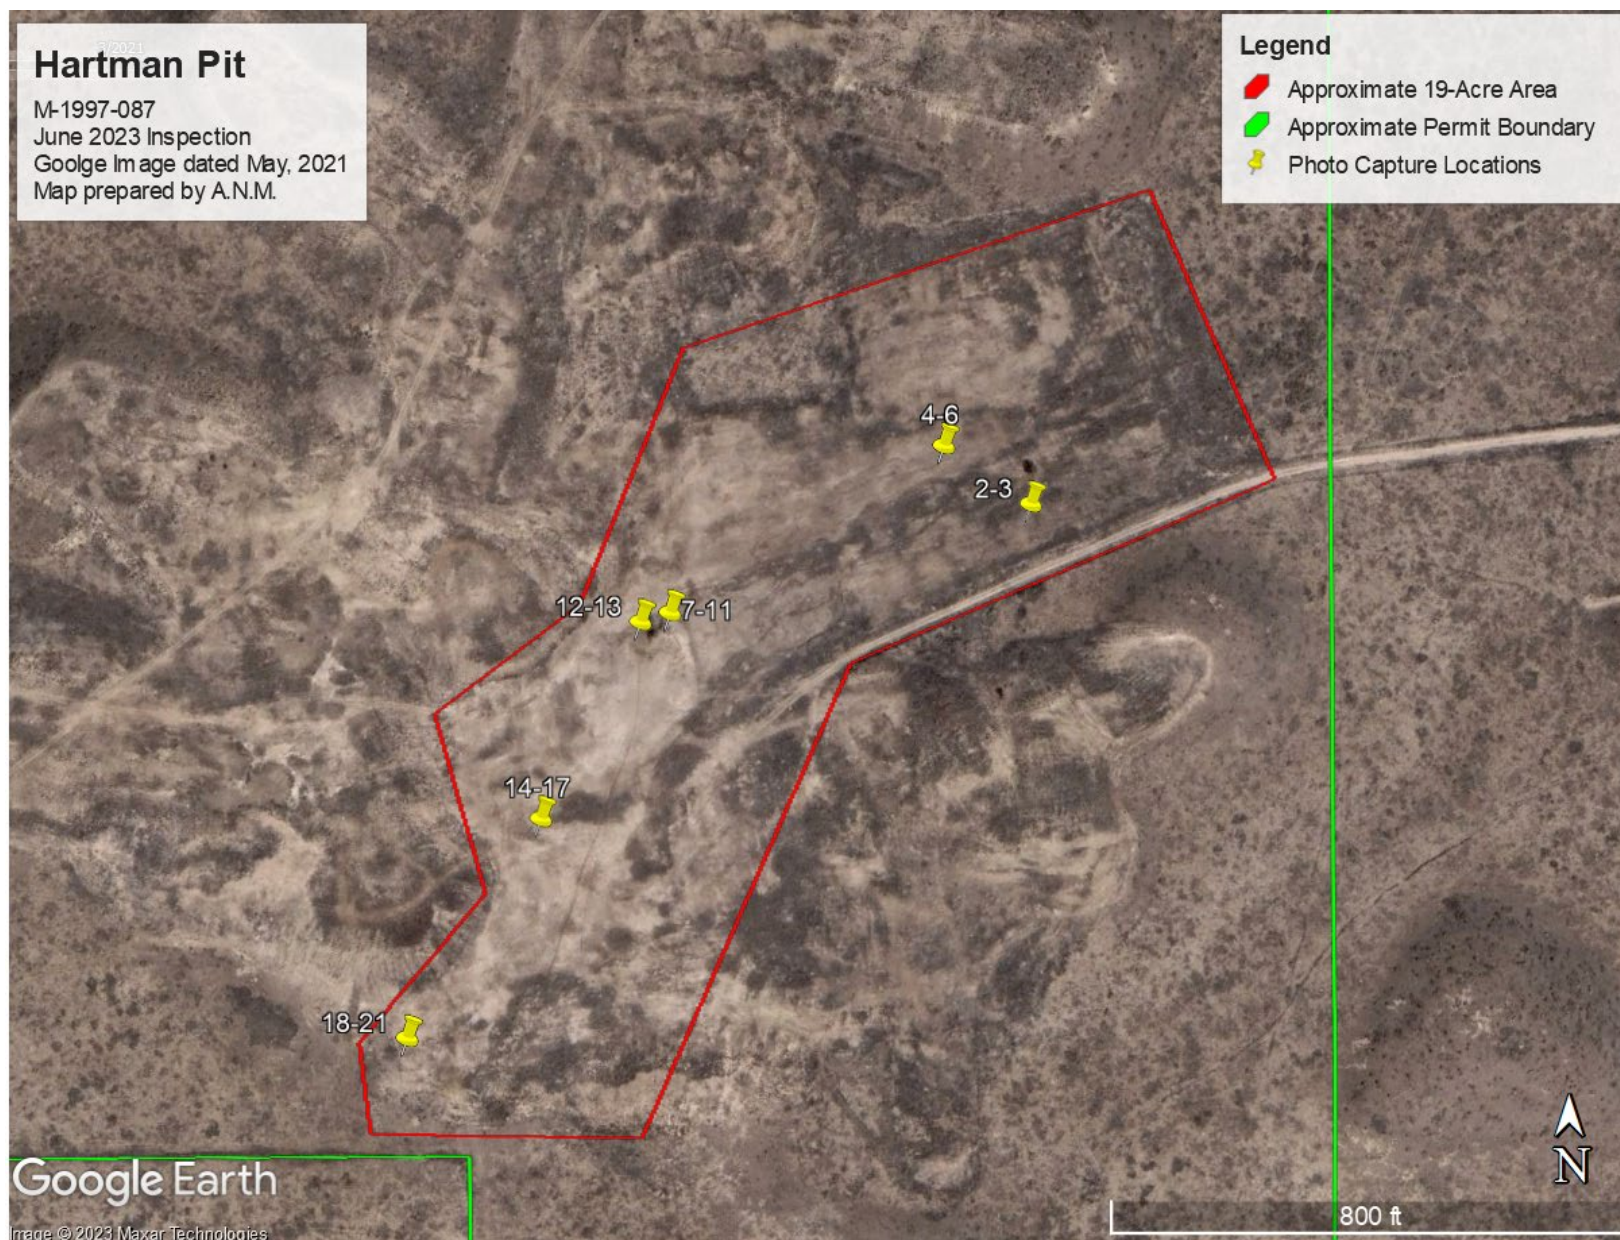
**Map 2:** Map generated in Google Earth Pro to display a closer look at the 19-acre area that was not in a releasable state during the previous DRMS inspection conducted in 2021.
