File: June 2023 Monitoring Summary

Date: July 31, 2023

**Reference: June 2023 Geotechnical Monitoring Summary Pikeview Quarry**

PIKEVIEW QUARRY SLOPE  
MONITORING

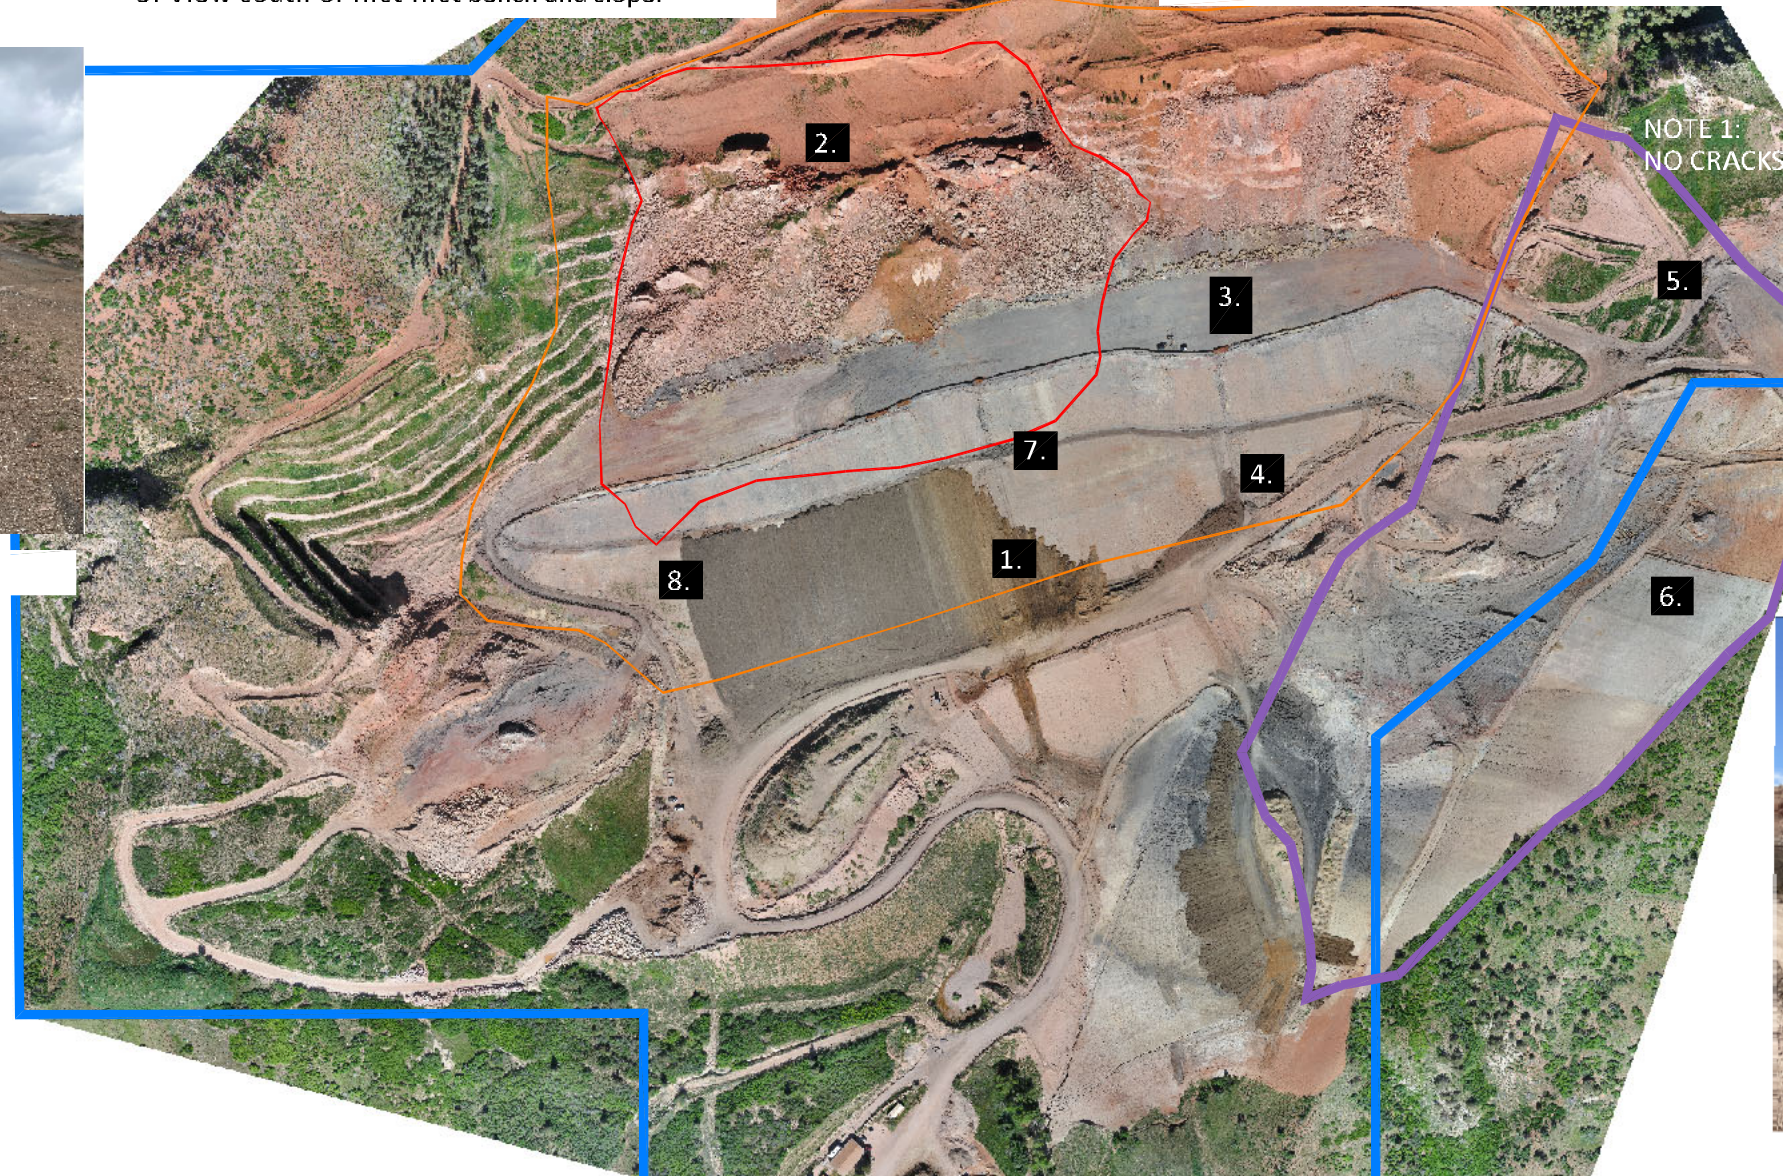
NOTE 1:  
NO CRACKS

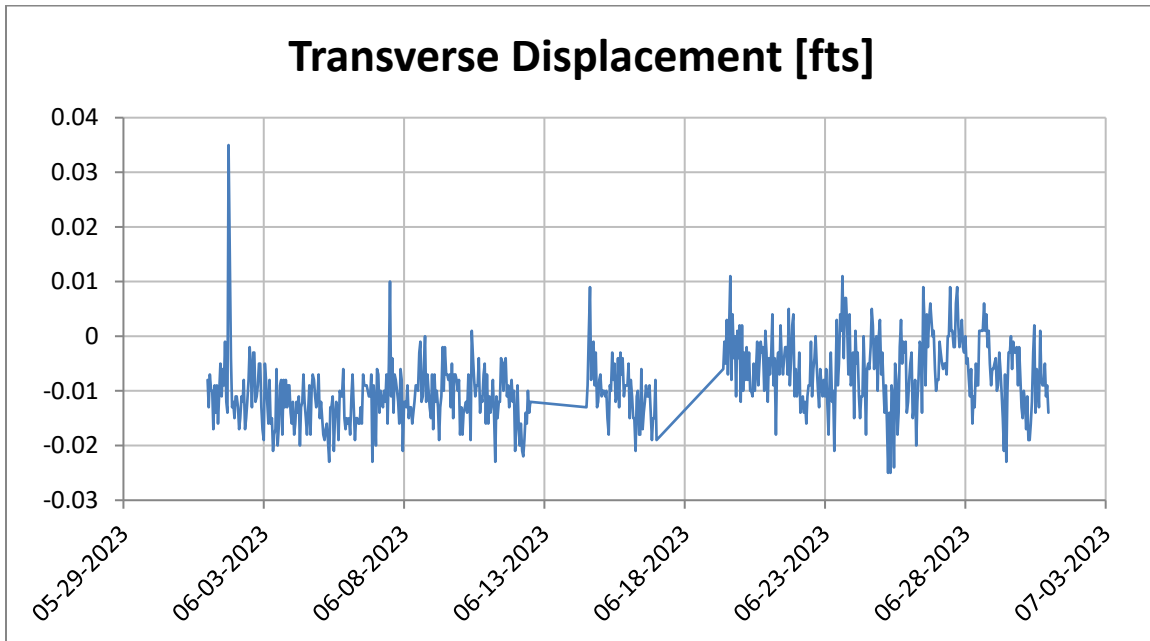
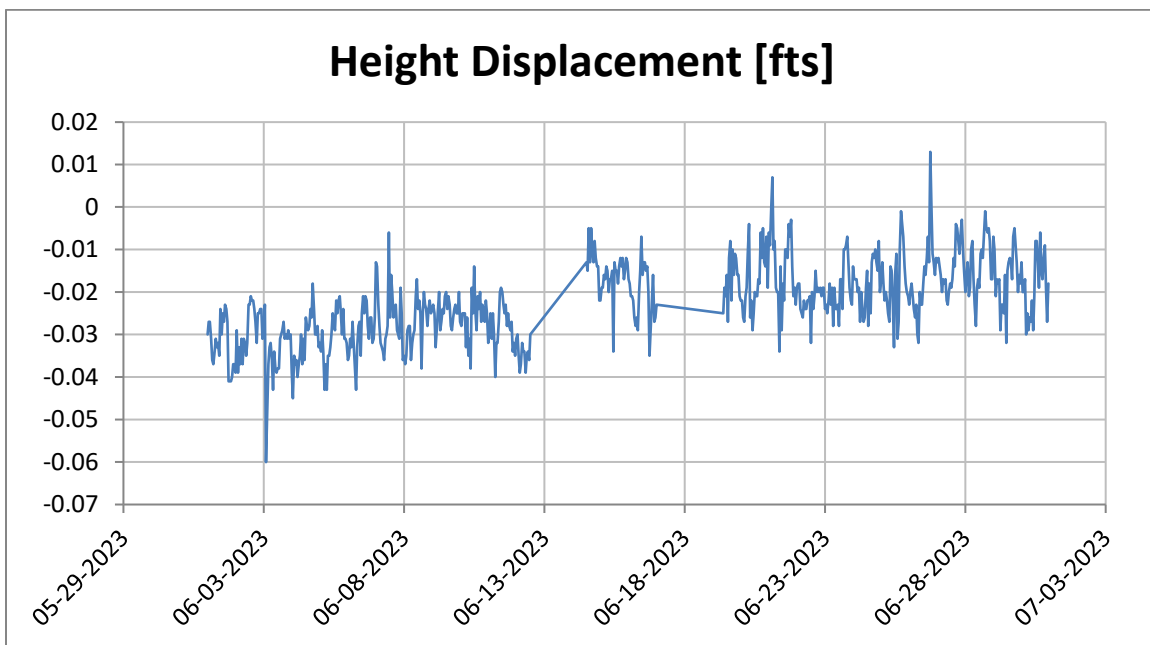
## Prism P2

1. Survey accuracy is  $\pm 0.016$  feet.
2. Alert threshold is  $\pm 0.35$  feet.
3. Transverse displacement is in the horizontal direction. Positive direction means closer to the robotic station.
4. Height displacement is in the vertical direction. Positive direction means higher in elevation.
5. Regression limit alert received on June 1.

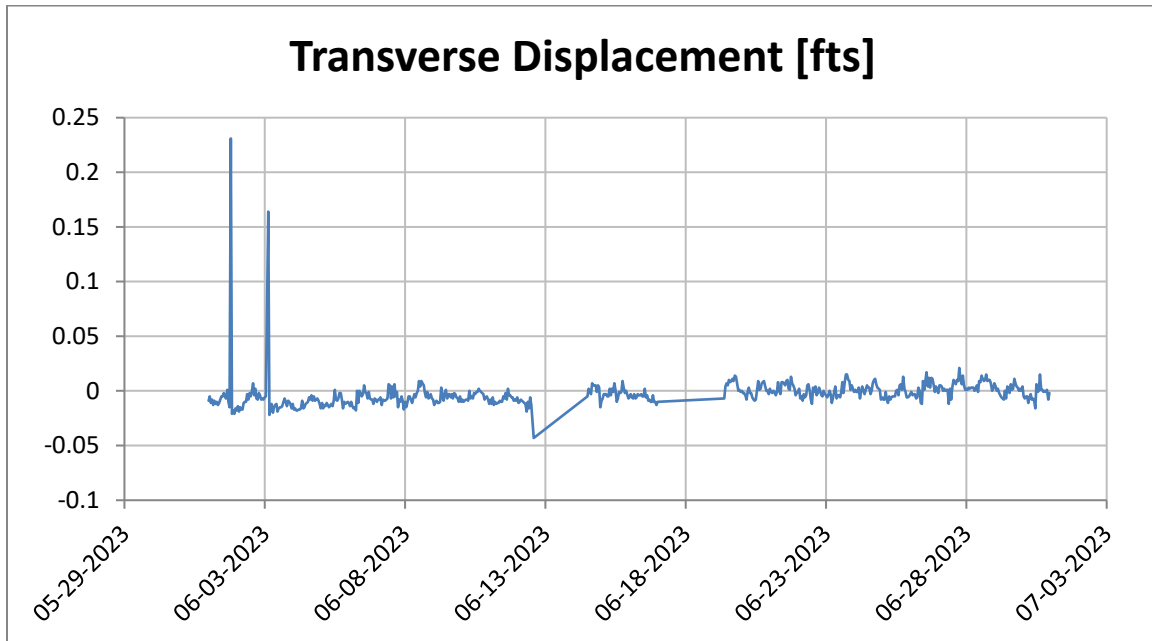
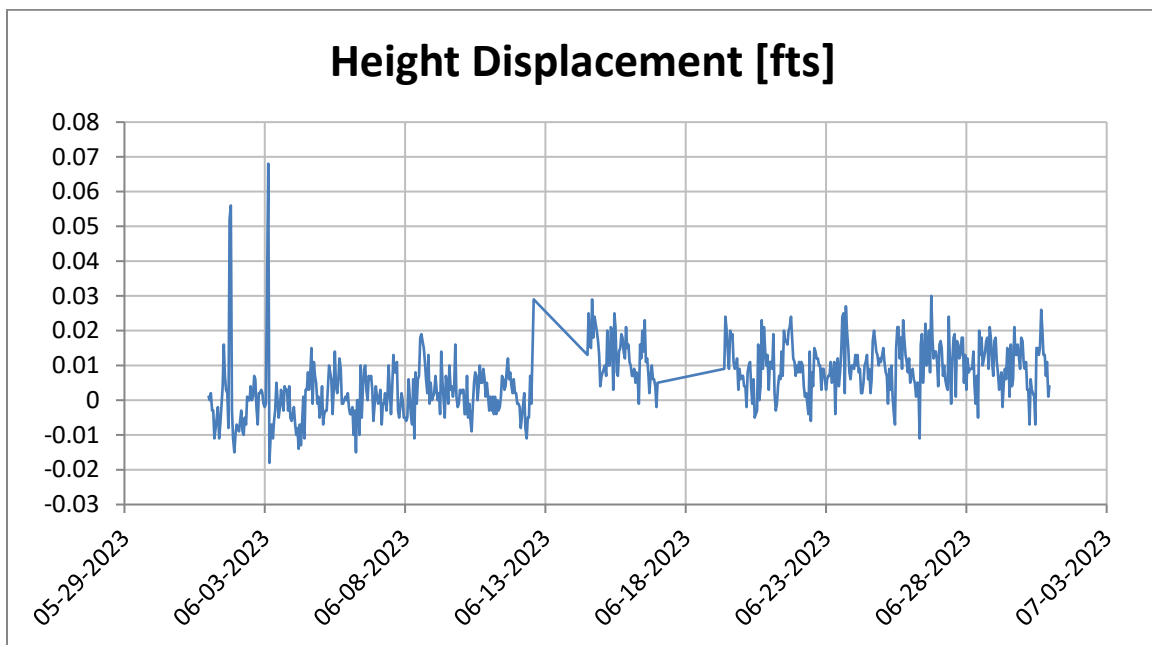
## Prism P25

1. Survey accuracy is  $\pm 0.016$  feet.
2. Alert threshold is  $\pm 0.35$  feet.
3. Transverse displacement is in the horizontal direction. Positive direction means closer to the robotic station.
4. Height displacement is in the vertical direction. Positive direction means higher in elevation.
5. Regression limit alerts received on June 1 and June 3.

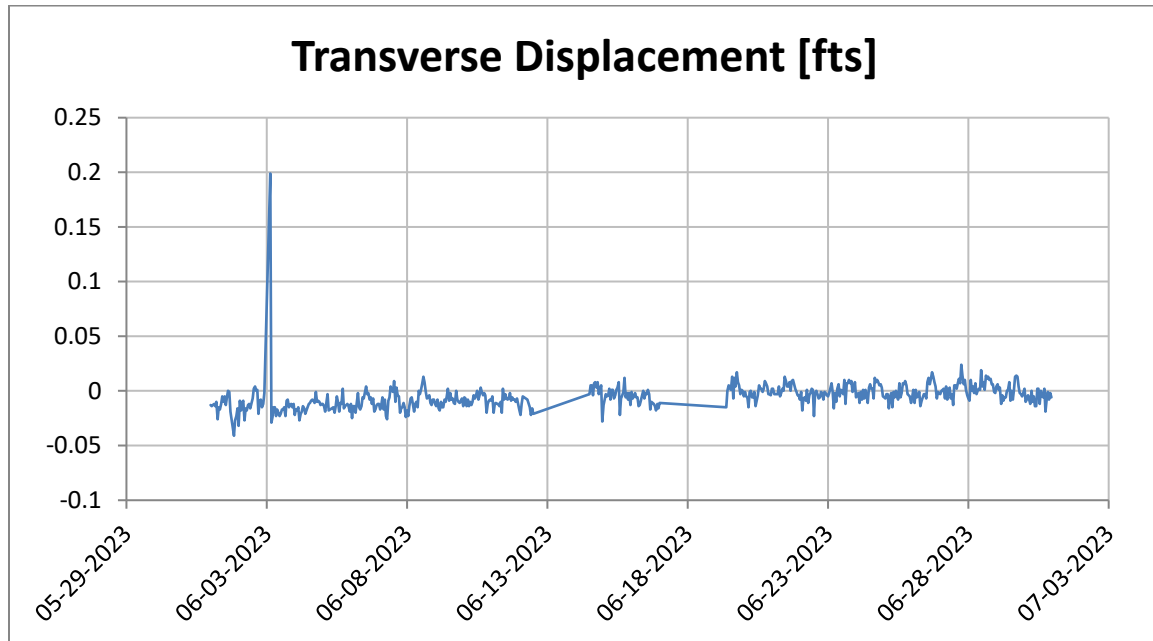
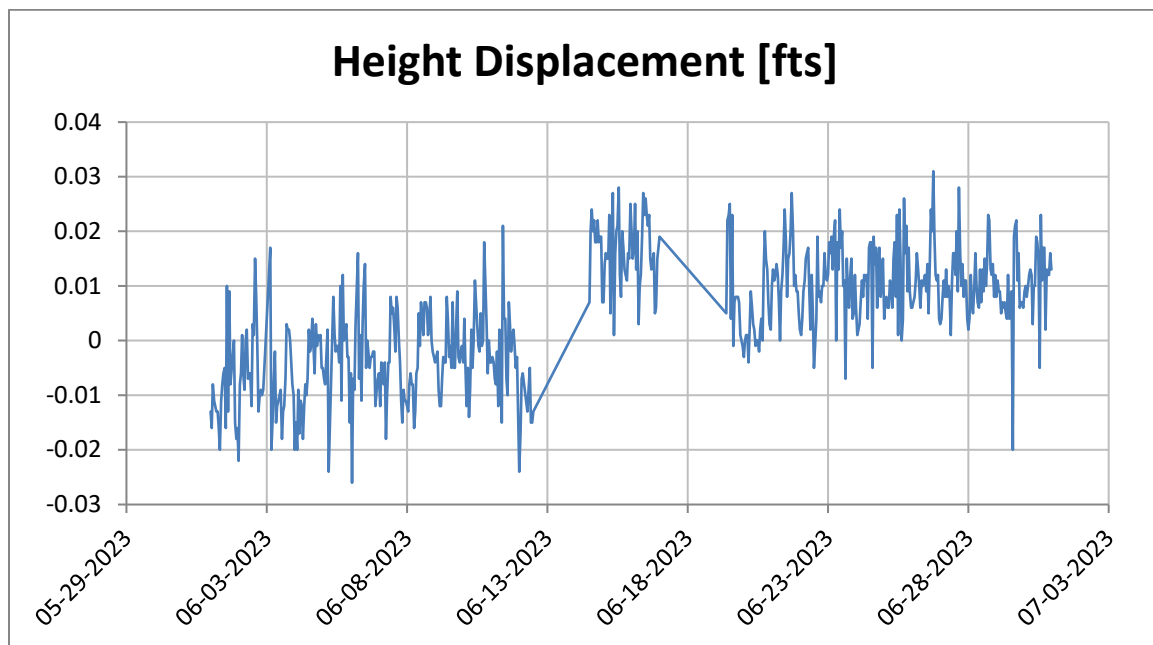
## Prism P32

1. Survey accuracy is  $\pm 0.016$  feet.
2. Alert threshold is  $\pm 0.35$  feet.
3. Transverse displacement is in the horizontal direction. Positive direction means closer to the robotic station.
4. Height displacement is in the vertical direction. Positive direction means higher in elevation.
5. Regression limit alert received on June 3.

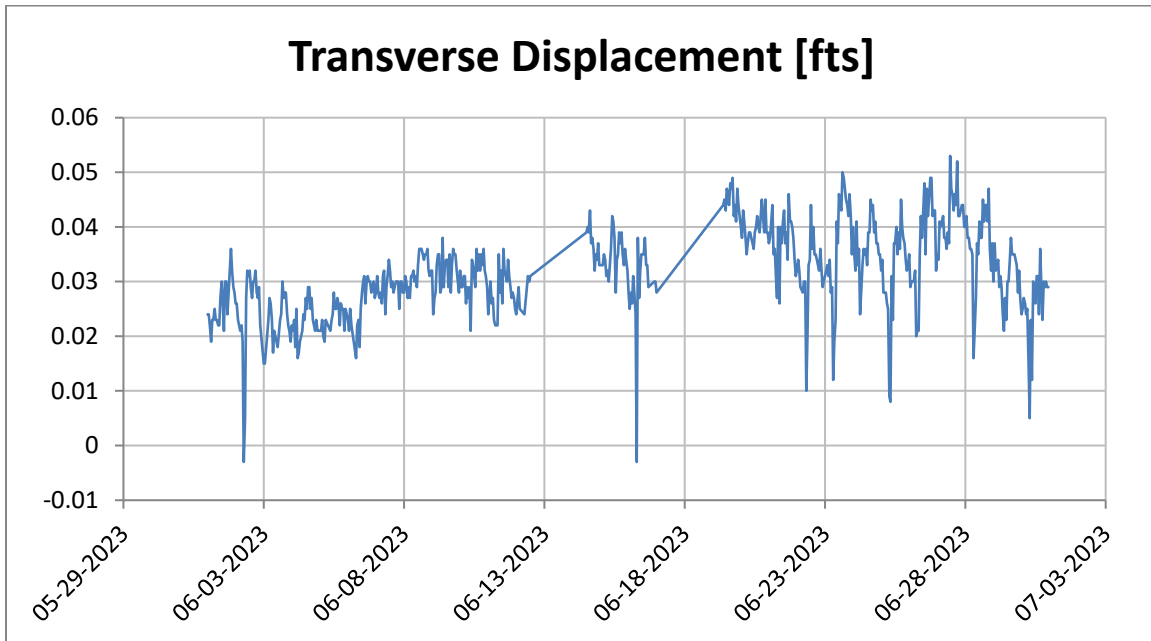
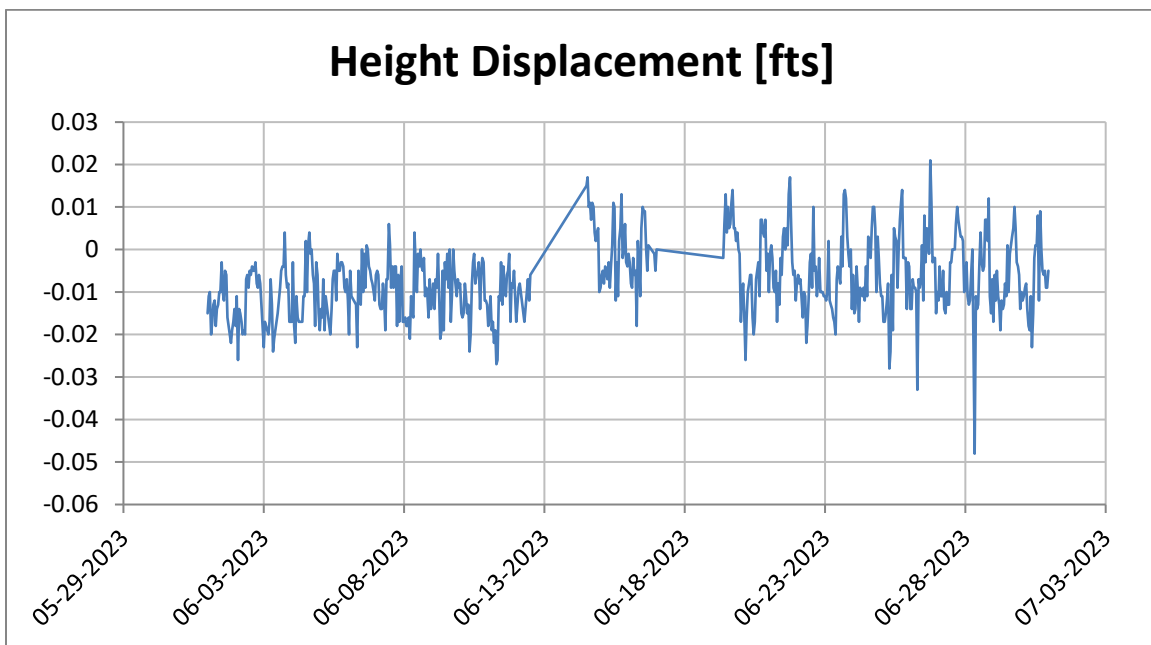
## Prism P70

1. Survey accuracy is  $\pm 0.016$  feet.
2. Alert threshold is  $\pm 0.35$  feet.
3. Transverse displacement is in the horizontal direction. Positive direction means closer to the robotic station.
4. Height displacement is in the vertical direction. Positive direction means higher in elevation.
5. Regression limit alerts received on June 1 and June 2.
