# Geotechnical Addendum

2022 Annual Report

Aggregate Industries Deer Creek Quarry

Permit M1977-014 Jefferson County, Colorado

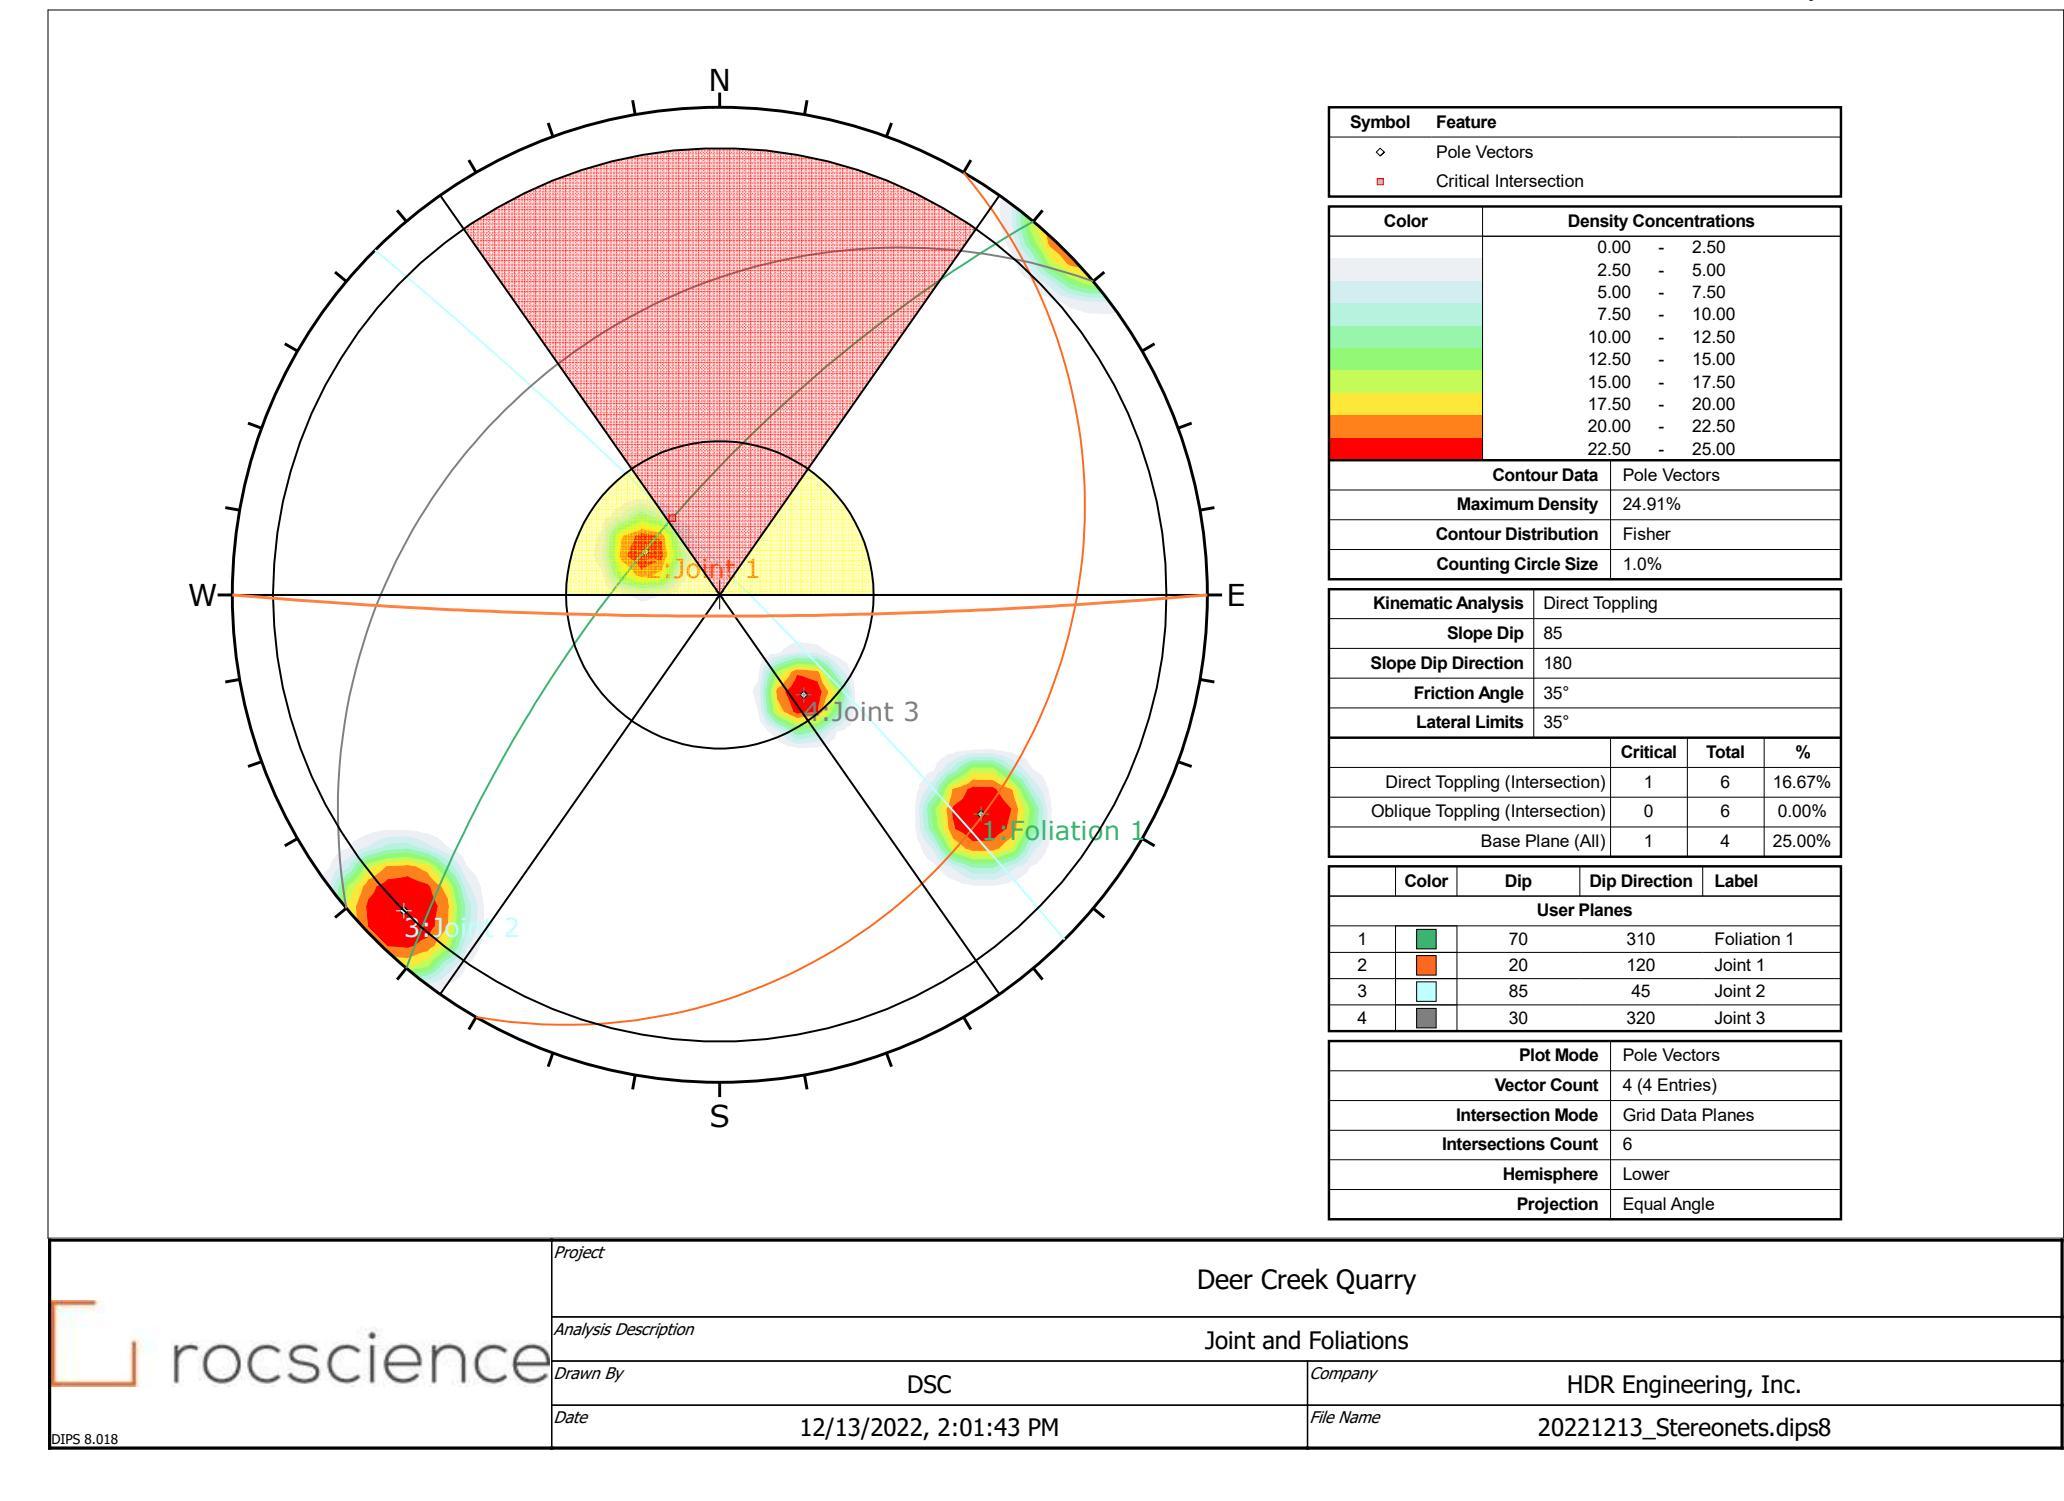
South Facing - Direct Toppling

Failure Mode	North-Facing Slopes Risk	East-Facing Slopes Risk	South-Facing Slopes Risk	West-Facing Slopes Risk
Planar Sliding	0.0%	0.0%	0.0%	0.0%
Wedge Sliding	16.7%	0.0%	0.0%	16.7%
Flexural Toppling	0.0%	0.0%	0.0%	0.0%
Direct Toppling	0.0%	0.0%	16.7%	0.0%
