MINERALS PROGRAM INSPECTION REPORT
PHONE: (303) 866-3567

| MINE NAME: Wagner Rock Pit | MINE/PROSPECTING ID#: M-1999-018 | MINERAL: Gravel | COUNTY: Moffat |
| INSPECTION TYPE: Monitoring | WEATHER: Clear | INSP. DATE: July 25, 2023 | INSP. TIME: 14:30 |

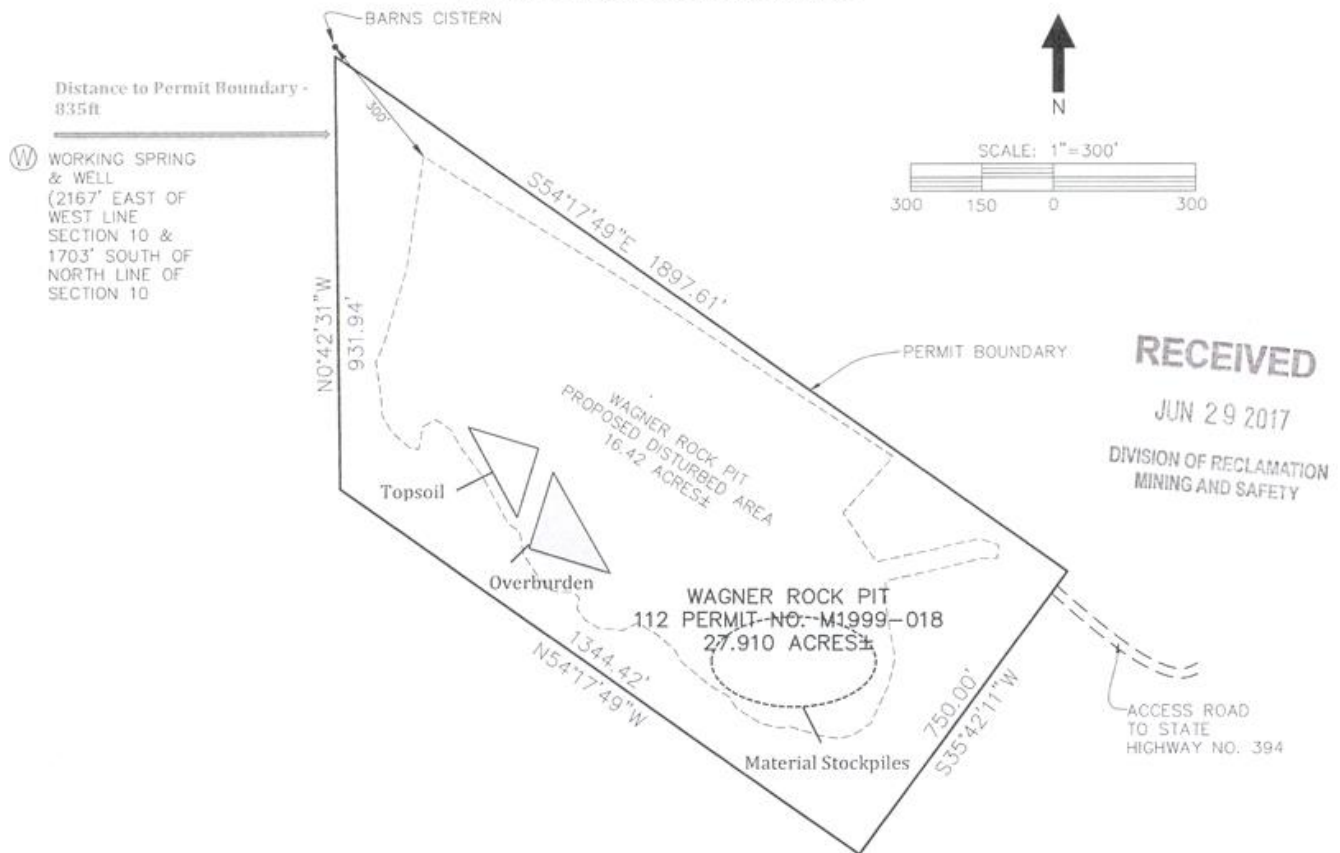
Approved Exhibit C – Mining Plan Map: Location of Murphy Spring

"My family's property, the Ashbaugh ranch, borders the Wagner gravel pit. When I talked our property line this spring, it looked like the gravel pit had expanded closer to my fence line and therefore closer to the spring that feeds 6 families including ourselves and surrounding neighbors. My understanding after reading several documents regarding this pit is that the instance from the pit to the spring needs to be a certain distance. The neighbors and my family are continually concerned of the potential effects to our spring water if damaged by the Wagner pit through their mining operation.

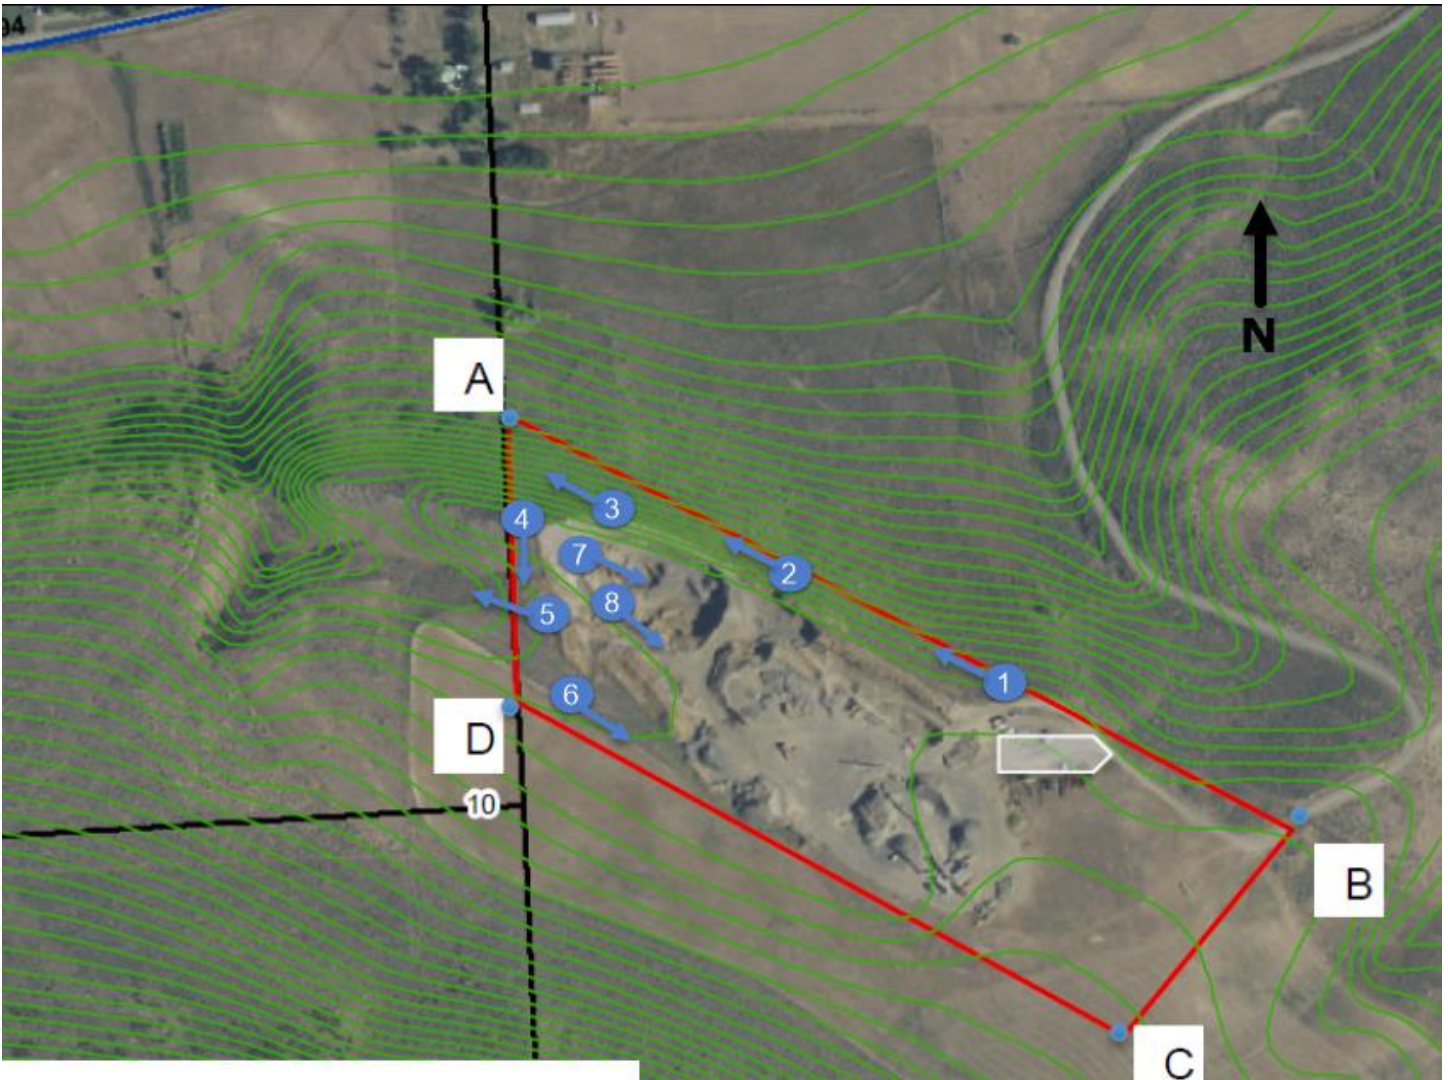
Wagner Pit – Inspection Picture Identification, Location and Direction

During the inspection, the Division inspected the entire permit boundary, disturbance boundary, and the excavated pit for potential issues or violations associated with the complaint. Using Field Maps, the approved boundaries were traversed and inspected for any signs of groundwater exposure and off-site impact such as mining outside of the approved boundary, surface runoff, erosion, and/or gullyng that would be associated with the mine.
