MINERALS PROGRAM INSPECTION REPORT
PHONE: (303) 866-3567

MINE NAME: AMSO RD&D Project-Phase 1	MINE/PROSPECTING ID#: P-2008-046	MINERAL: Oil shale	COUNTY: Rio Blanco
INSPECTION TYPE: Monitoring	WEATHER: Clear	INSP. DATE: August 7, 2023	INSP. TIME: 12:00
OPERATOR: American Shale Oil, LLC	OPERATOR REPRESENTATIVE: Bruce Smith	TYPE OF OPERATION: MP - Mineral Prospecting	
REASON FOR INSPECTION: Normal I&E Program	BOND CALCULATION TYPE: None	BOND AMOUNT: \$46,789.00	
DATE OF COMPLAINT: NA	POST INSP. CONTACTS: None	JOINT INSP. AGENCY: None	
INSPECTOR(S): Amy Yeldell	INSPECTOR'S SIGNATURE:

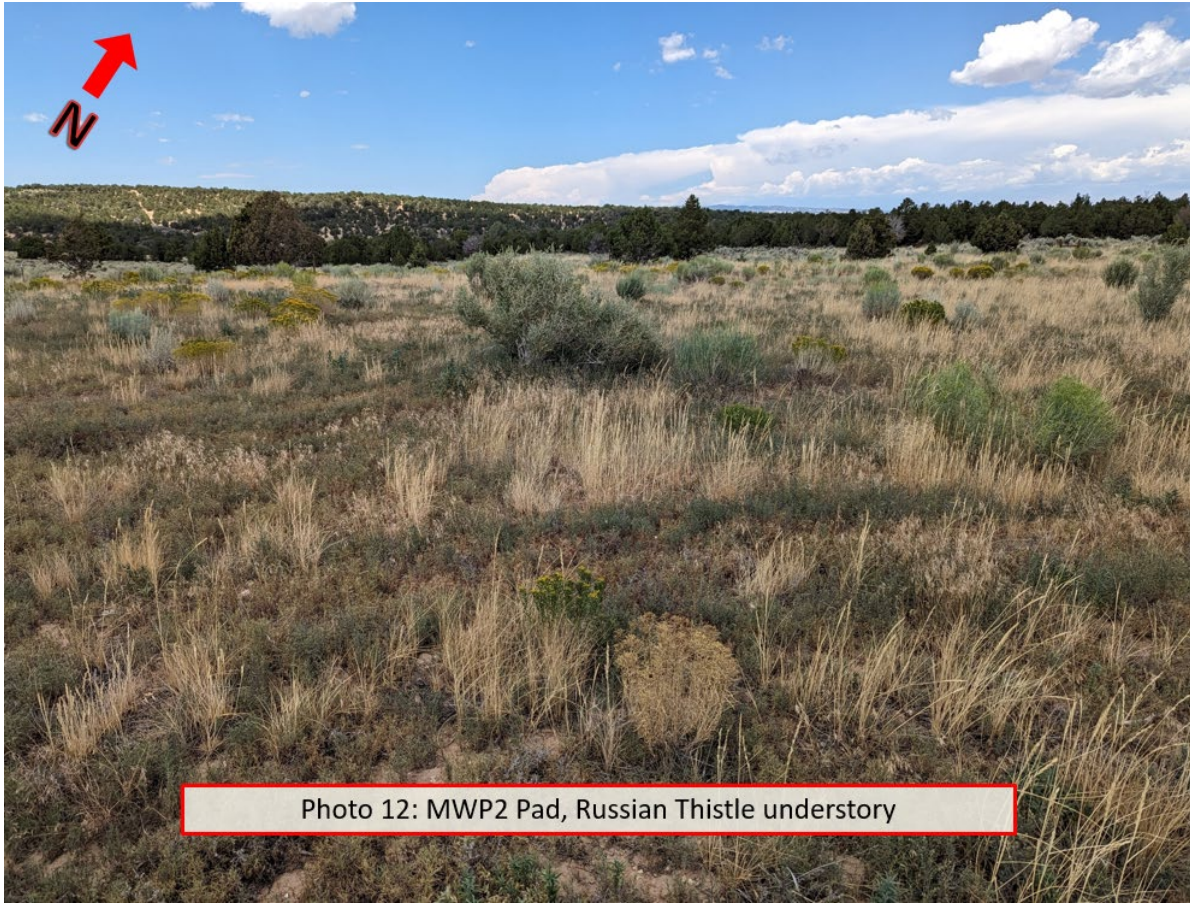
The MWP-2 Pad have a very long access road off of the east side of TM pad. It also has a break in the exclusion fencing to allow for animals to cross. Overall reclamation of the road is spotty. Areas within the fence break appear to be doing no worse than areas within the protection of the fencing. The northern section of road is better established compared to the south (Photo Eleven). The pad itself has sufficient shrub cover but the understory is mostly Russian Thistle (undesirable). Very few areas were observed without some presence of Russian Thistle (Photo Twelve). Desirable grasses were observed but they are not abundant enough to outcompete weeds or to be considered sustainable or successfully reclaimed.

Photo 11: MWP2 Pad access road, break in fence

general the site would benefit from a more aggressive weed management plan. Multiple surveys and treatments throughout the growing season are critical for effective management. The Operator may wish to explore alternative method for noxious weed management as well. Both burning and controlled grazing were discussed as potential options. The Operator should first discuss these options with the BLM and gain approval prior to implementation. Given that overall initial reclamation efforts with the current weed management have proven inadequate the Operator will likely need to re-reclaim areas of failure. The two growing season minimum for evaluation of reclamation success will begin anew for any areas where reclamation efforts have started over.
