## C-1981-035 August Partial Inspection Report and Cover Letter

**Re: King Coal Mine Permit No. C-1981-035**  
**August 2023 Post Inspection Outstanding Maintenance Items**

<b>Inspection Start Date:</b> August 16, 2023 <b>Inspection Start Time:</b> 13:34 <b>Inspection End Date:</b> August 16, 2023 <b>Inspection End Time:</b> 15:41	<b>Inspection Type:</b> Coal Partial Inspection <b>Inspection Reason:</b> Normal I&E Program <b>Weather:</b> Clear
<b>Joint Inspection Agency:</b>  None	<b>Joint Inspection Contacts:</b>  None
<b>Post Inspection Agency:</b>  None	<b>Post Inspection Contacts:</b>  None
<b>Inspector(s):</b>  Lucas West	<b>Inspector's Signature:</b>

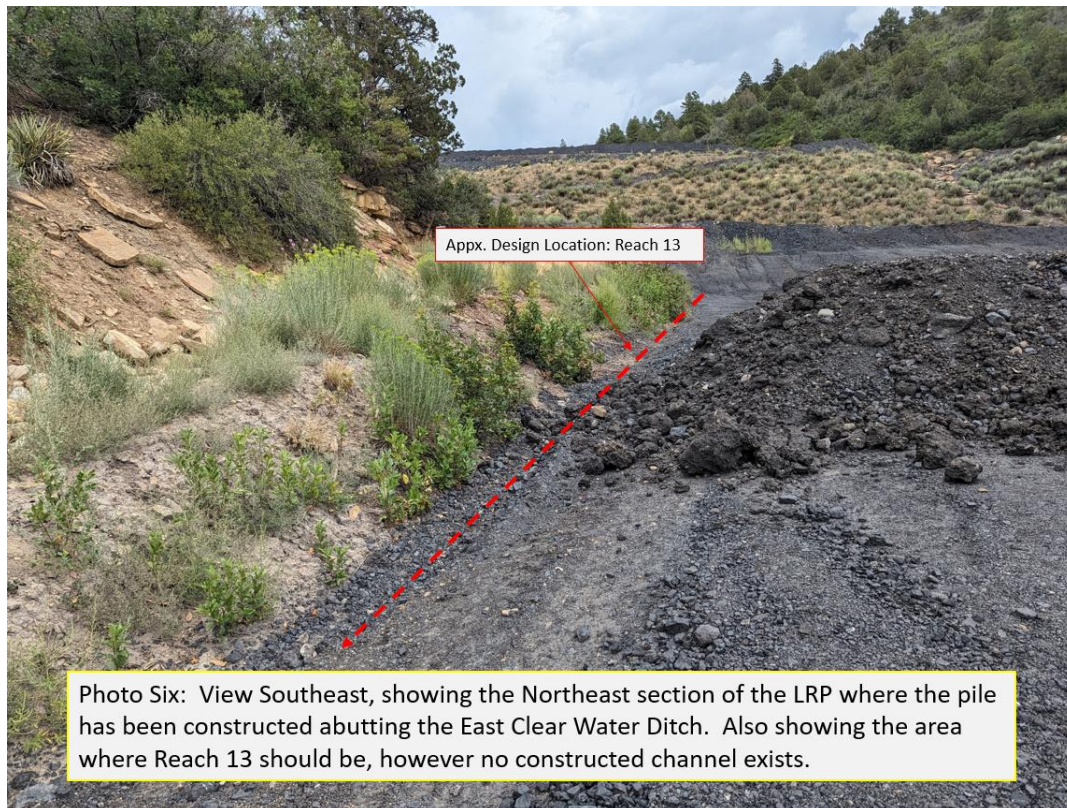
The newly construction section of Reach 10 that conveys water from the Lower Refuse Pile (LRP) was noted to be in good condition and free from obstruction. The ditch can be seen in Photo Three. As noted in the cover letter the new location and design of ditch will be more effective, however is not consistent with the approved design. This will need to be handled through the Technical Revision Process. Additionally, The approved design for water conveyances around the LRP include Reaches 10 and 13. Reach 10 is supposed to flow from the lowest culvert along the access road, along the South and West sides of the LRP, however currently there is no established ditch to convey the water as noted in Photos Four and Five. Surface water is conveyed by way of sheet flow across the graded top of the LRP eventually joining the newly constructed ditch as shown in Photo Three. The Operator should re-establish the design and location that is approved for Reach 10, controlling the flow around the LRP. Similarly, Reach 13 is designed to convey surface flows from the hillside between the LRP and the Upper Refuse Pile (URP) down a constructed slope to the culvert system below the LRP. This ditch and constructed slope has been consumed by waste placement, leaving no conveyance to control the surface flows as seen in Photos Six and Seven. The Division recommends establishing a temporary conveyance that connects Reach 13 with Reach 10 as noted as Item 2, of Attachment 1 to the cover letter included with this report. The establishment of these conveyances is considered a maintenance item that requires immediate attention. The Operator should establish the conveyances in their intended or temporary location, to their approved design specifications and provide photo documentation of completion via email to the Division no later than Tuesday September 5, 2023.

2. A portion of Reach 13, around the northeast side of the Lower Refuse Pile is non-existent creating improper drainage. The Operator needs to re-route Reach 13 along the south of the access road connecting it with Reach 10 ensuring proper drainage of surface water around the Refuse Pile. This must be completed and photo documentation provided to the Division no later than Tuesday September 5, 2023.
