File: July 2023 Monitoring Summary

Date: August 31, 2023

Reference: July 2023 Geotechnical Monitoring Summary Pikeview Quarry

PIKEVIEW QUARRY SLOPE
MONITORING

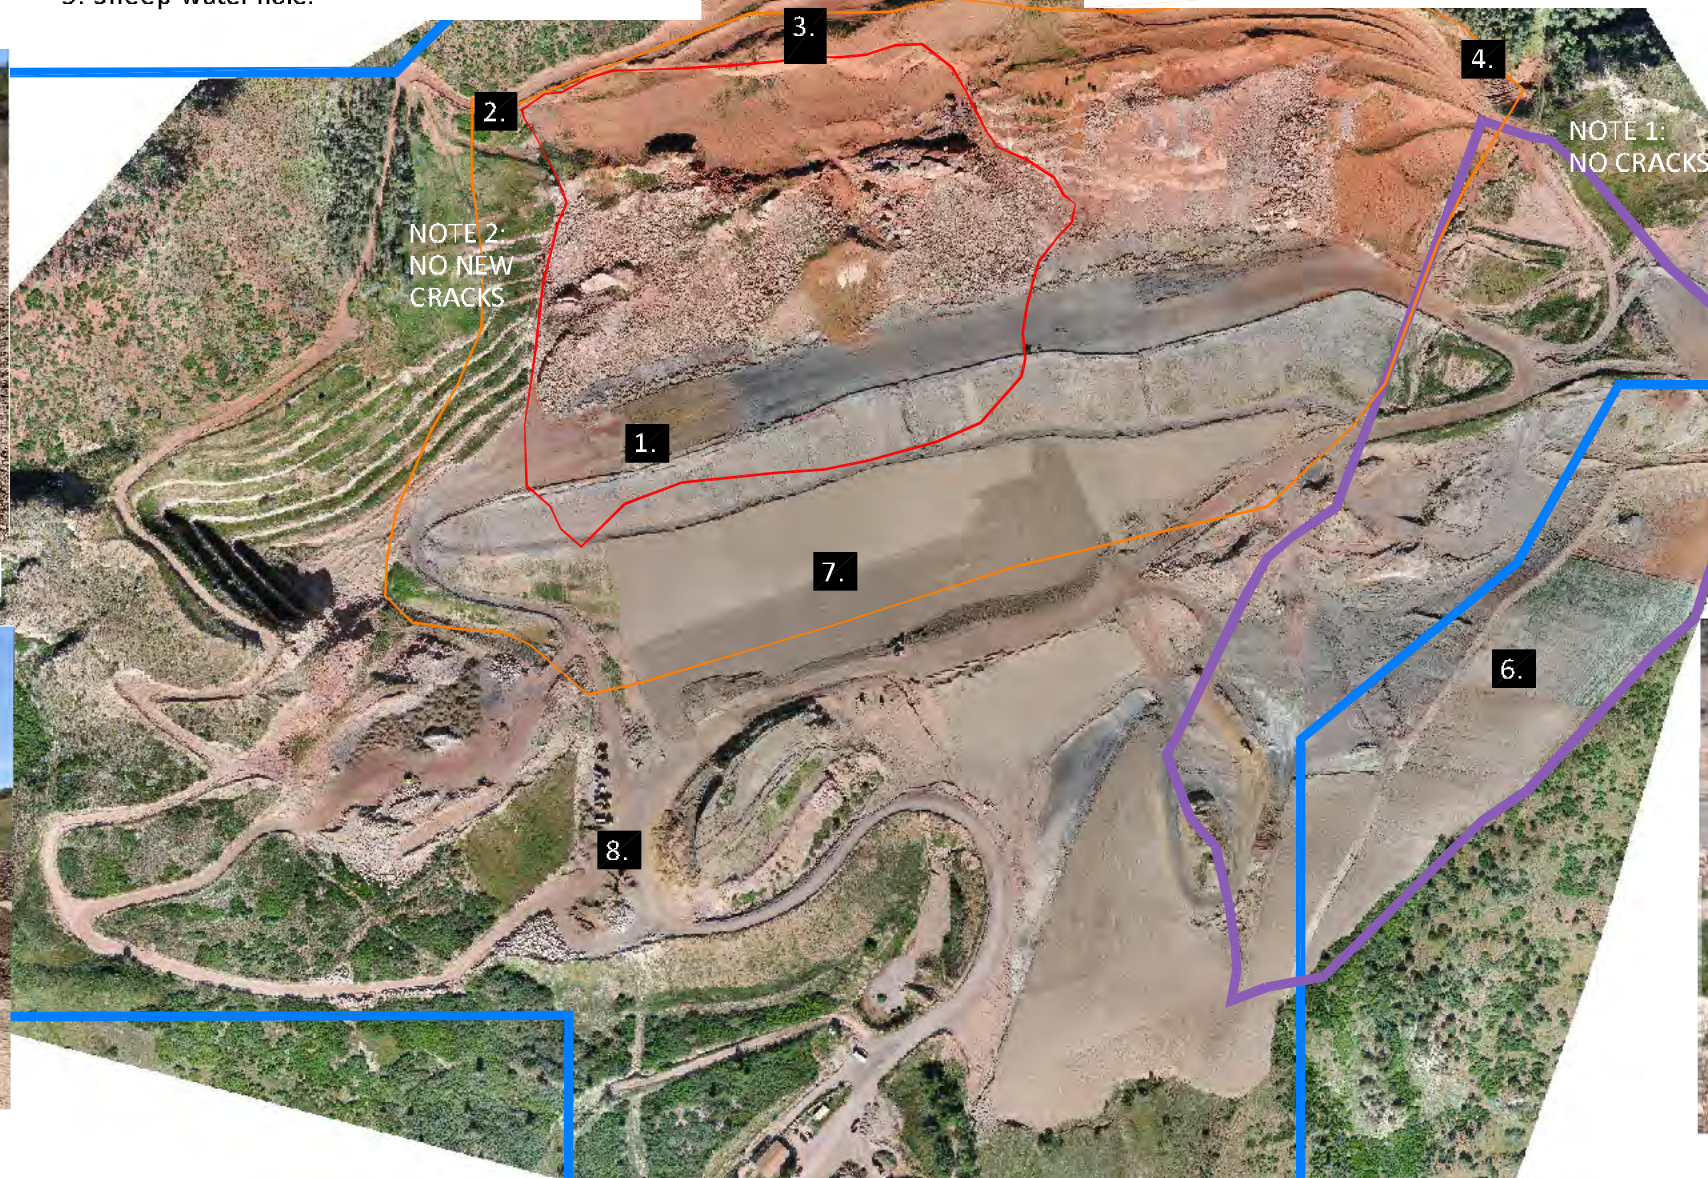
7. No cracking or slumping on bench slope.

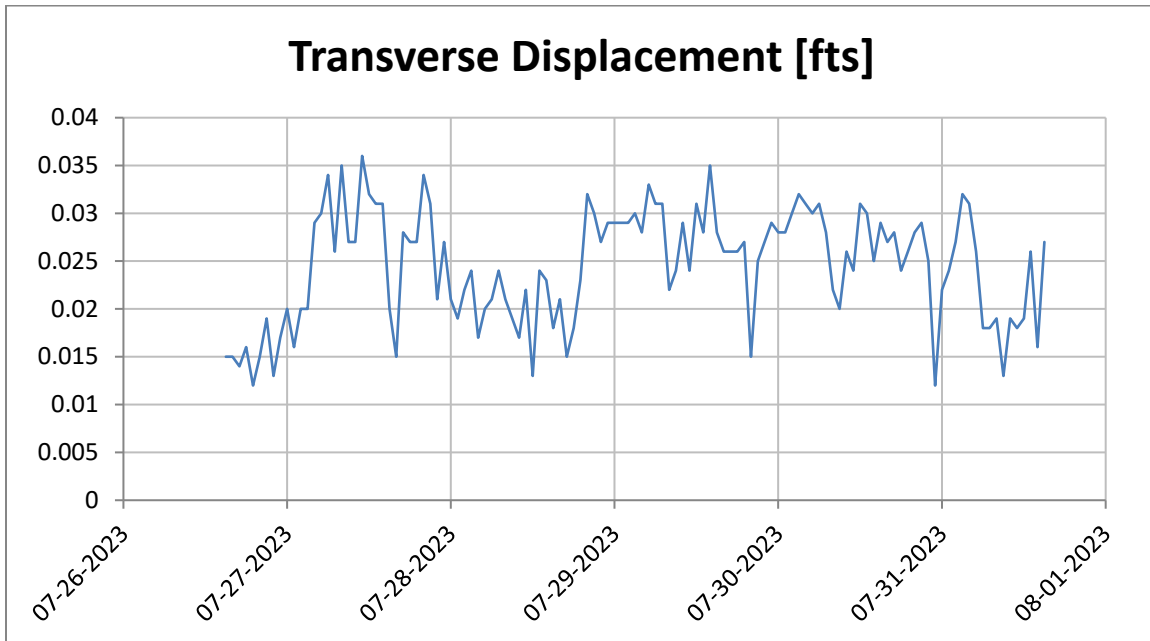
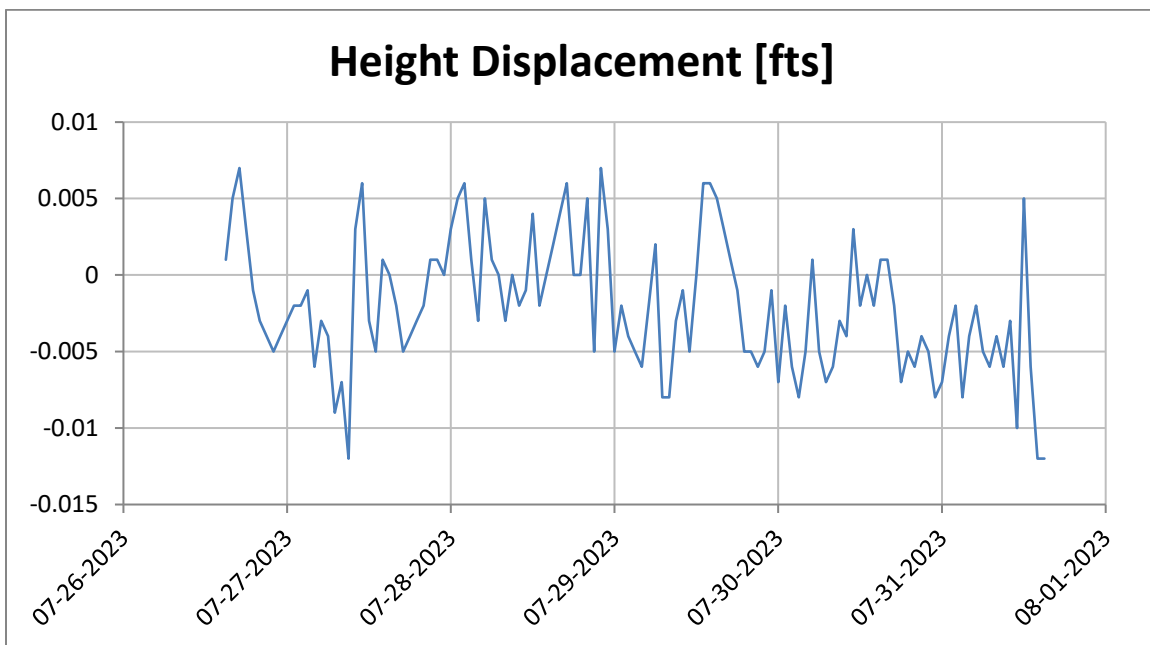
Prism B7300-0

1. Survey accuracy is ± 0.016 feet.
2. Alert threshold is ± 0.35 feet.
3. Transverse displacement is in the horizontal direction. Positive direction means closer to the robotic station.
4. Height displacement is in the vertical direction. Positive direction means higher in elevation.
5. New prism installed in July.
