**MINERALS PROGRAM INSPECTION REPORT**  
**PHONE: (303) 866-3567**

| <b>MINE NAME:</b><br>Climax Mine | <b>MINE/PROSPECTING ID#:</b><br>M-1977-493 | <b>MINERAL:</b><br>Molybdenum | <b>COUNTY:</b><br>Lake, Summit |
| <b>INSPECTION TYPE:</b><br>Monitoring | <b>WEATHER:</b> Clear | <b>INSP. DATE:</b><br>August 23, 2023 | <b>INSP. TIME:</b><br>12:04 |

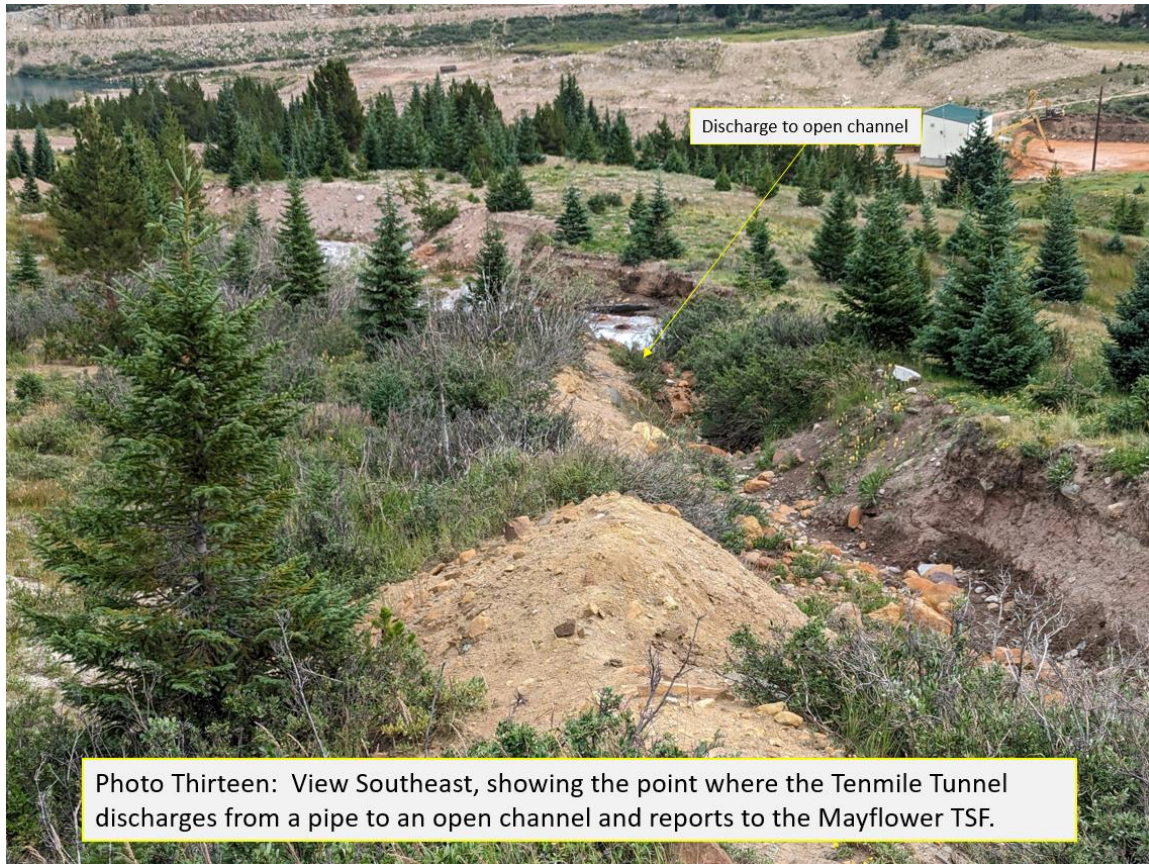
At the Mayflower TSF, the North Portal of the Tenmile Tunnel and associated discharge pipeline was observed. The discharge pipe is heavy gauge HDPE. A point in the discharge pipe has been severed, and dropped approximately 18 inches. The break in the pipe can be seen in Photo Twelve. Water is still flowing through the pipe, however evidence in the surrounding area suggests that during heavy flows, water is bypassing the pipe and eroding the surrounding area. The surrounding area is all within the greater footprint of the Mayflower TSF, and the water ultimately follows the discharge pipe to the point the pipe outfalls into an open channel and reports to the TSF. The point where the discharge pipe outfalls to open channel is shown in Photo Thirteen. There is no threat of loss of containment or migration at this time, however the Operator should develop a plan to repair the pipe to prevent further damage.

Photo Twelve: View South, showing the break in the Tenmile Tunnel Discharge Pipe within the footprint of the Mayflower TSF. The pipe is still functioning however should be repaired.
