MINERALS PROGRAM INSPECTION REPORT
PHONE: (303) 866-3567

MINE NAME: Ophir Lode	MINE/PROSPECTING ID#: M-2001-063	MINERAL: Silver, gold, lead, zinc	COUNTY: Hinsdale
INSPECTION TYPE: Monitoring	WEATHER: Clear	INSP. DATE: August 30, 2023	INSP. TIME: 13:43
OPERATOR: Midas Mining Company, Inc.	OPERATOR REPRESENTATIVE: Wayne Giesy	TYPE OF OPERATION: 110(2) - Hard Rock Limited Impact	
REASON FOR INSPECTION: Normal I&E Program	BOND CALCULATION TYPE:	BOND AMOUNT: \$7,077.00	
DATE OF COMPLAINT: NA	POST INSP. CONTACTS: None	JOINT INSP. AGENCY: None	
INSPECTOR(S): Lucas West	INSPECTOR'S SIGNATURE:

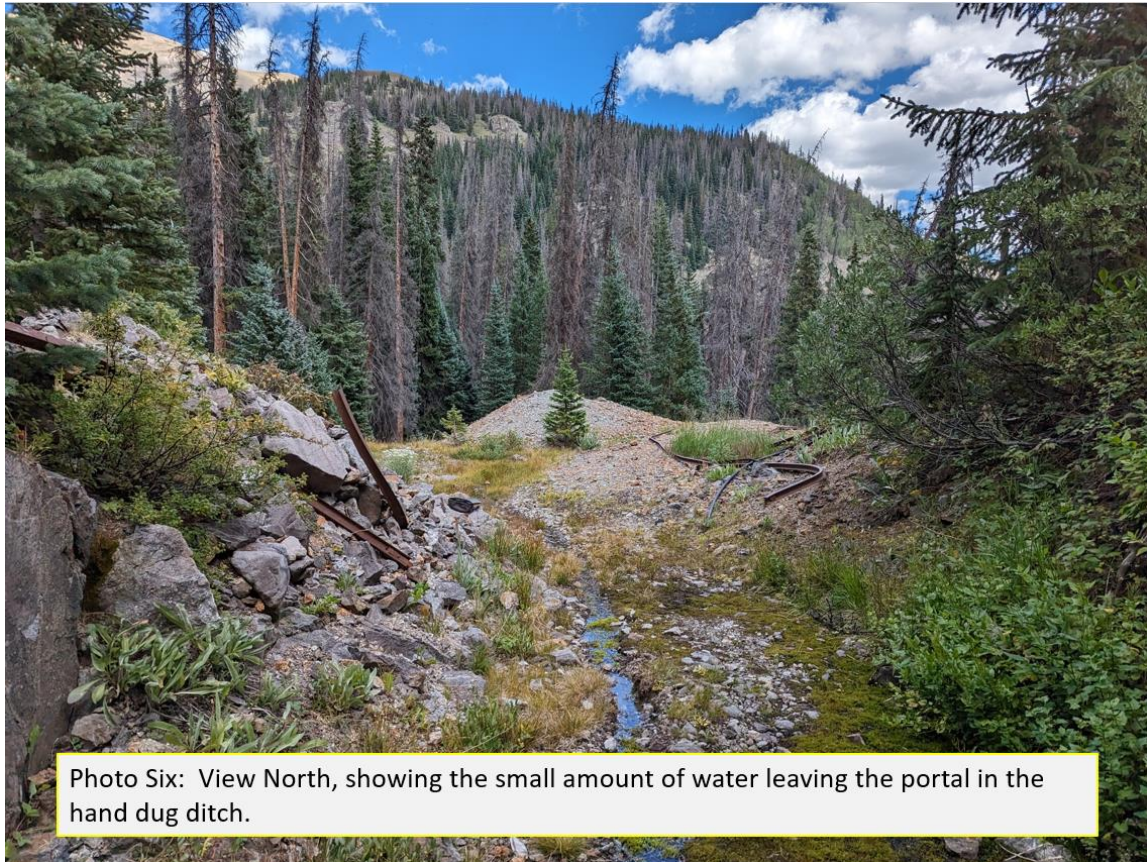
The portal was observed to be in good condition and secured by way of a locking metal gate. The frame and gate are in good condition and show no signs of vandalism or attempted unauthorized entry. The portal gate can be seen in Photo Five. A small amount of water has accumulated near the entrance and into a small and dug ditch leading away from the portal. The water appears to be coming from just near the door, and dripping down to the floor. The flow was barely flowing, estimated to be less than ½ gallon per minute, and infiltrates into the ground approximately 100 feet from the portal. Photo Six shows the water as it leaves the portal. The water shows no visual signs of impairment or mineral staining, and water testing at the time of permitting indicates it to be of high quality. The source of the water is likely to be Red Cloud Creek which flows just up gradient from the portal. It appears historic operations had rerouted the creek, but its proximity to the portal could explain the seepage of water. The presence of water is not considered a problem at this time.

Photo Five: View Southwest showing the portal and gated closure. The gate shows no signs of damage, and is set within a timbered frame surrounded by grouted rock. Also visible is the small pool of water around the gate.
