**MINERALS PROGRAM INSPECTION REPORT**  
**PHONE: (303) 866-3567**

<b>MINE NAME:</b> Pitch Project	<b>MINE/PROSPECTING ID#:</b> M-1977-004	<b>MINERAL:</b> Uranium	<b>COUNTY:</b> Saguache
<b>INSPECTION TYPE:</b> Monitoring	<b>WEATHER:</b> Clear	<b>INSP. DATE:</b> August 23, 2023	<b>INSP. TIME:</b> 09:00
<b>OPERATOR:</b> Homestake Mining Company	<b>OPERATOR REPRESENTATIVE:</b> Dave Wykoff	<b>TYPE OF OPERATION:</b> 112d-3 - Designated Mining Operation	
<b>REASON FOR INSPECTION:</b> Normal I&E Program	<b>BOND CALCULATION TYPE:</b>	<b>BOND AMOUNT:</b> \$24,451,940.00	
<b>DATE OF COMPLAINT:</b> NA	<b>POST INSP. CONTACTS:</b> None	<b>JOINT INSP. AGENCY:</b> None	
<b>INSPECTOR(S):</b> Dustin Czapla Russ Means	<b>INSPECTOR'S SIGNATURE:</b>

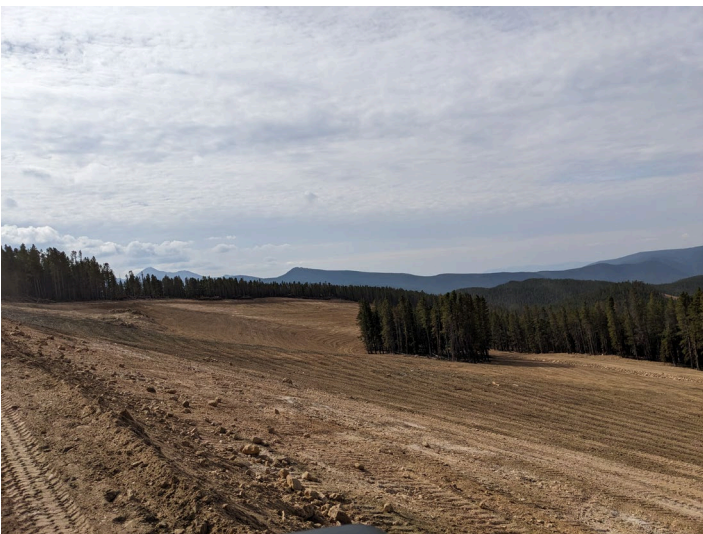
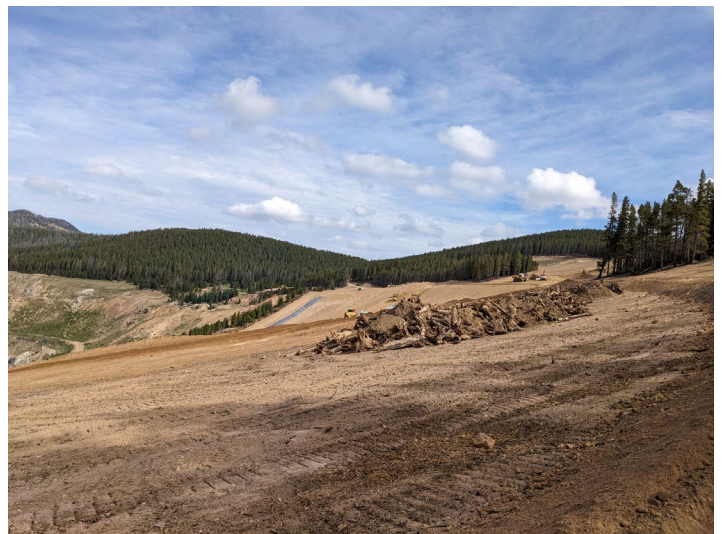
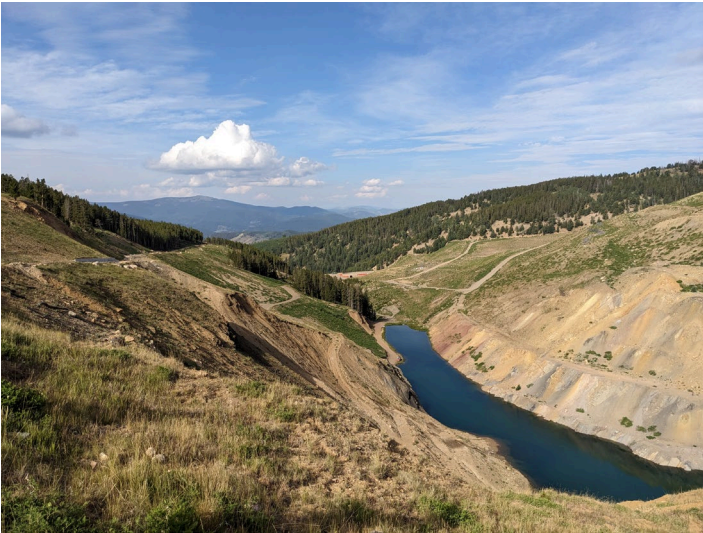
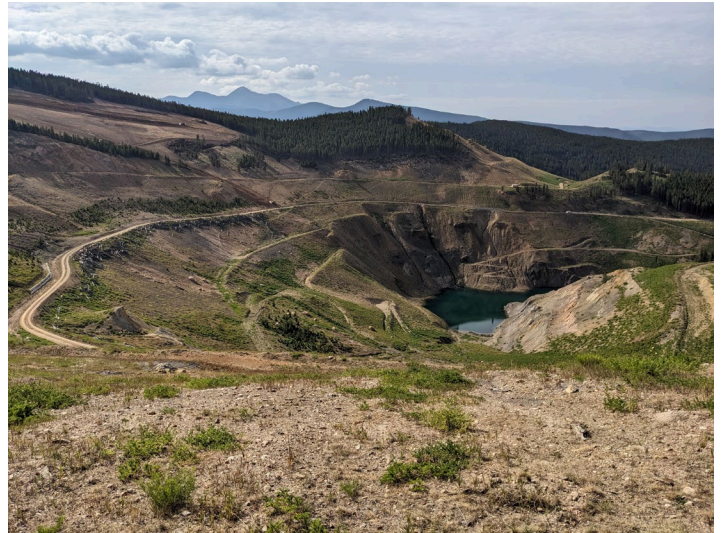
North Pit: The landslide area has been logged and grading is underway. The operator has made significant progress in the area during this operating season. The North Pit diversion ditch was extended behind the Mine Shop and additional drainage channels are being constructed in the landslide area. No problems were noted in this area.
