MINERALS PROGRAM INSPECTION REPORT
PHONE: (303) 866-3567

MINE NAME: Nahcolite Project	MINE/PROSPECTING ID#: M-1983-194	MINERAL: Carbonates	COUNTY: Rio Blanco
INSPECTION TYPE: Monitoring	WEATHER: Clear	INSP. DATE: August 28, 2023	INSP. TIME: 11:00
OPERATOR: Natural Soda LLC	OPERATOR REPRESENTATIVE: Kirk Daehling	TYPE OF OPERATION: 112d-3 - Designated Mining Operation	
REASON FOR INSPECTION: Normal I&E Program	BOND CALCULATION TYPE: None	BOND AMOUNT: \$4,466,425.00	
DATE OF COMPLAINT: NA	POST INSP. CONTACTS: DRMS	JOINT INSP. AGENCY: None	
INSPECTOR(S): Amy Yeldell	INSPECTOR'S SIGNATURE:

This is the third quarter inspection for 2023. The primary focus of this inspection was stormwater management. Additionally the two new/extended pads and additional roads for the 18H-1V and 18H-IR-W wells were observed. There are no open revisions for this permit. No changes to production level or staffing have occurred or are anticipated in the near future. Division staff first checked in at the main office.

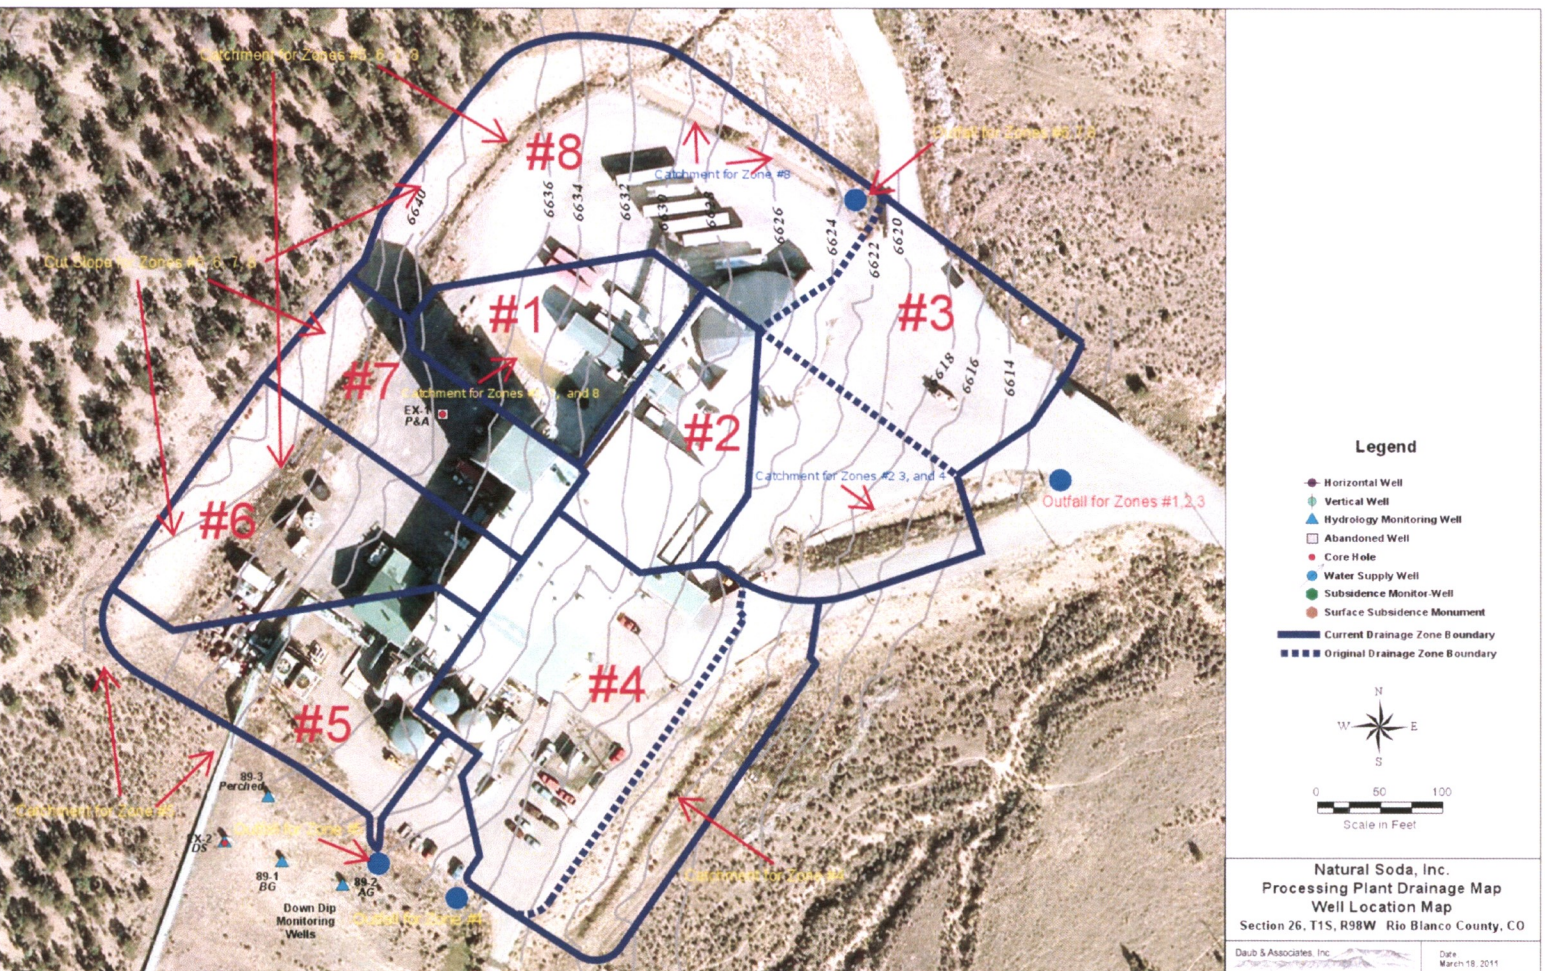
water cannot flow into the catchment, rather it flows along the ditch and out into the driveway entrance (Photo Eleven). Water designed to flow into the Zone 2, 3 and 4 catchment is not being properly channeled and flowing from the road into the unnamed tributary of the Yellow Creek. This is cited as a problem for failure to operate and maintain drainage control and containment facilities per Rule 6.4.21(10)(b). Ditched and berms within Zones 1, 2 and 3 need to be cleaned out/constructed so that water flows to the appropriate BMP features as designed prior to discharge.

Photo 11: berm between catchment Zone 2, 3, and 4 so that water flows along the ditch and out into the driveway entrance
