**MINERALS PROGRAM INSPECTION REPORT**  
**PHONE: (303) 866-3567**

<b>MINE NAME:</b> White Wolf Construction Borrow Pit	<b>MINE/PROSPECTING ID#:</b> M-2018-029	<b>MINERAL:</b> Borrow material for construction	<b>COUNTY:</b> Las Animas
<b>INSPECTION TYPE:</b> Monitoring	<b>WEATHER:</b> Clear	<b>INSP. DATE:</b> August 23, 2023	<b>INSP. TIME:</b> 11:00
<b>OPERATOR:</b> White Wolf Construction & Landscaping, LLC	<b>OPERATOR REPRESENTATIVE:</b> Bernard (Joe) Montoya	<b>TYPE OF OPERATION:</b> 111(1)(b) - Special One-Time Incidental	
<b>REASON FOR INSPECTION:</b> Surety Related	<b>BOND CALCULATION TYPE:</b> None	<b>BOND AMOUNT:</b> \$3,628.00	
<b>DATE OF COMPLAINT:</b> NA	<b>POST INSP. CONTACTS:</b> None	<b>JOINT INSP. AGENCY:</b> None	
<b>INSPECTOR(S):</b> Amber Michels Brock Bowles	<b>INSPECTOR'S SIGNATURE:</b>

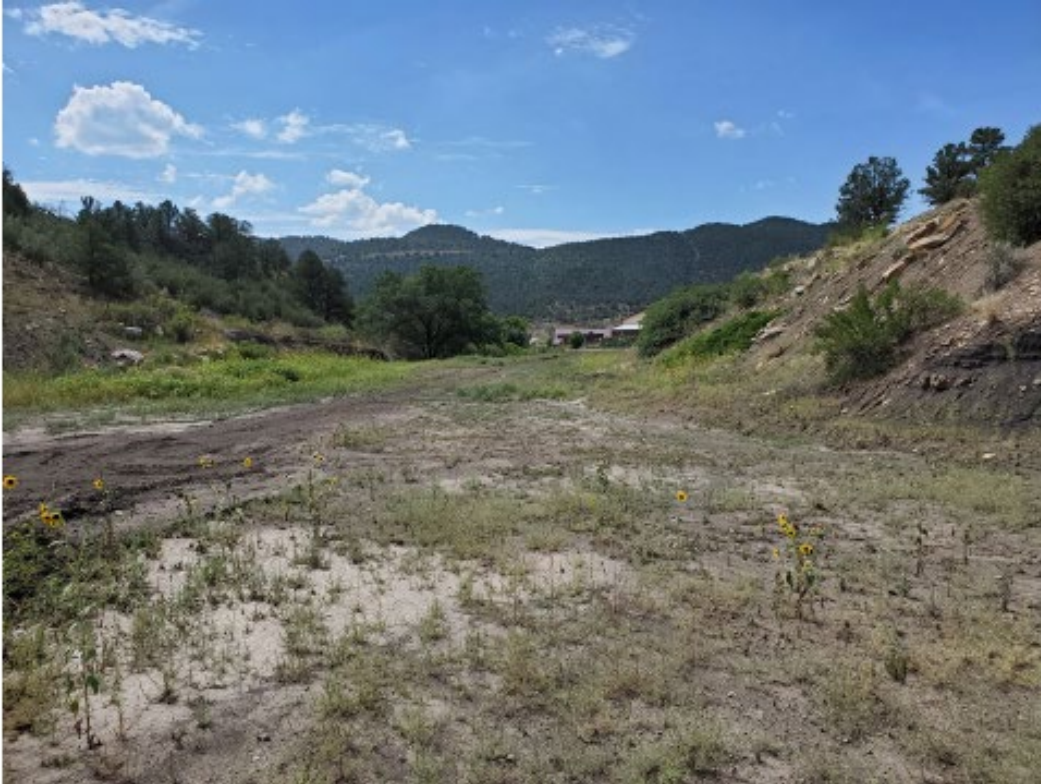
**Photo 5:** Looking south from the southern portion of the site towards the Operator's home and Highway 12.

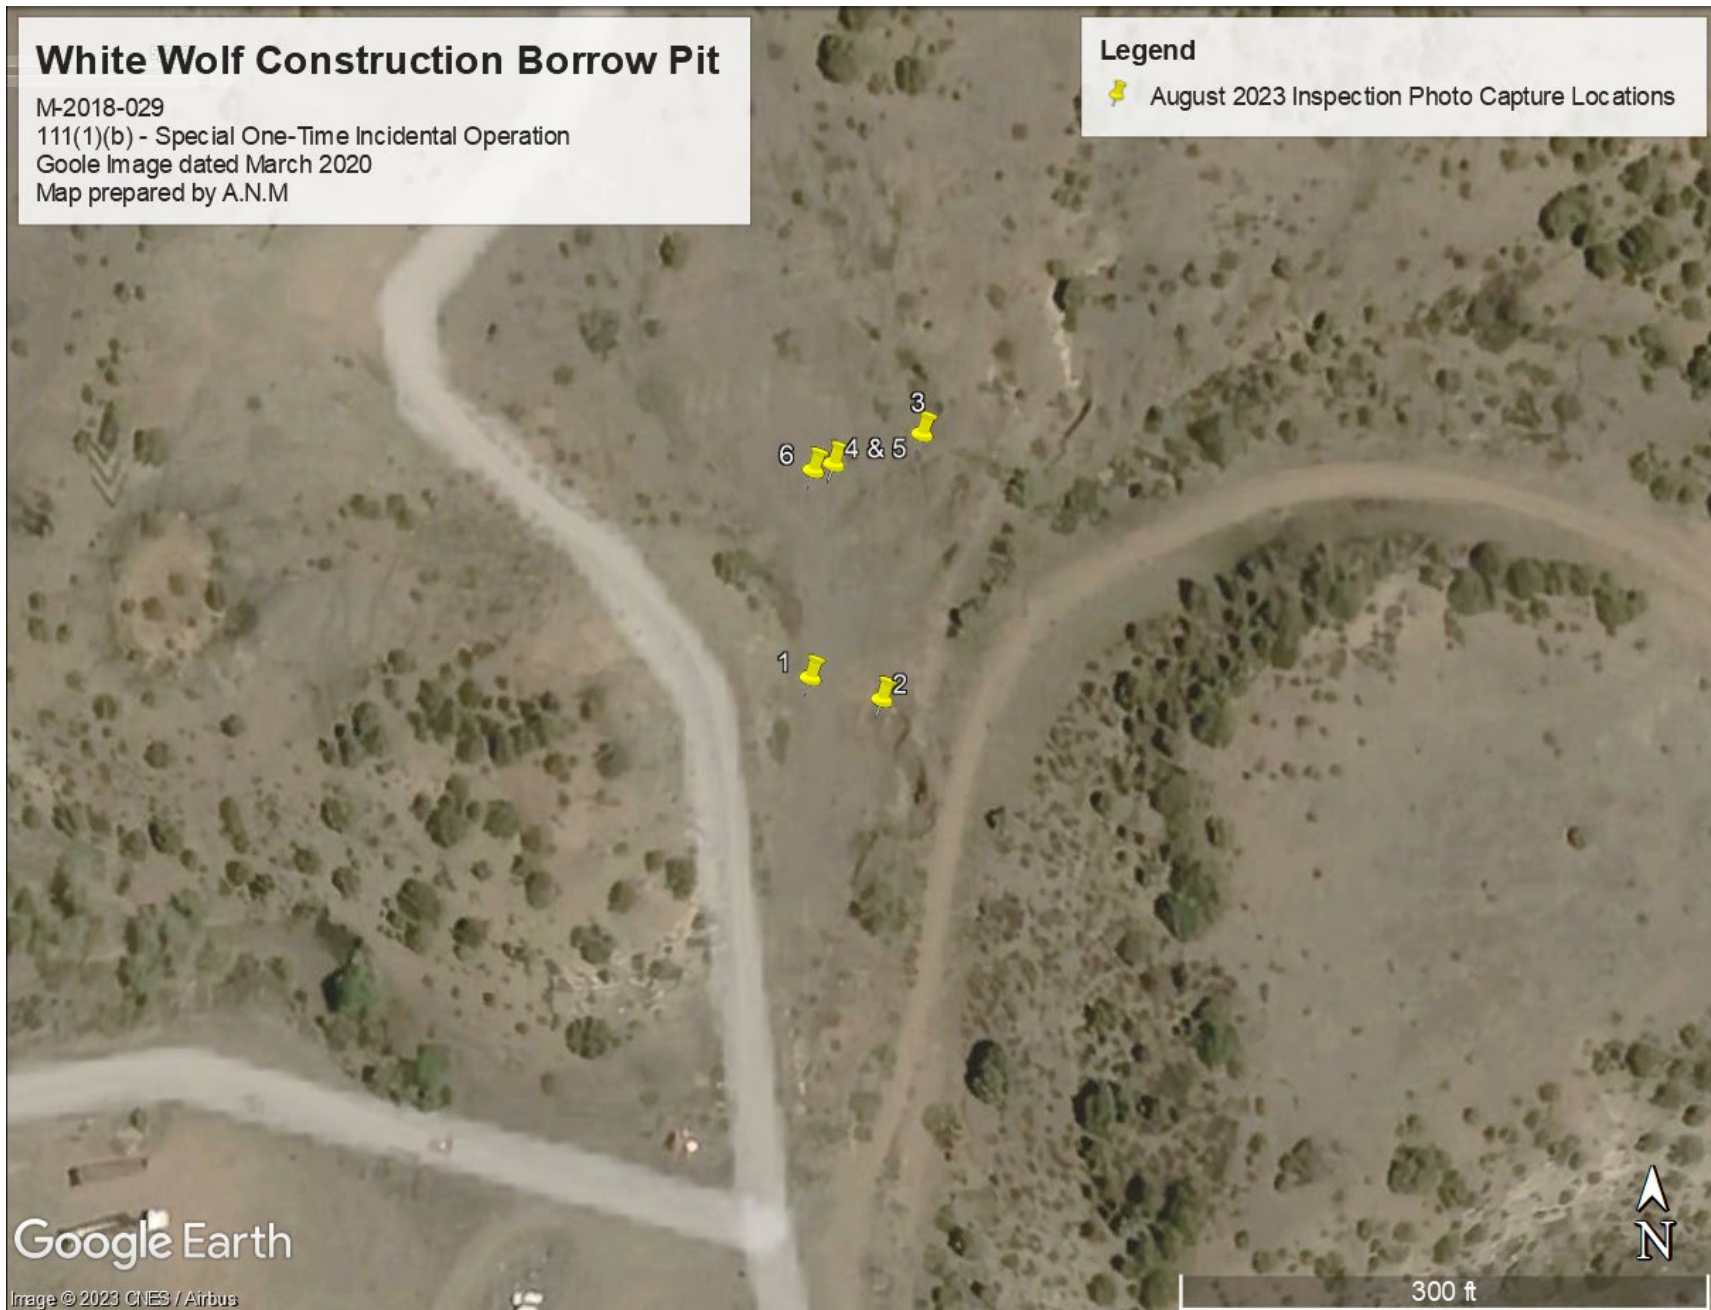
**Map 1:** Map prepared in Google Earth Pro showing the photo capture locations during the Division’s August, 23, 2023 routine monitoring inspection of the White Wolf Construction Borrow Pit.
