To: Jerald Schnabel
Riverbend Industries Inc.
File: August 2023 Monitoring Summary

Reference: August 2023 Geotechnical Monitoring Summary Pikeview Quarry

PIKEVIEW QUARRY SLOPE
MONITORING

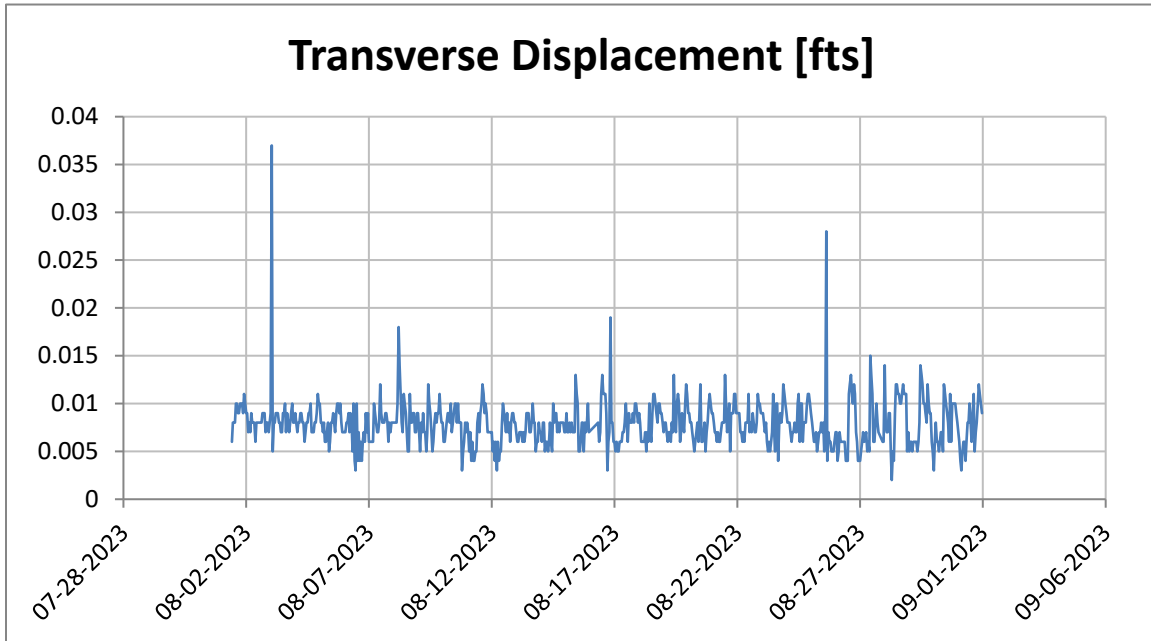
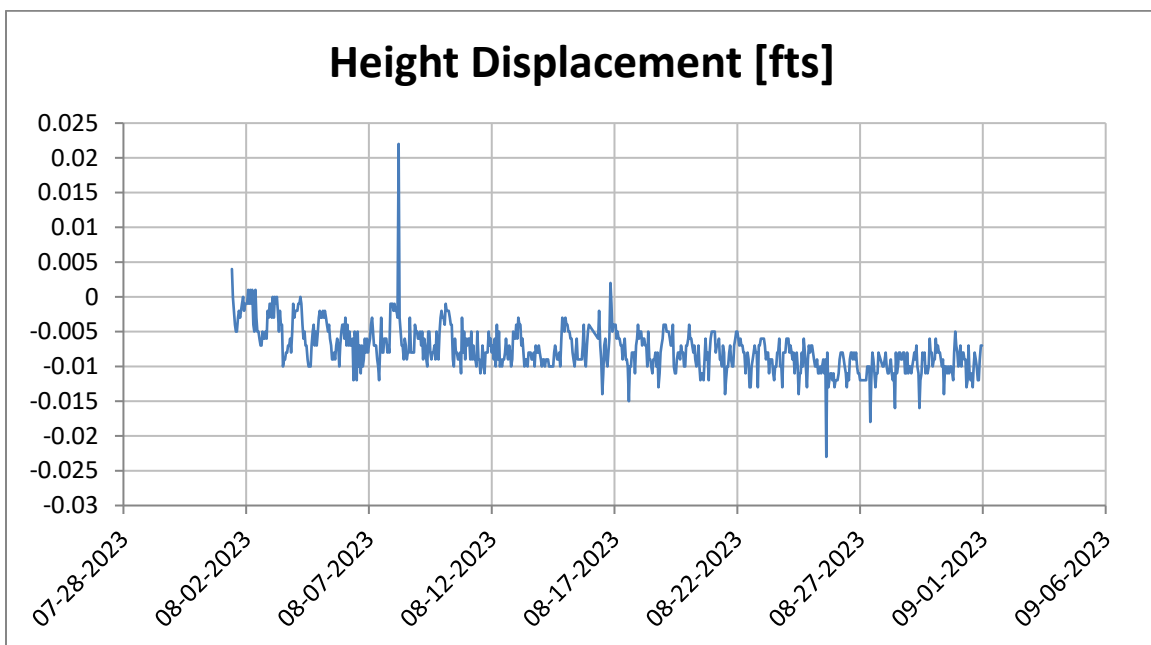
Prism B7200-2

1. Survey accuracy is ± 0.016 feet.
2. Alert threshold is ± 0.35 feet.
3. Transverse displacement is in the horizontal direction. Positive direction means closer to the robotic station.
4. Height displacement is in the vertical direction. Positive direction means higher in elevation.
5. Apparent movements believed to be the result of topsoil placement around prism.

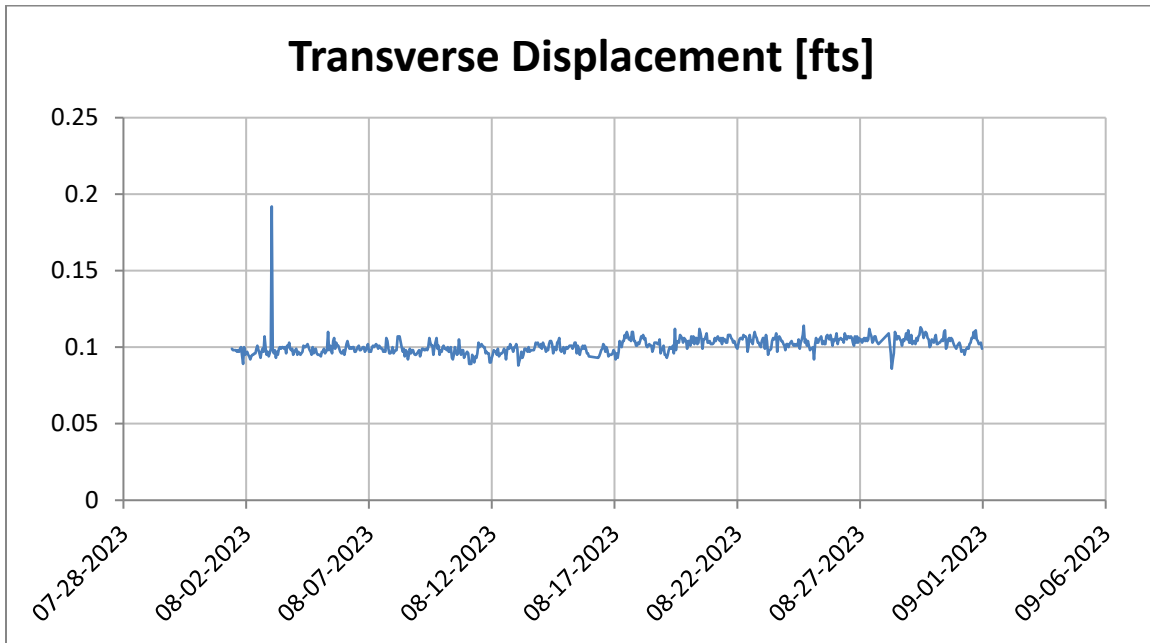
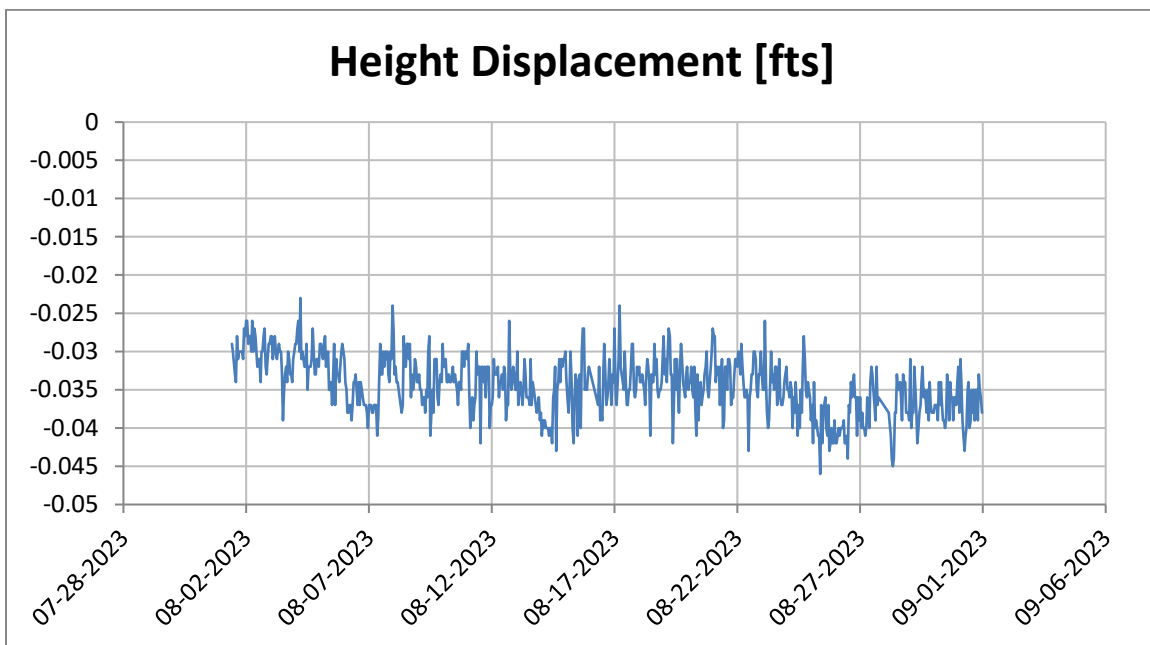
Prism B7200-3

1. Survey accuracy is +/-0.016 feet.
2. Alert threshold is +/-0.35 feet.
3. Transverse displacement is in the horizontal direction. Positive direction means closer to the robotic station.
4. Height displacement is in the vertical direction. Positive direction means higher in elevation.
5. Apparent movements believed to be the result of topsoil placement around prism.

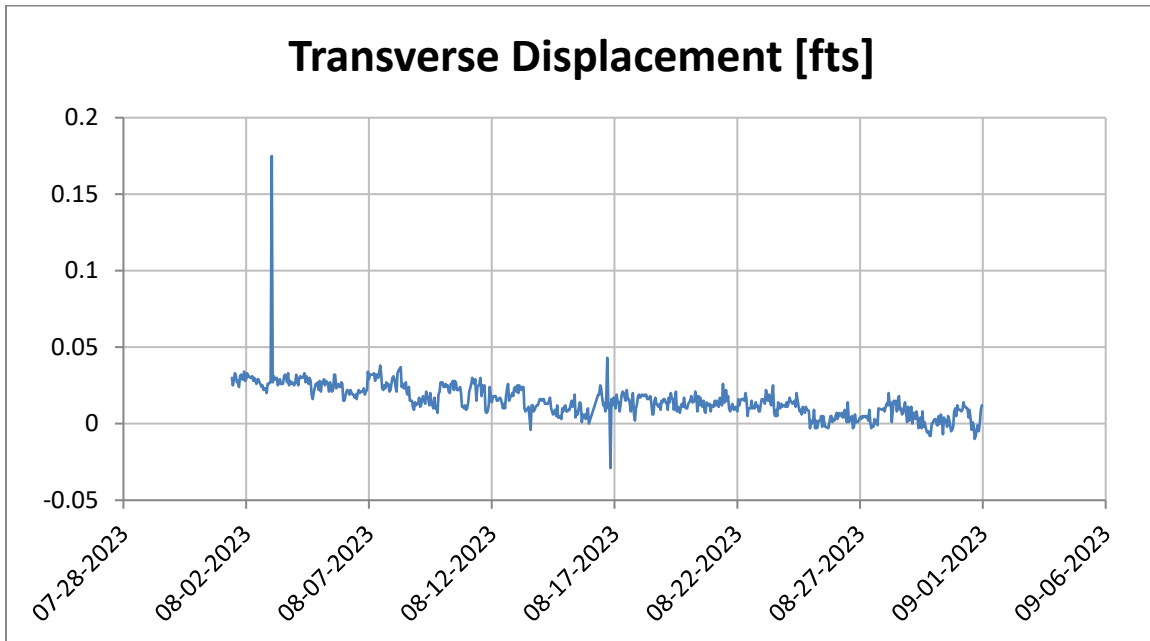
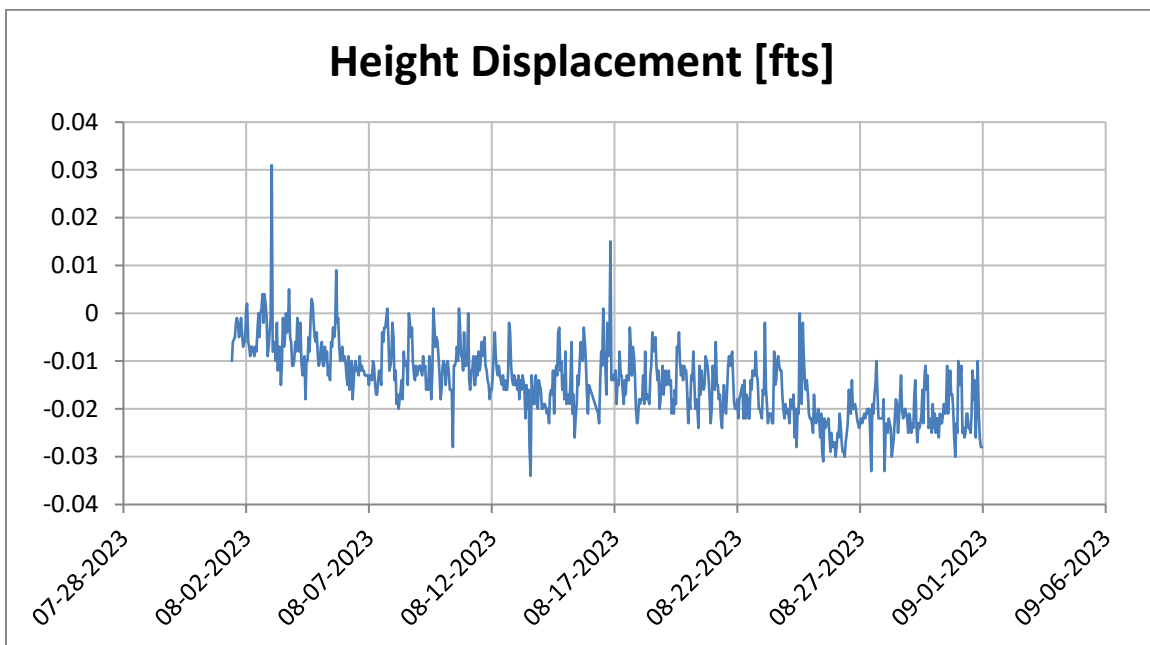
Prism B7300-0

1. Survey accuracy is ± 0.016 feet.
2. Alert threshold is ± 0.35 feet.
3. Transverse displacement is in the horizontal direction. Positive direction means closer to the robotic station.
4. Height displacement is in the vertical direction. Positive direction means higher in elevation.
5. Apparent movements believed to be the result of topsoil placement around prism.

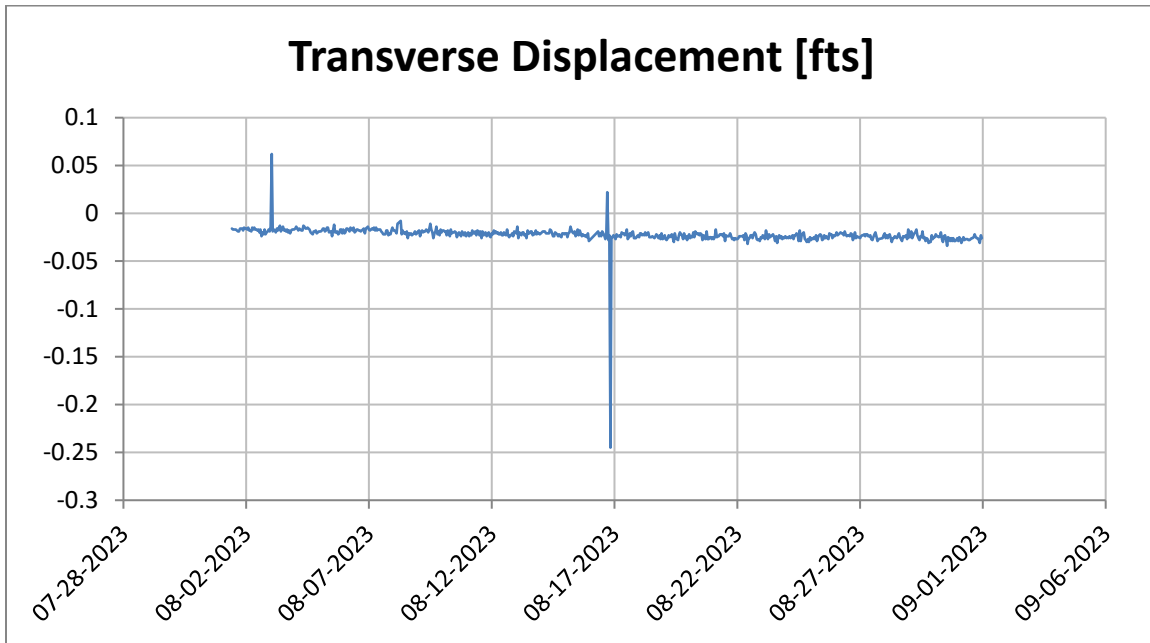
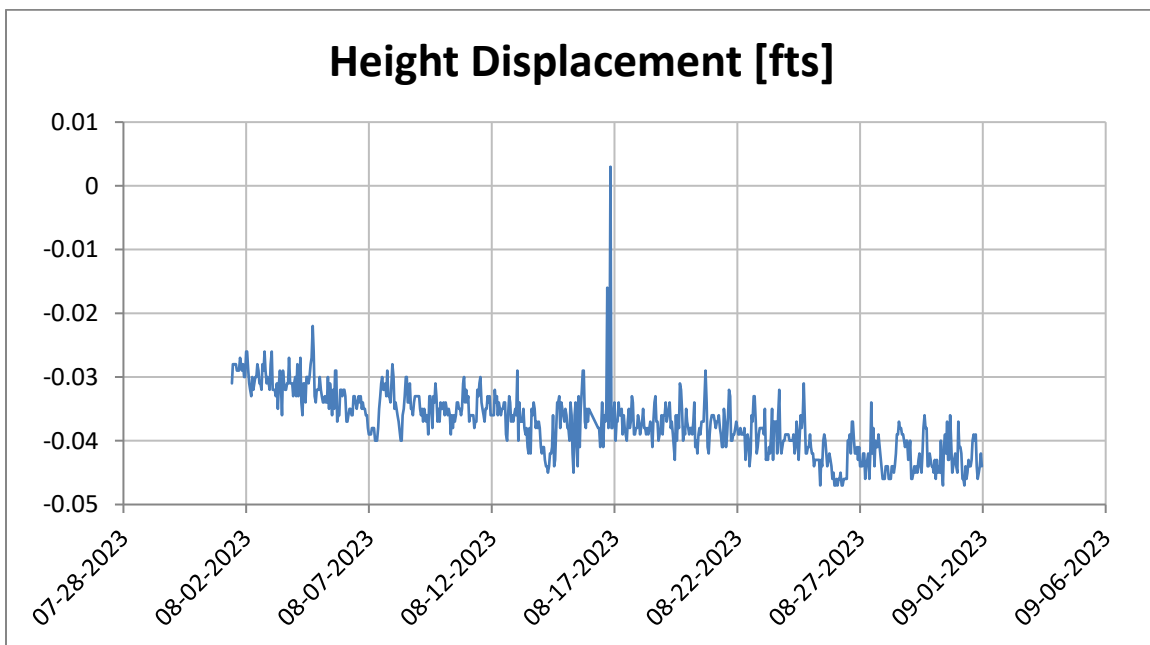
Prism B7300-1

1. Survey accuracy is ± 0.016 feet.
2. Alert threshold is ± 0.35 feet.
3. Transverse displacement is in the horizontal direction. Positive direction means closer to the robotic station.
4. Height displacement is in the vertical direction. Positive direction means higher in elevation.
5. Apparent movements believed to be the result of topsoil placement around prism.

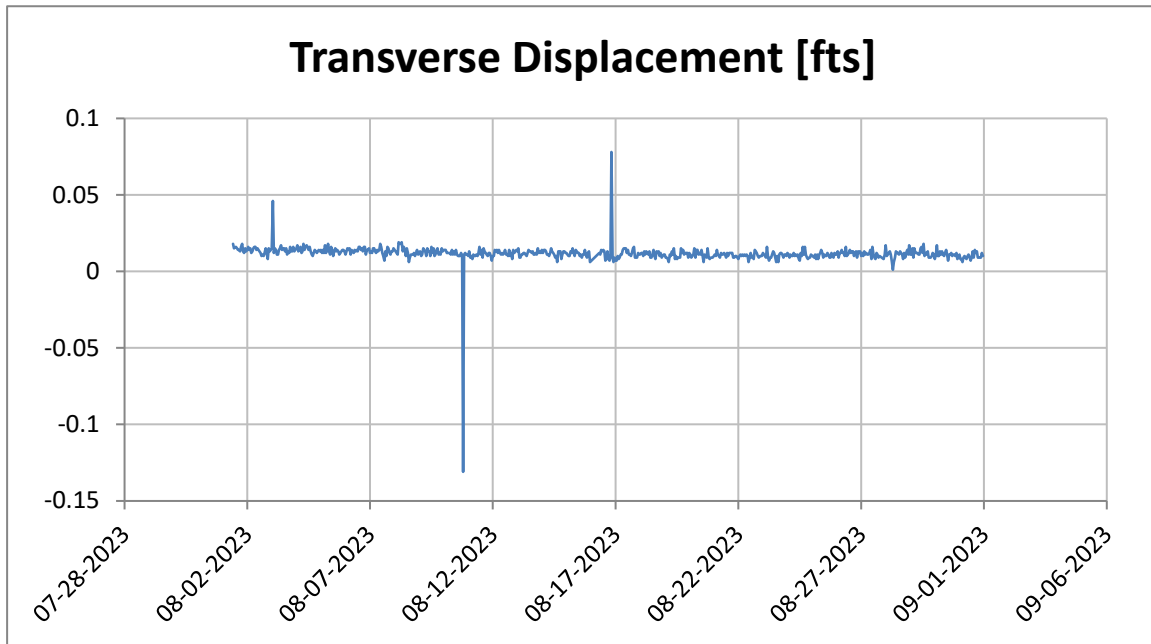
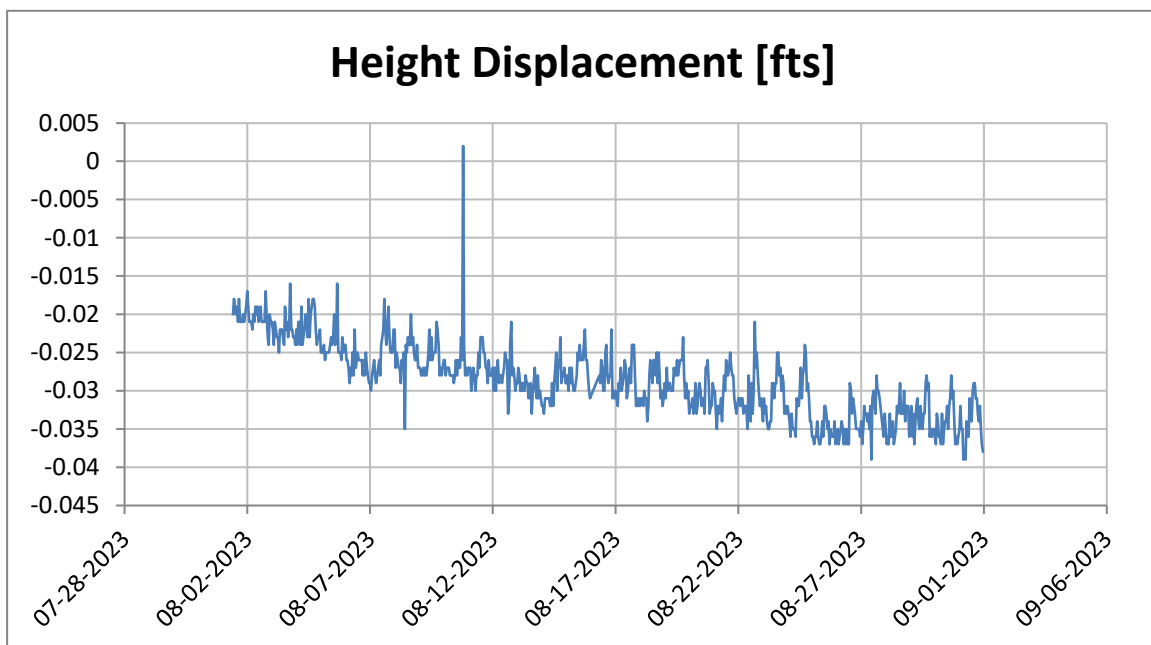
Prism B7300-2

1. Survey accuracy is ± 0.016 feet.
2. Alert threshold is ± 0.35 feet.
3. Transverse displacement is in the horizontal direction. Positive direction means closer to the robotic station.
4. Height displacement is in the vertical direction. Positive direction means higher in elevation.
5. Apparent movements believed to be the result of topsoil placement around prism.

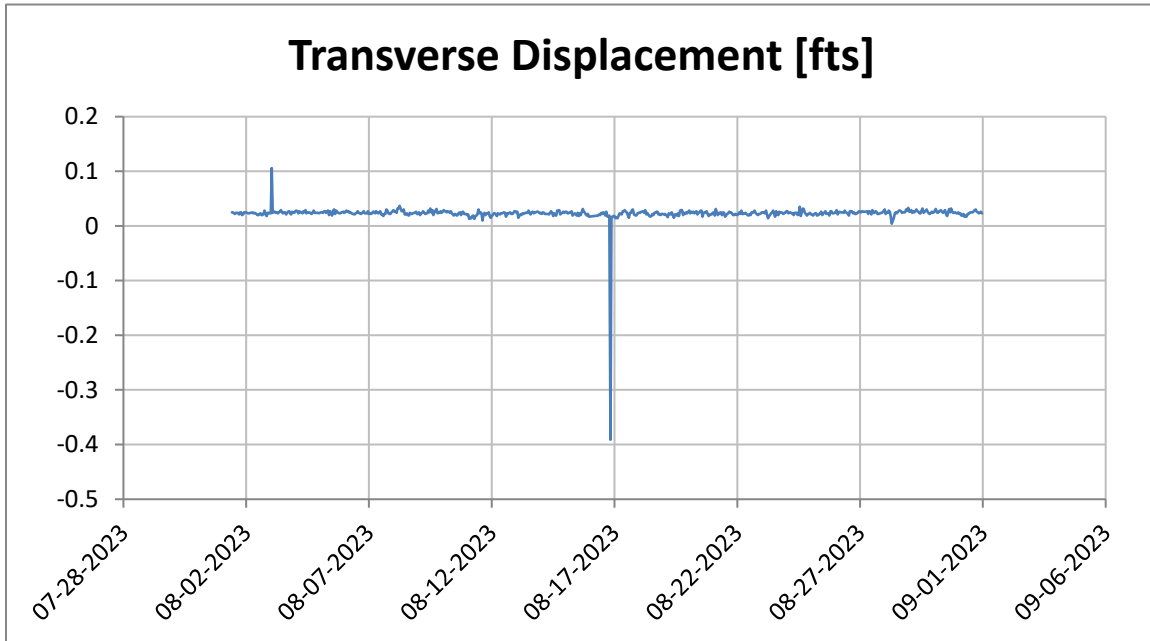
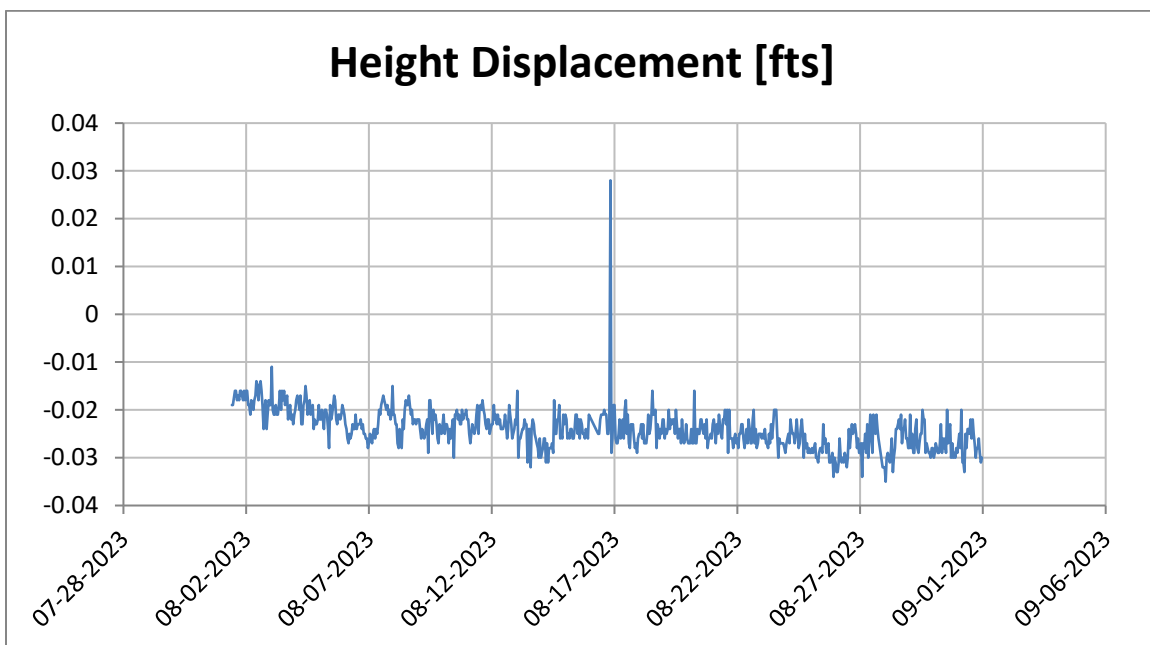
Prism B7300-3

1. Survey accuracy is ± 0.016 feet.
2. Alert threshold is ± 0.35 feet.
3. Transverse displacement is in the horizontal direction. Positive direction means closer to the robotic station.
4. Height displacement is in the vertical direction. Positive direction means higher in elevation.
5. Apparent movements believed to be the result of topsoil placement around prism.

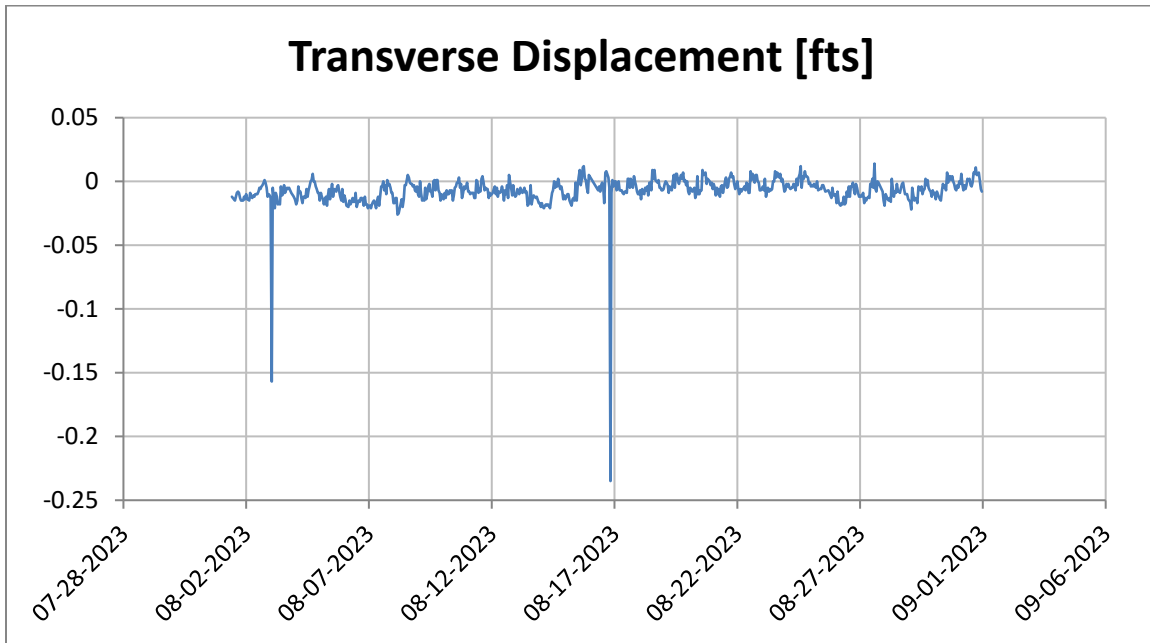
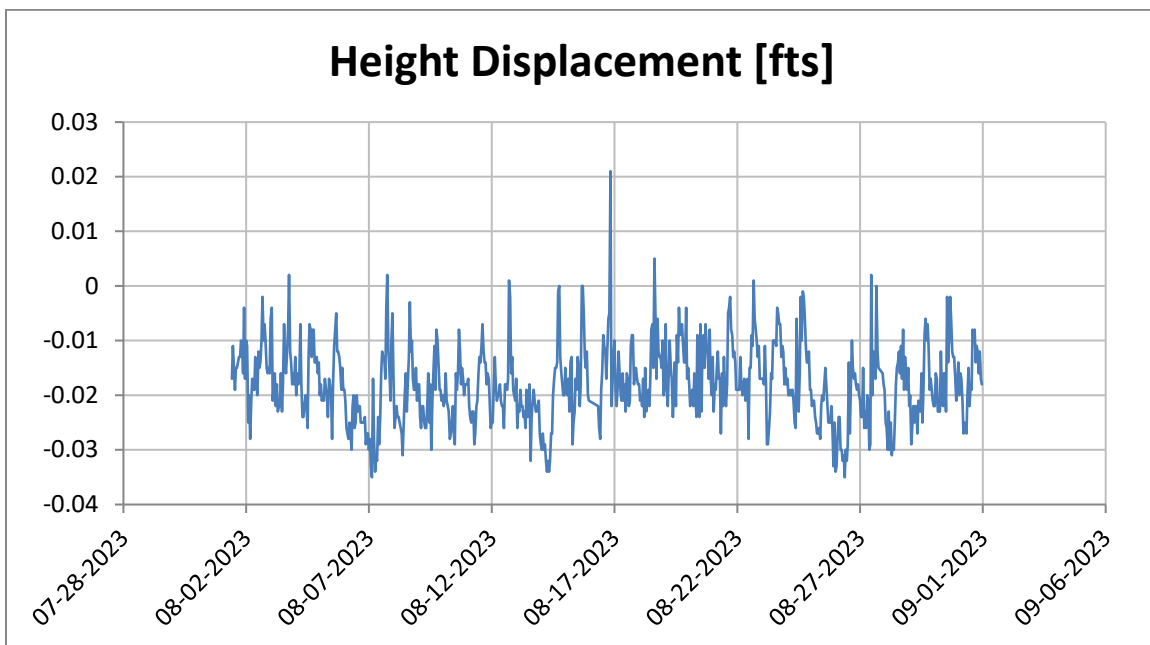
Prism P2

1. Survey accuracy is +/-0.016 feet.
2. Alert threshold is +/-0.35 feet.
3. Transverse displacement is in the horizontal direction. Positive direction means closer to the robotic station.
4. Height displacement is in the vertical direction. Positive direction means higher in elevation.
5. Regression limit alerts received on August 3 and 16.

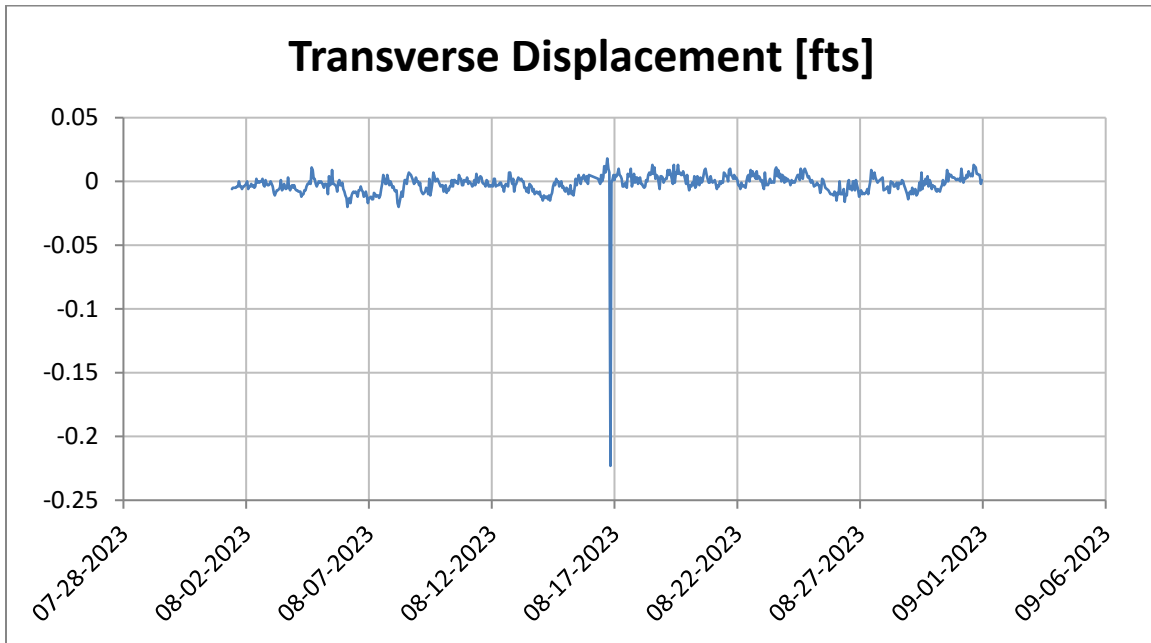
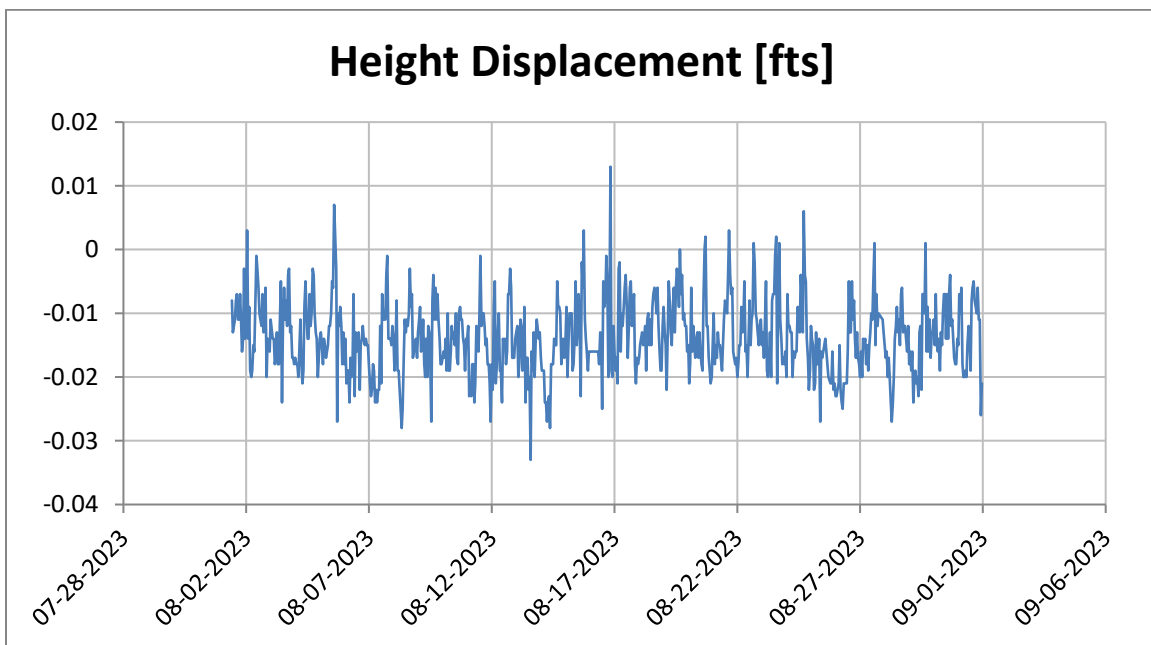
Prism P5

1. Survey accuracy is +/-0.016 feet.
2. Alert threshold is +/-0.35 feet.
3. Transverse displacement is in the horizontal direction. Positive direction means closer to the robotic station.
4. Height displacement is in the vertical direction. Positive direction means higher in elevation.
5. Regression limit alerts received on August 16.

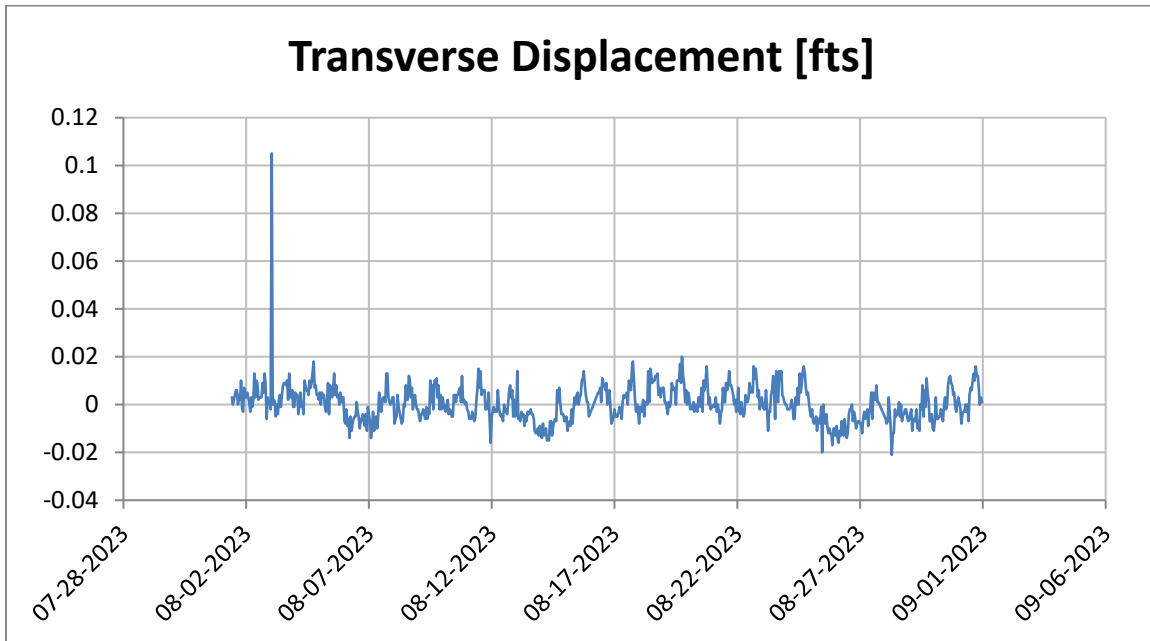
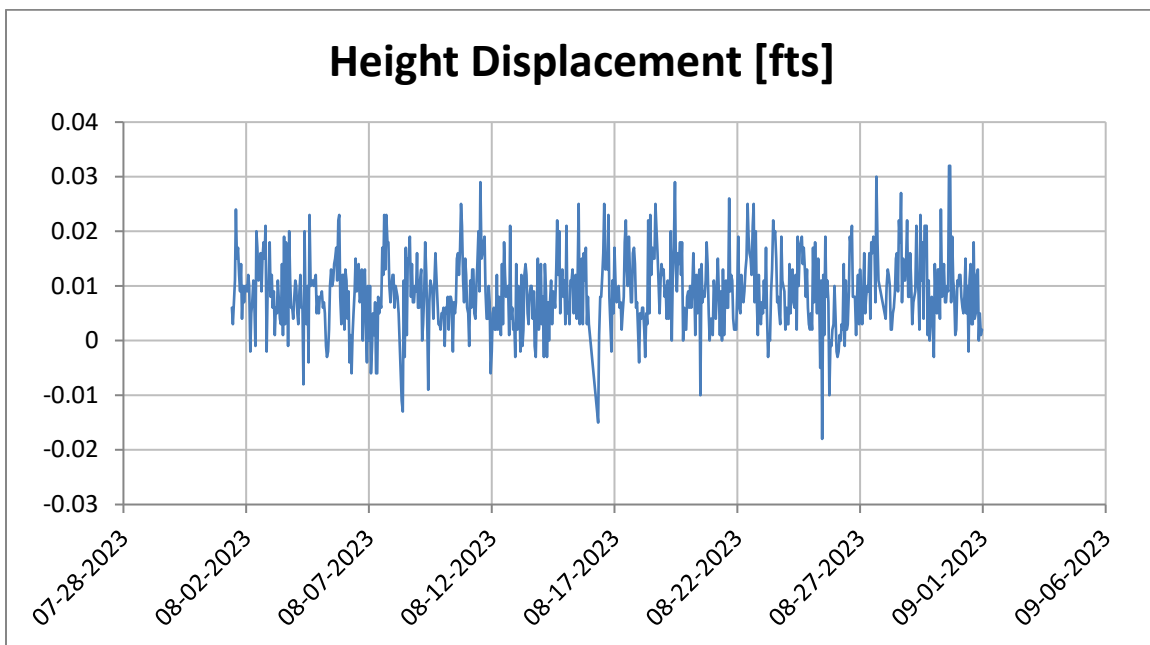
Prism P25

1. Survey accuracy is ± 0.016 feet.
2. Alert threshold is ± 0.35 feet.
3. Transverse displacement is in the horizontal direction. Positive direction means closer to the robotic station.
4. Height displacement is in the vertical direction. Positive direction means higher in elevation.
5. Regression limit alerts received on August 3.

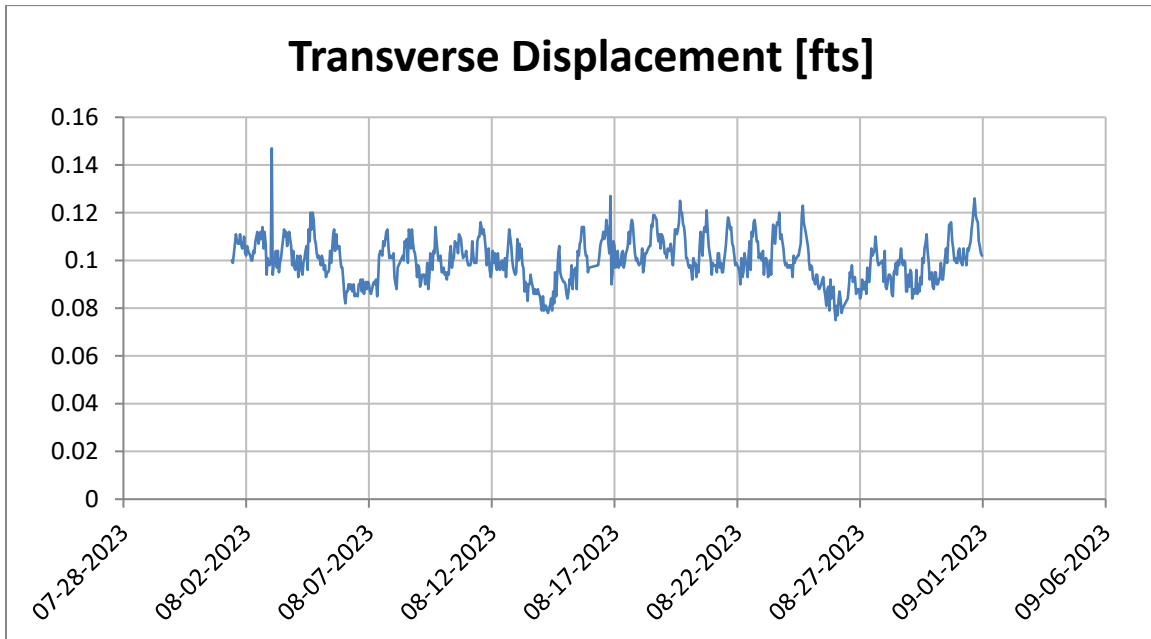
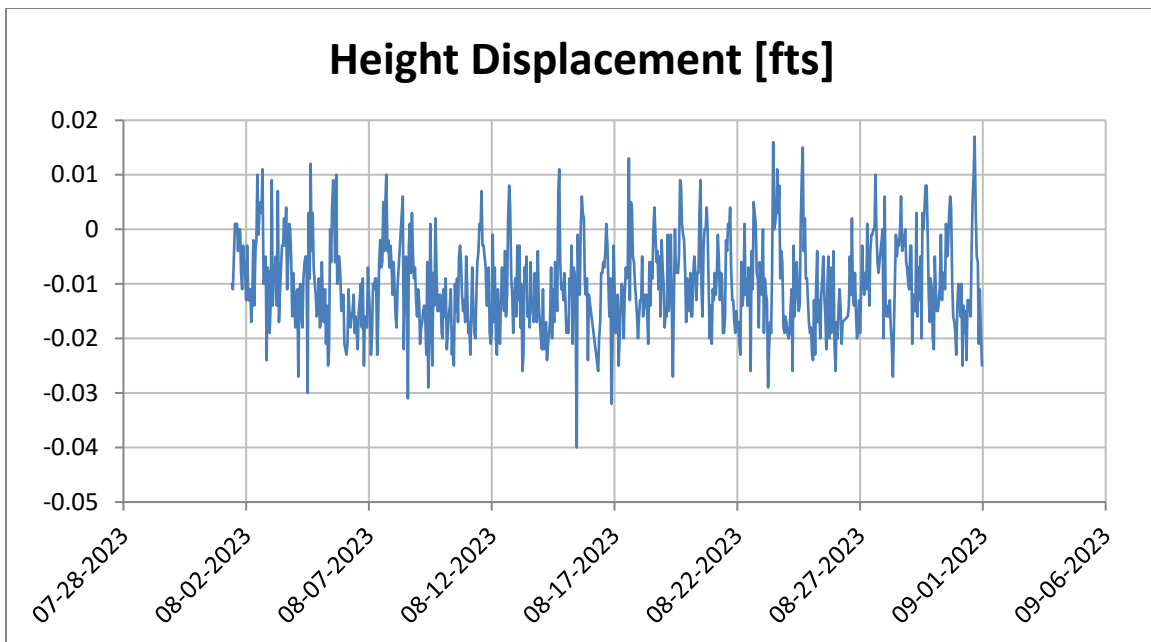
Prism P33

1. Survey accuracy is +/-0.016 feet.
2. Alert threshold is +/-0.35 feet.
3. Transverse displacement is in the horizontal direction. Positive direction means closer to the robotic station.
4. Height displacement is in the vertical direction. Positive direction means higher in elevation.
5. Regression limit alerts received on August 3.

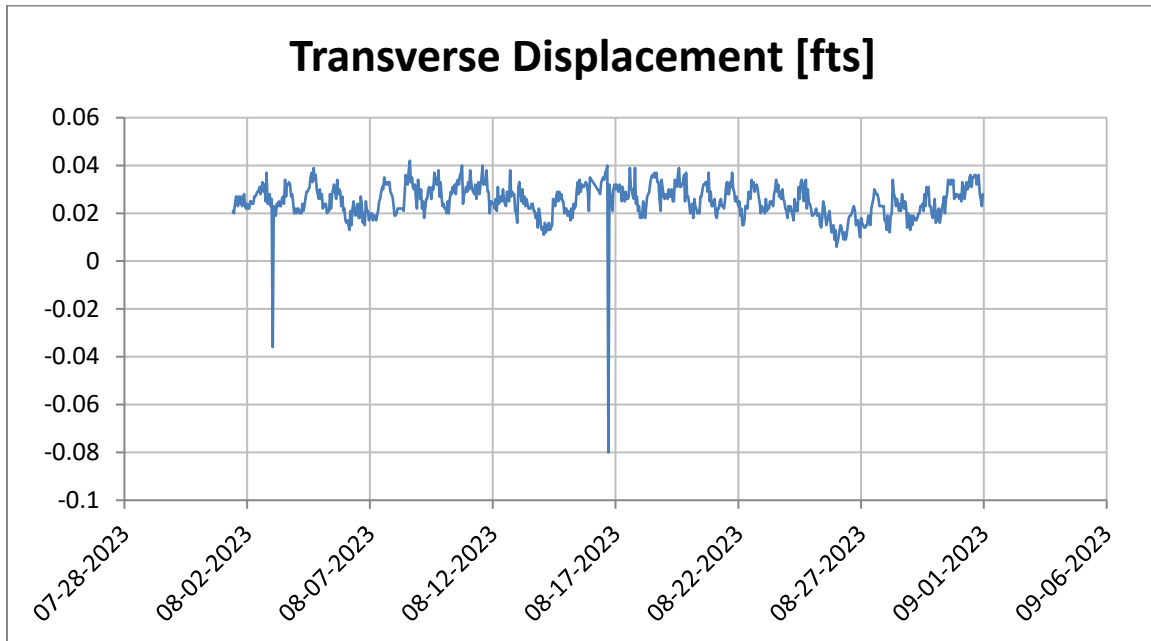
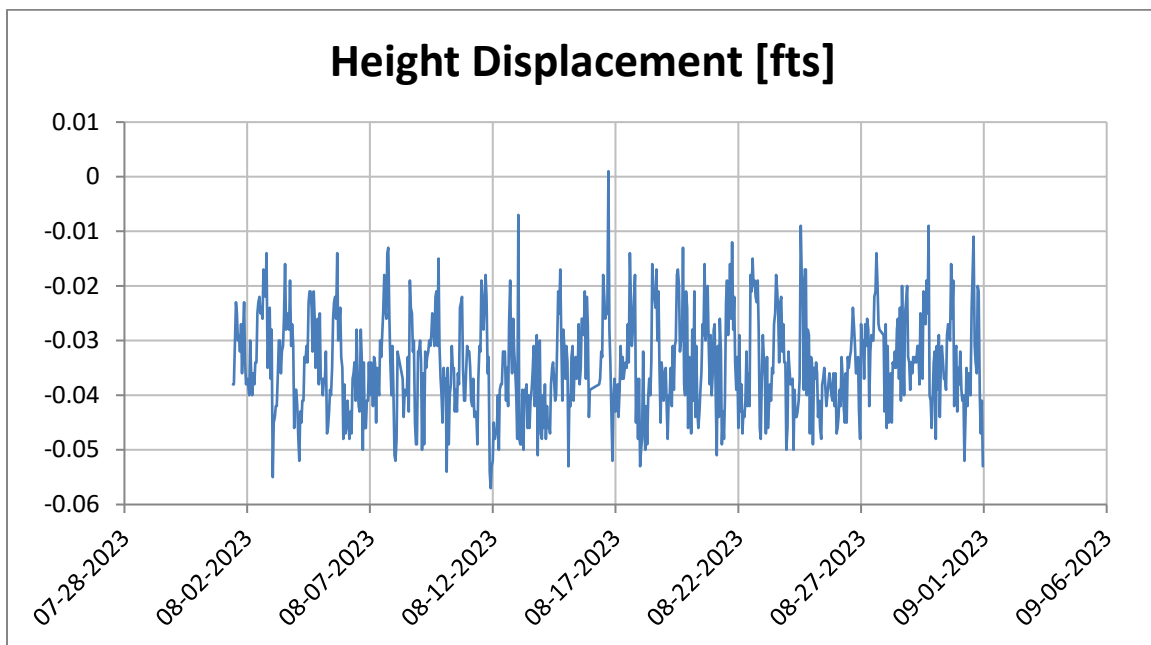
Prism P70

1. Survey accuracy is ± 0.016 feet.
2. Alert threshold is ± 0.35 feet.
3. Transverse displacement is in the horizontal direction. Positive direction means closer to the robotic station.
4. Height displacement is in the vertical direction. Positive direction means higher in elevation.
5. Regression limit alerts received on August 3 and 16.
