**MINERALS PROGRAM INSPECTION REPORT**  
**PHONE: (303) 866-3567**

<b>MINE NAME:</b> Liberty Mine	<b>MINE/PROSPECTING ID#:</b> M-2013-070	<b>MINERAL:</b> Uranium and vanadium	<b>COUNTY:</b> Mesa
<b>INSPECTION TYPE:</b> Monitoring	<b>WEATHER:</b> Clear	<b>INSP. DATE:</b> August 23, 2023	<b>INSP. TIME:</b> 13:15
<b>OPERATOR:</b> Liberty Mining, LLC	<b>OPERATOR REPRESENTATIVE:</b> None	<b>TYPE OF OPERATION:</b> 110d - Designated Limited Impact	
<b>REASON FOR INSPECTION:</b> Normal I&E Program	<b>BOND CALCULATION TYPE:</b> None	<b>BOND AMOUNT:</b> \$93,862.42	
<b>DATE OF COMPLAINT:</b> NA	<b>POST INSP. CONTACTS:</b> DRMS	<b>JOINT INSP. AGENCY:</b> U.S.BLM	
<b>INSPECTOR(S):</b> Amy Yeldell	<b>INSPECTOR'S SIGNATURE:</b>

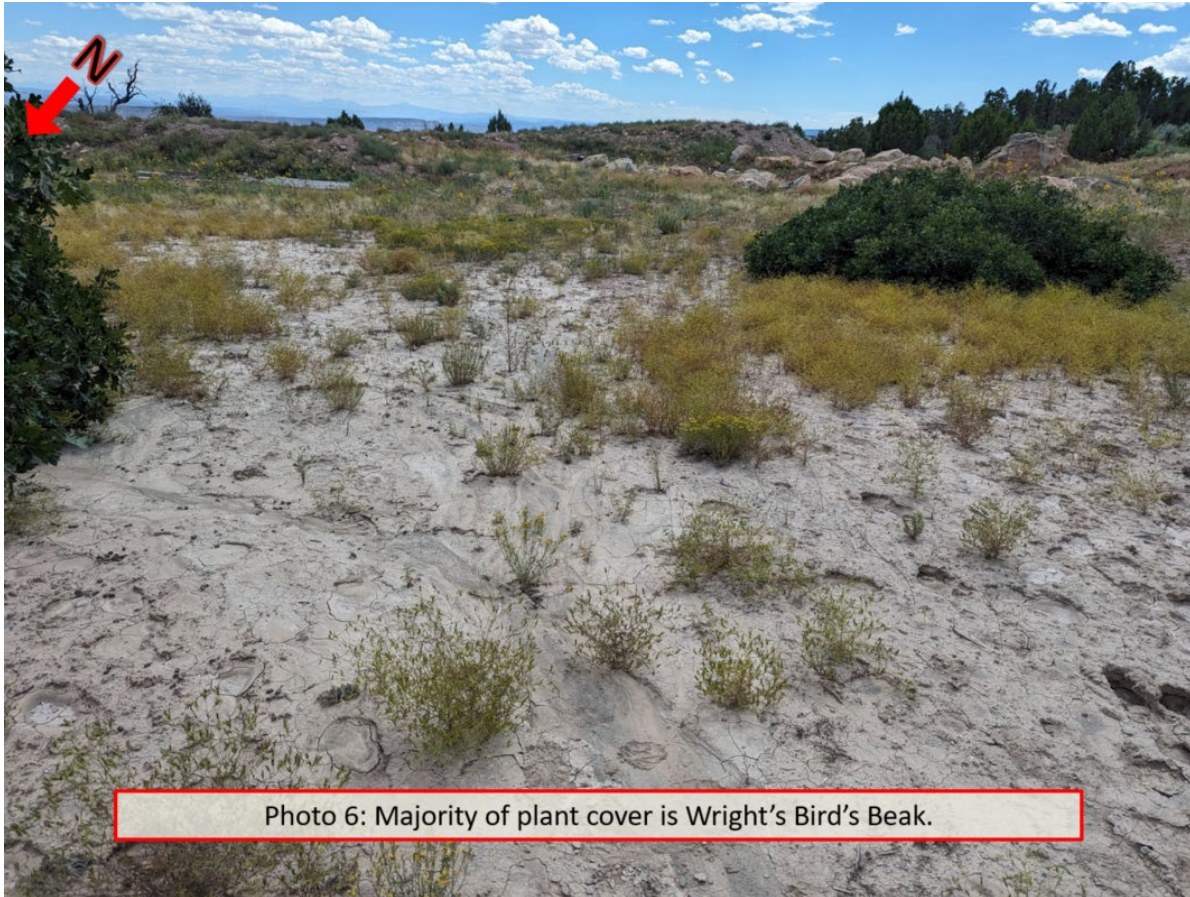
Some plants have volunteered throughout the site. Primarily scrub oak, rabbit brush and perennial grasses. As compared to previous inspections the site has become overwhelmed with Wright's Bird's Beak (*Cordylanthus wrightii*). This flower is native and seems to have a cyclical cycle, in that it is abundant one year then absent for many years (Photos Five and Six, the lime green plants). In addition to Wright's Bird's Beak lots of sunflowers and curlycup gumweed were observed as compared to previous inspections (Photo Seven). Noxious weeds appeared to be well controlled and no infestations were observed.

Photo 5: Wright's Bird's Beak (lime green) all over access road
