Spring 2023 Subsidence and Geologic Field Observations

Southern Panels and Sunset Trail Mining Areas

Jonathan M. Kelly, P.E., Project Manager
Wright Water Engineers, Inc.

September 2023

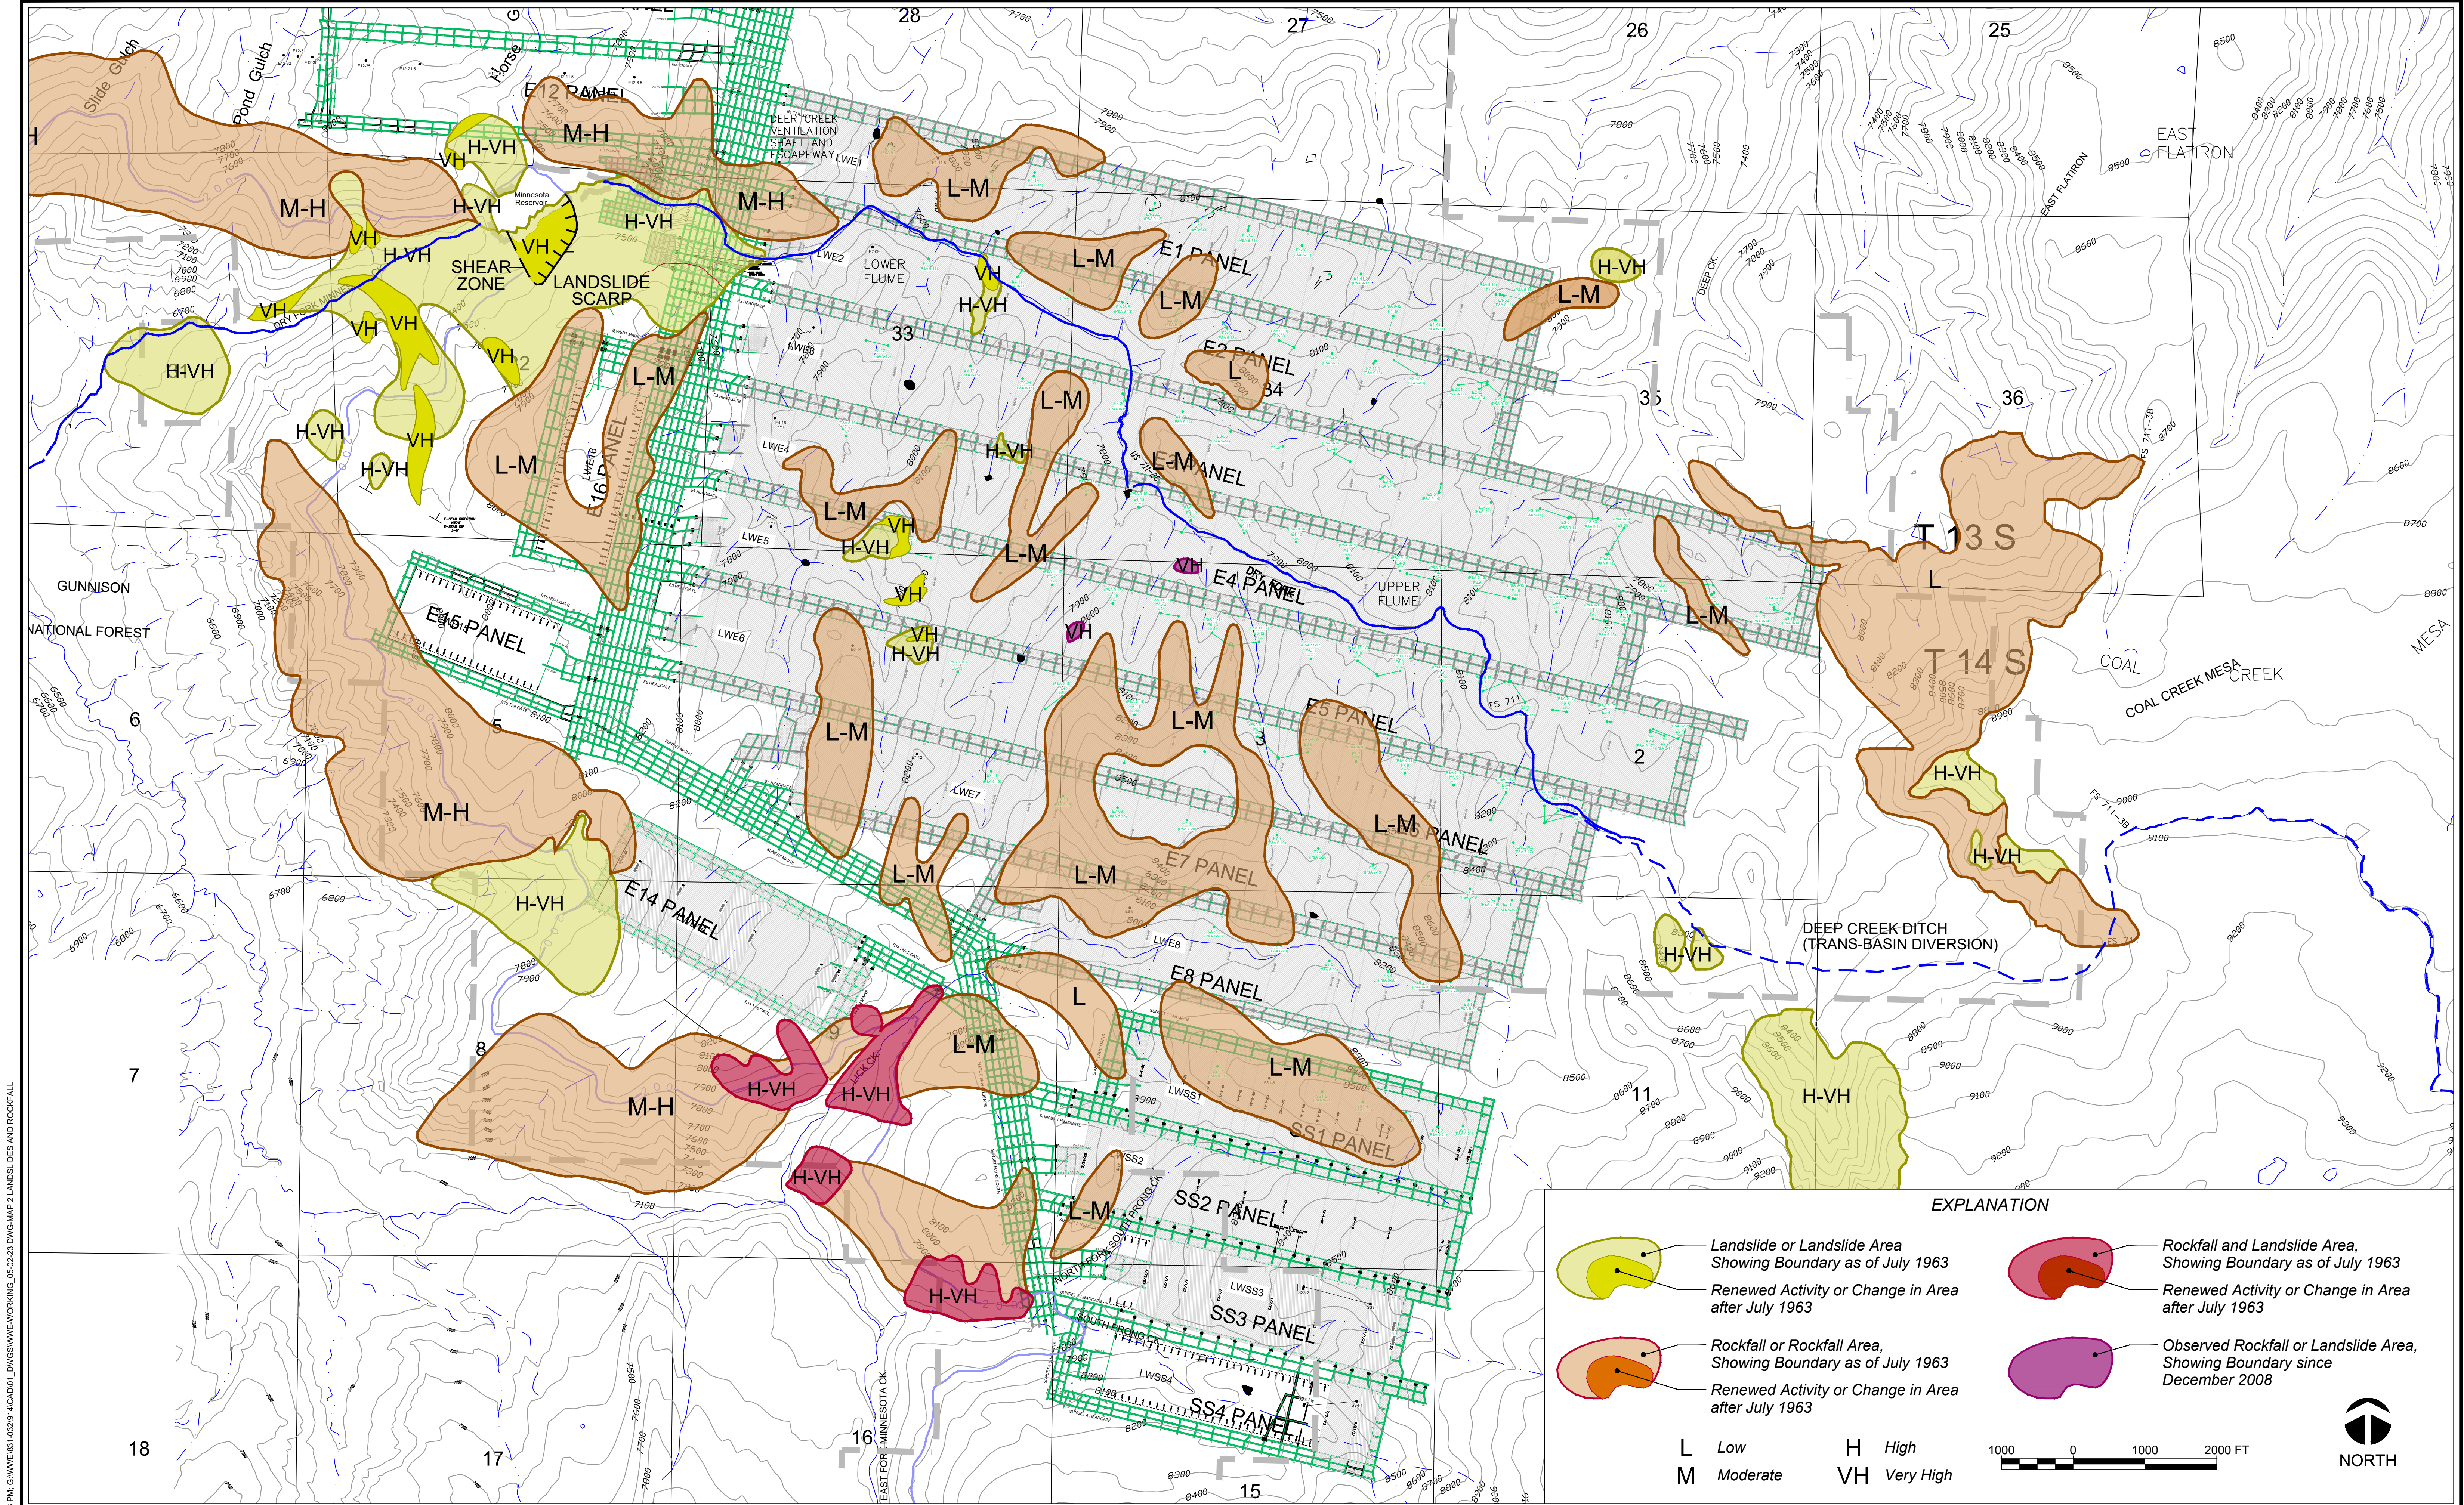
MAP
1

Readers should note that observations are discussed relative to traverses along segments of drill roads providing access to drilling pads containing mine ventilation boreholes (MVBs). Given the dynamic nature of the mining activities (i.e., adding and reclaiming of road segments and MVB pads), future naming of traverses will likely vary from report to report. Specific nomenclature for observed features will be regularly represented on Map 1 of each report.
