M1984041, Eagle-Gypsum Mine, August 2023 Inspection Report

MINERALS PROGRAM INSPECTION REPORT

MINE NAME: Eagle-Gypsum Mine	MINE/PROSPECTING ID#: M-1984-041	MINERAL: Anhydrite, gypsum	COUNTY: Eagle
INSPECTION TYPE: Monitoring	WEATHER: Clear	INSP. DATE: August 17, 2023	INSP. TIME: 10:30
OPERATOR: American Gypsum Company LLC	OPERATOR REPRESENTATIVE: Jon Edeen	TYPE OF OPERATION: 112c - Construction Regular Operation

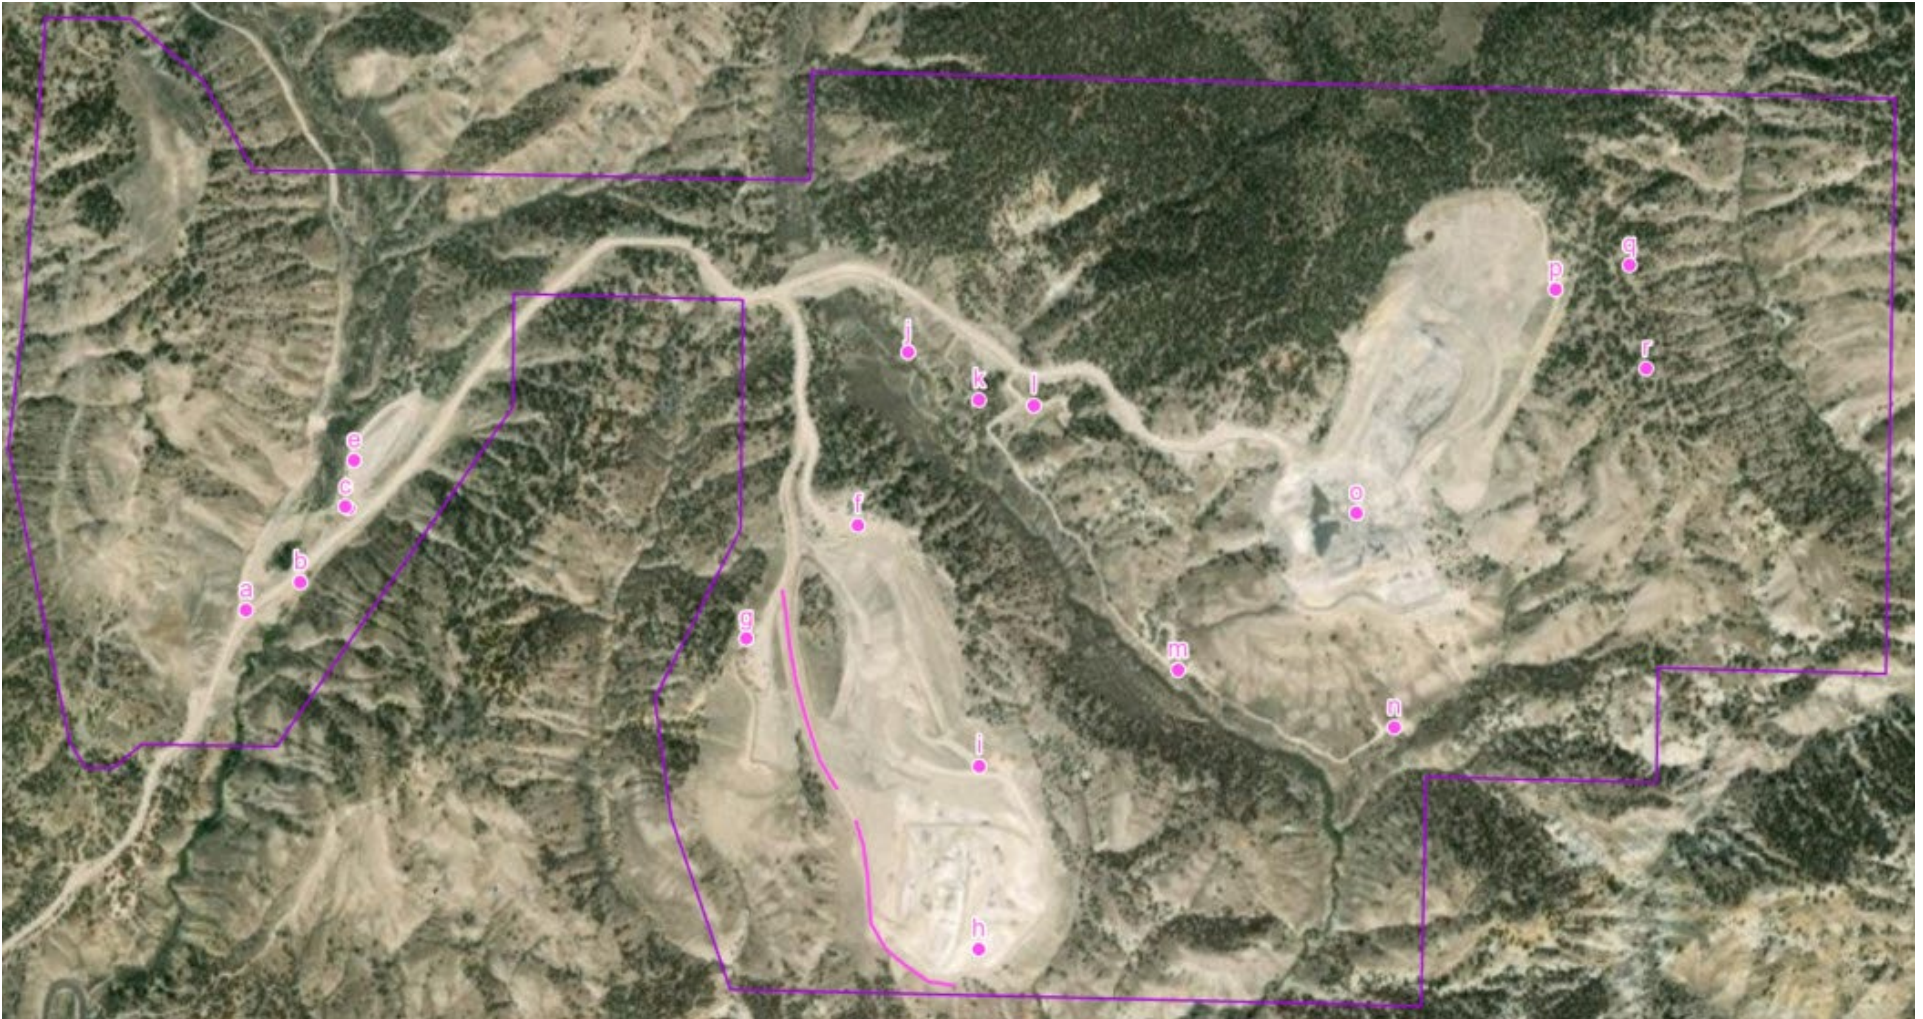
The existing haul road to the Lower Pit was in use for the transportation of material, but, to the east, a new haul road which will replace it was under construction. The mine plan calls for the lower (southern) section of the existing haul road to be mined through and for the upper (northern) section to be backfilled, (see Figures 2 and 8).

Figure 2: Permit boundary and inspection features, overlaid on satellite imagery. Existing Lower Pit haul road shown with pink line.
