MINERALS PROGRAM INSPECTION REPORT

MINE NAME: Weathers Mine #1	MINE/PROSPECTING ID#: M-1999-089	MINERAL: Borrow material for construction, Sand, Clay	COUNTY: Yuma
INSPECTION TYPE: Monitoring	WEATHER: Clear	INSP. DATE: August 31, 2023	INSP. TIME: 14:00
OPERATOR: Byron J. & LaLani R. Weathers	OPERATOR REPRESENTATIVE: Bryon Weathers	TYPE OF OPERATION: 110c - Construction Limited Impact	
REASON FOR INSPECTION: Normal I&E Program	BOND CALCULATION TYPE: Complete Bond	BOND AMOUNT: \$22,000.00	
DATE OF COMPLAINT: NA	POST INSP. CONTACTS: None	JOINT INSP. AGENCY: None	
INSPECTOR(S): Nikie Gagnon	INSPECTOR'S SIGNATURE:

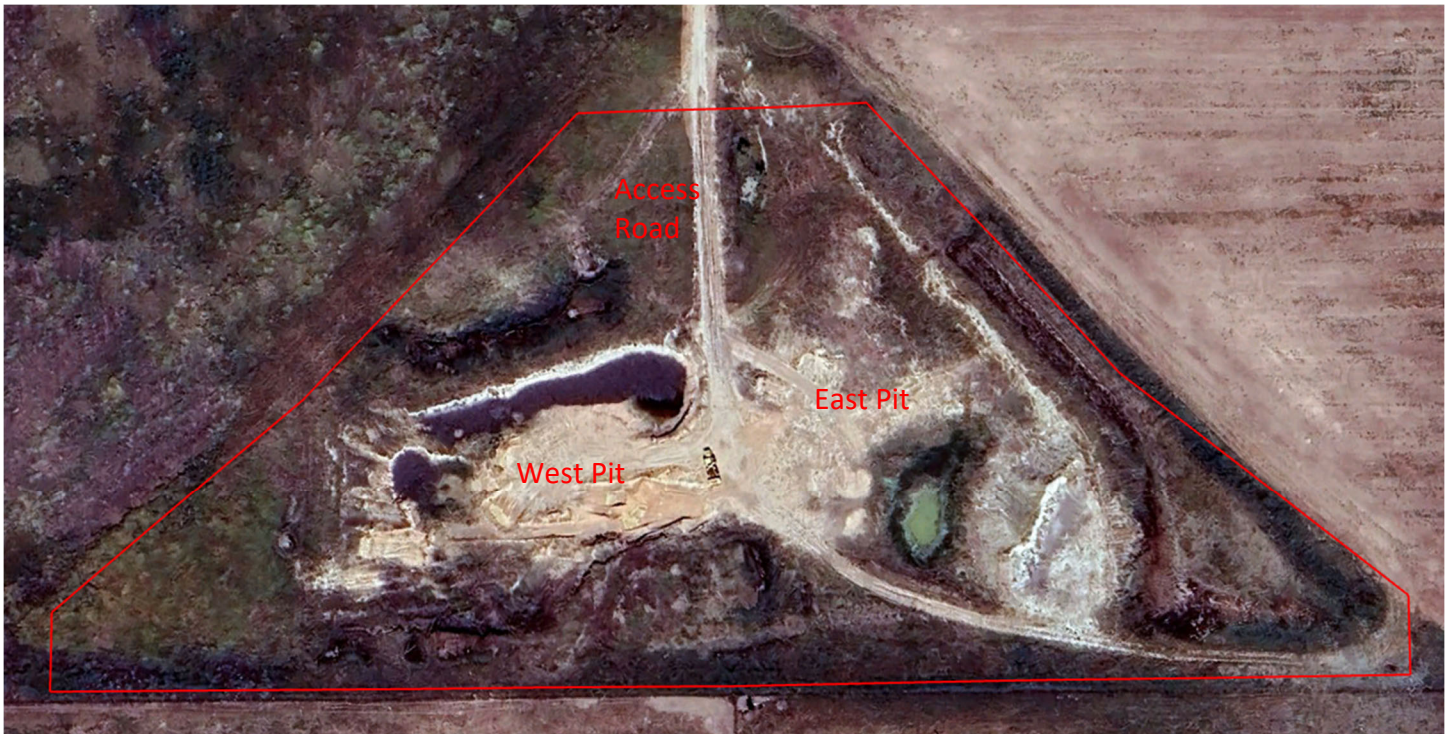
On the west side, the pit floor and the deeper excavated pits appear to be collecting storm water. Soil cracks were evident in two areas and several inches of water was observed below the northern highwall in the northeast corner in an excavated pit. Based on the color of the water, and staining of the pit walls above the water indicating the water was higher at one point in time, stormwater is not draining quickly. Additionally, Google imagery from 08/2022 and 09/2023 shows standing water in both the east and west mining areas.

Figure 1: Google Earth imagery from 9/2023. Red line indicates the approximate permit boundary.
