MINERALS PROGRAM INSPECTION REPORT
PHONE: (303) 866-3567

MINE NAME: Burros Mine	MINE/PROSPECTING ID#: M-1977-297	MINERAL: Uranium and vanadium	COUNTY: San Miguel
INSPECTION TYPE: Multi Person Inspection	WEATHER: Clear	INSP. DATE: October 5, 2023	INSP. TIME: 09:58
OPERATOR: Gold Eagle Mining, Inc.	OPERATOR REPRESENTATIVE: Don Coram	TYPE OF OPERATION: 110d - Designated Limited Impact	
REASON FOR INSPECTION: Normal I&E Program	BOND CALCULATION TYPE:	BOND AMOUNT: \$100.00	
DATE OF COMPLAINT: NA	POST INSP. CONTACTS: None	JOINT INSP. AGENCY: None	
INSPECTOR(S): Lucas West Travis Marshall	INSPECTOR'S SIGNATURE:

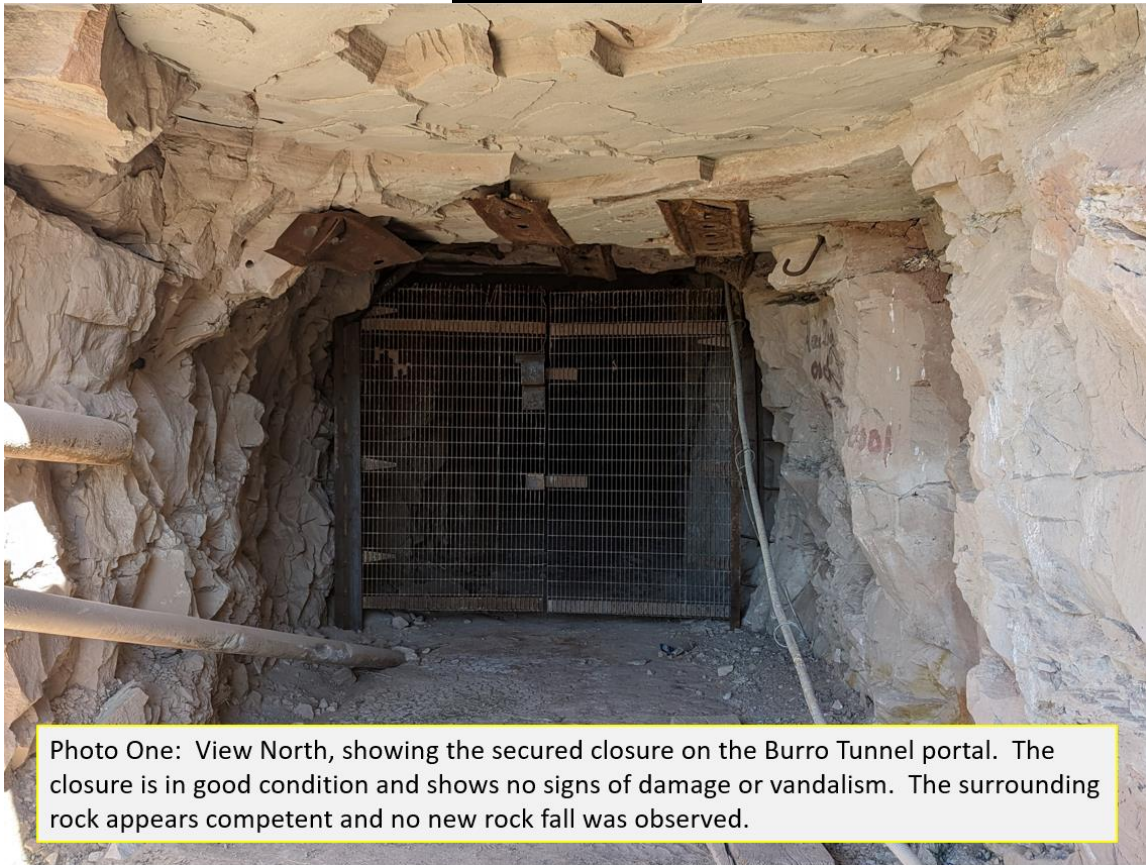
The 9.9 acres of this site includes the areas referred to as the Burro 3, 5 and 7 as well as the area surrounding the portal, main pad area and ore hopper area. Included in this are the roads leading from the Burro tunnel to the 5 and on to the 7. All of these areas are still included in the DRMS permit Boundary but fall under varying land management jurisdictions between DOE and BLM. The portal of the Burro Tunnel was observed, and verified to be secure as seen in Photo One. The portal is closed with a locking metal gate closure and shows no signs of vandalism or attempted unauthorized entry. Various items including historic air lines and other items surround the portal. The storm water control features across the site to divert storm water flow from the affected lands to a sediment basin near the county road, adjacent to a historic ore hopper located on site were all in good condition and appear to be functioning as designed. The ore hopper was stable at the time of the inspection and in good condition and can be seen in Photo Two.

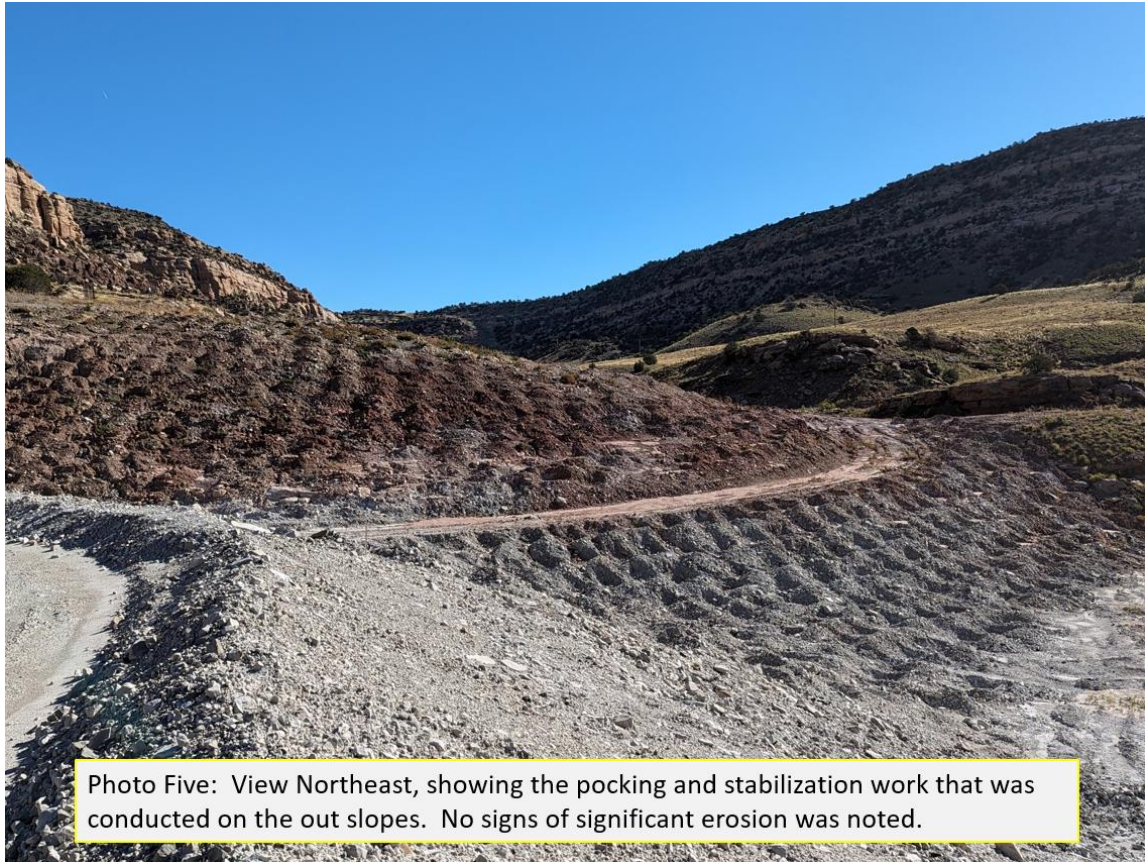
The main storage pad where the stockpiles were located can be seen in Photos Three and Four. The top of the pad was stable at the time of the inspection and clear of all materials. The out slopes have been regraded to pull the toe away from the dry creek bed of Burro Creek to prevent sediment from entering the creek. A portion of the slopes have been pocked for stability, and all out slopes observed appeared to be stable at the time of the inspection. Examples of the pocking and out slopes can be seen in Photos Five. The pad and its out slopes appeared stable at the time of the inspection, no signs of settling, slumping or erosion was noted during this inspection.
