**Reference: September 2023 Geotechnical Monitoring Summary Pikeview Quarry**

PIKEVIEW QUARRY SLOPE  
MONITORING

OBSERVATIONS FROM  
SEPTEMBER INSPECTION

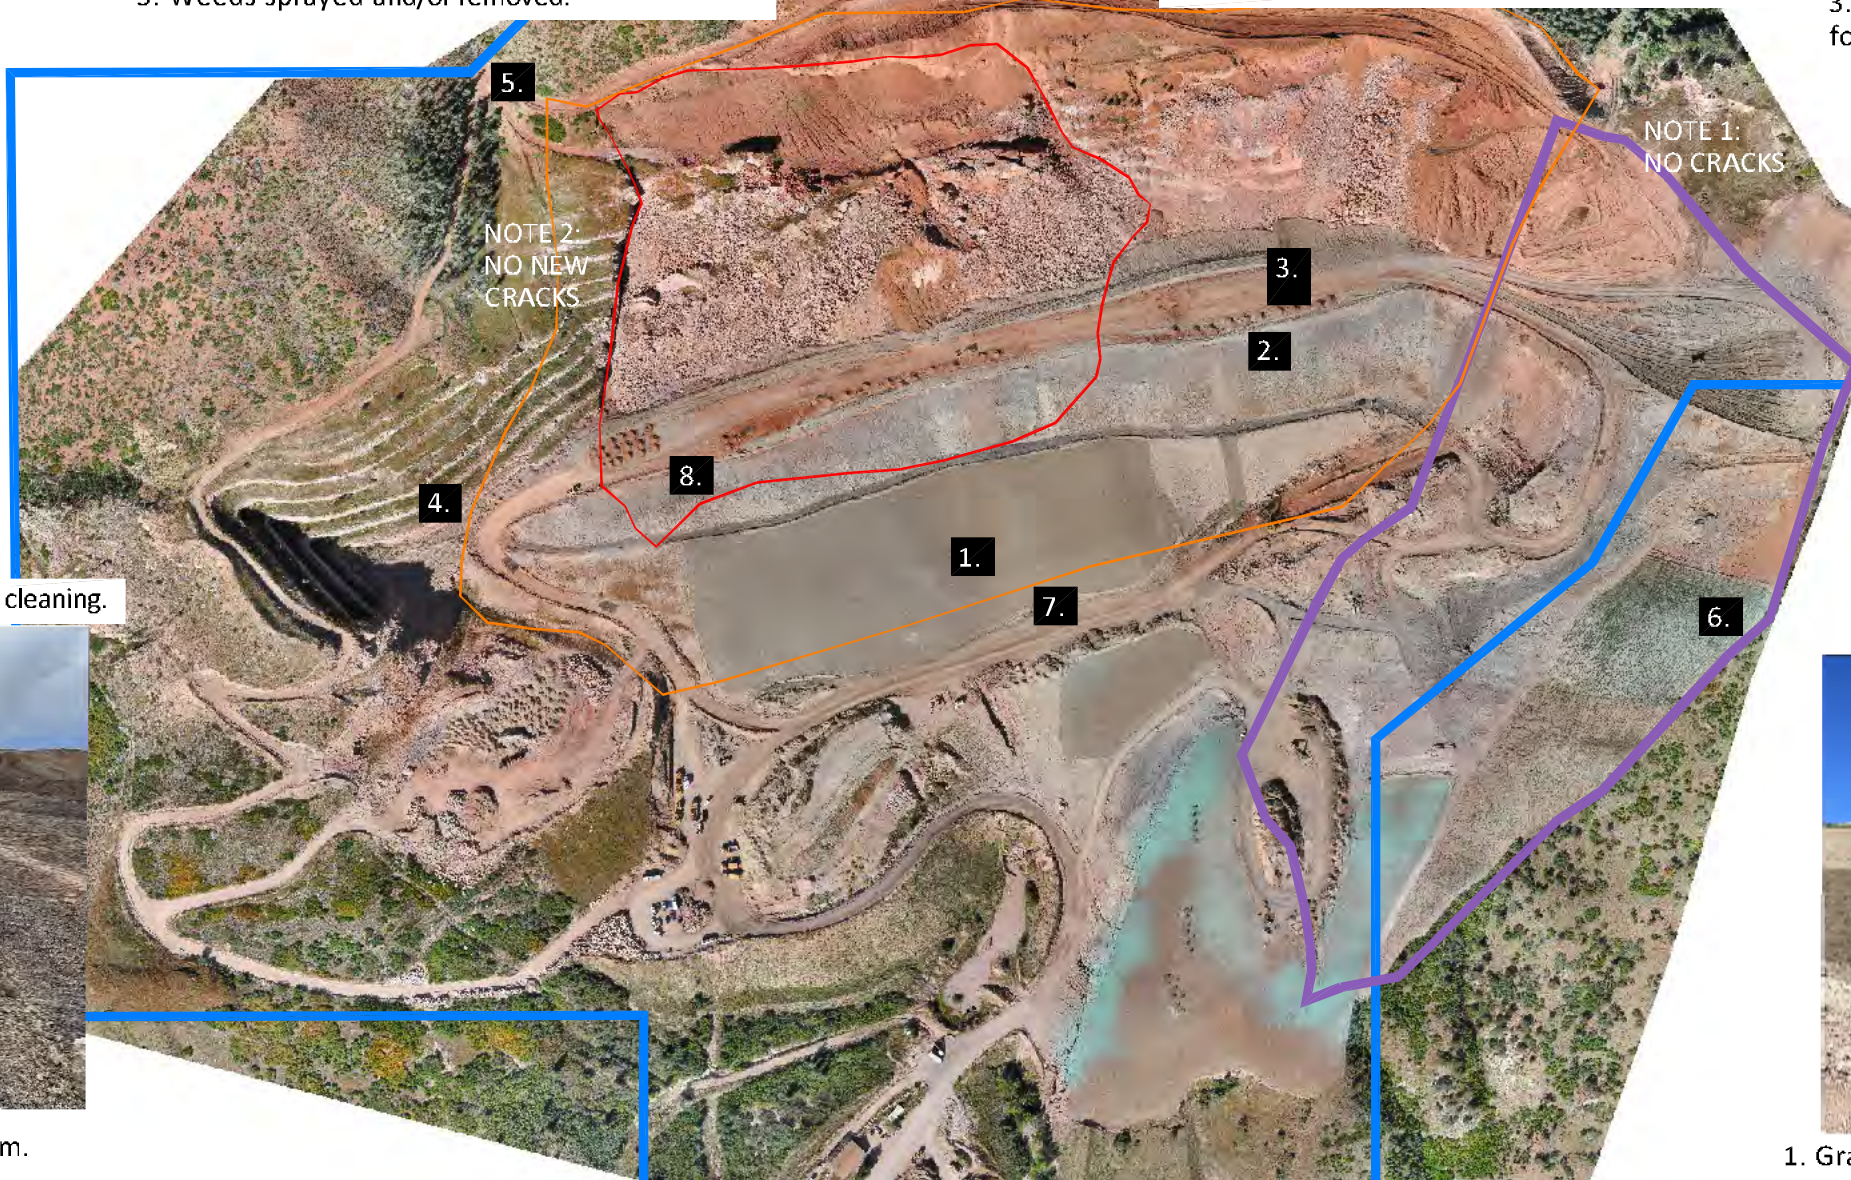
2. Repairing erosion on buttress.

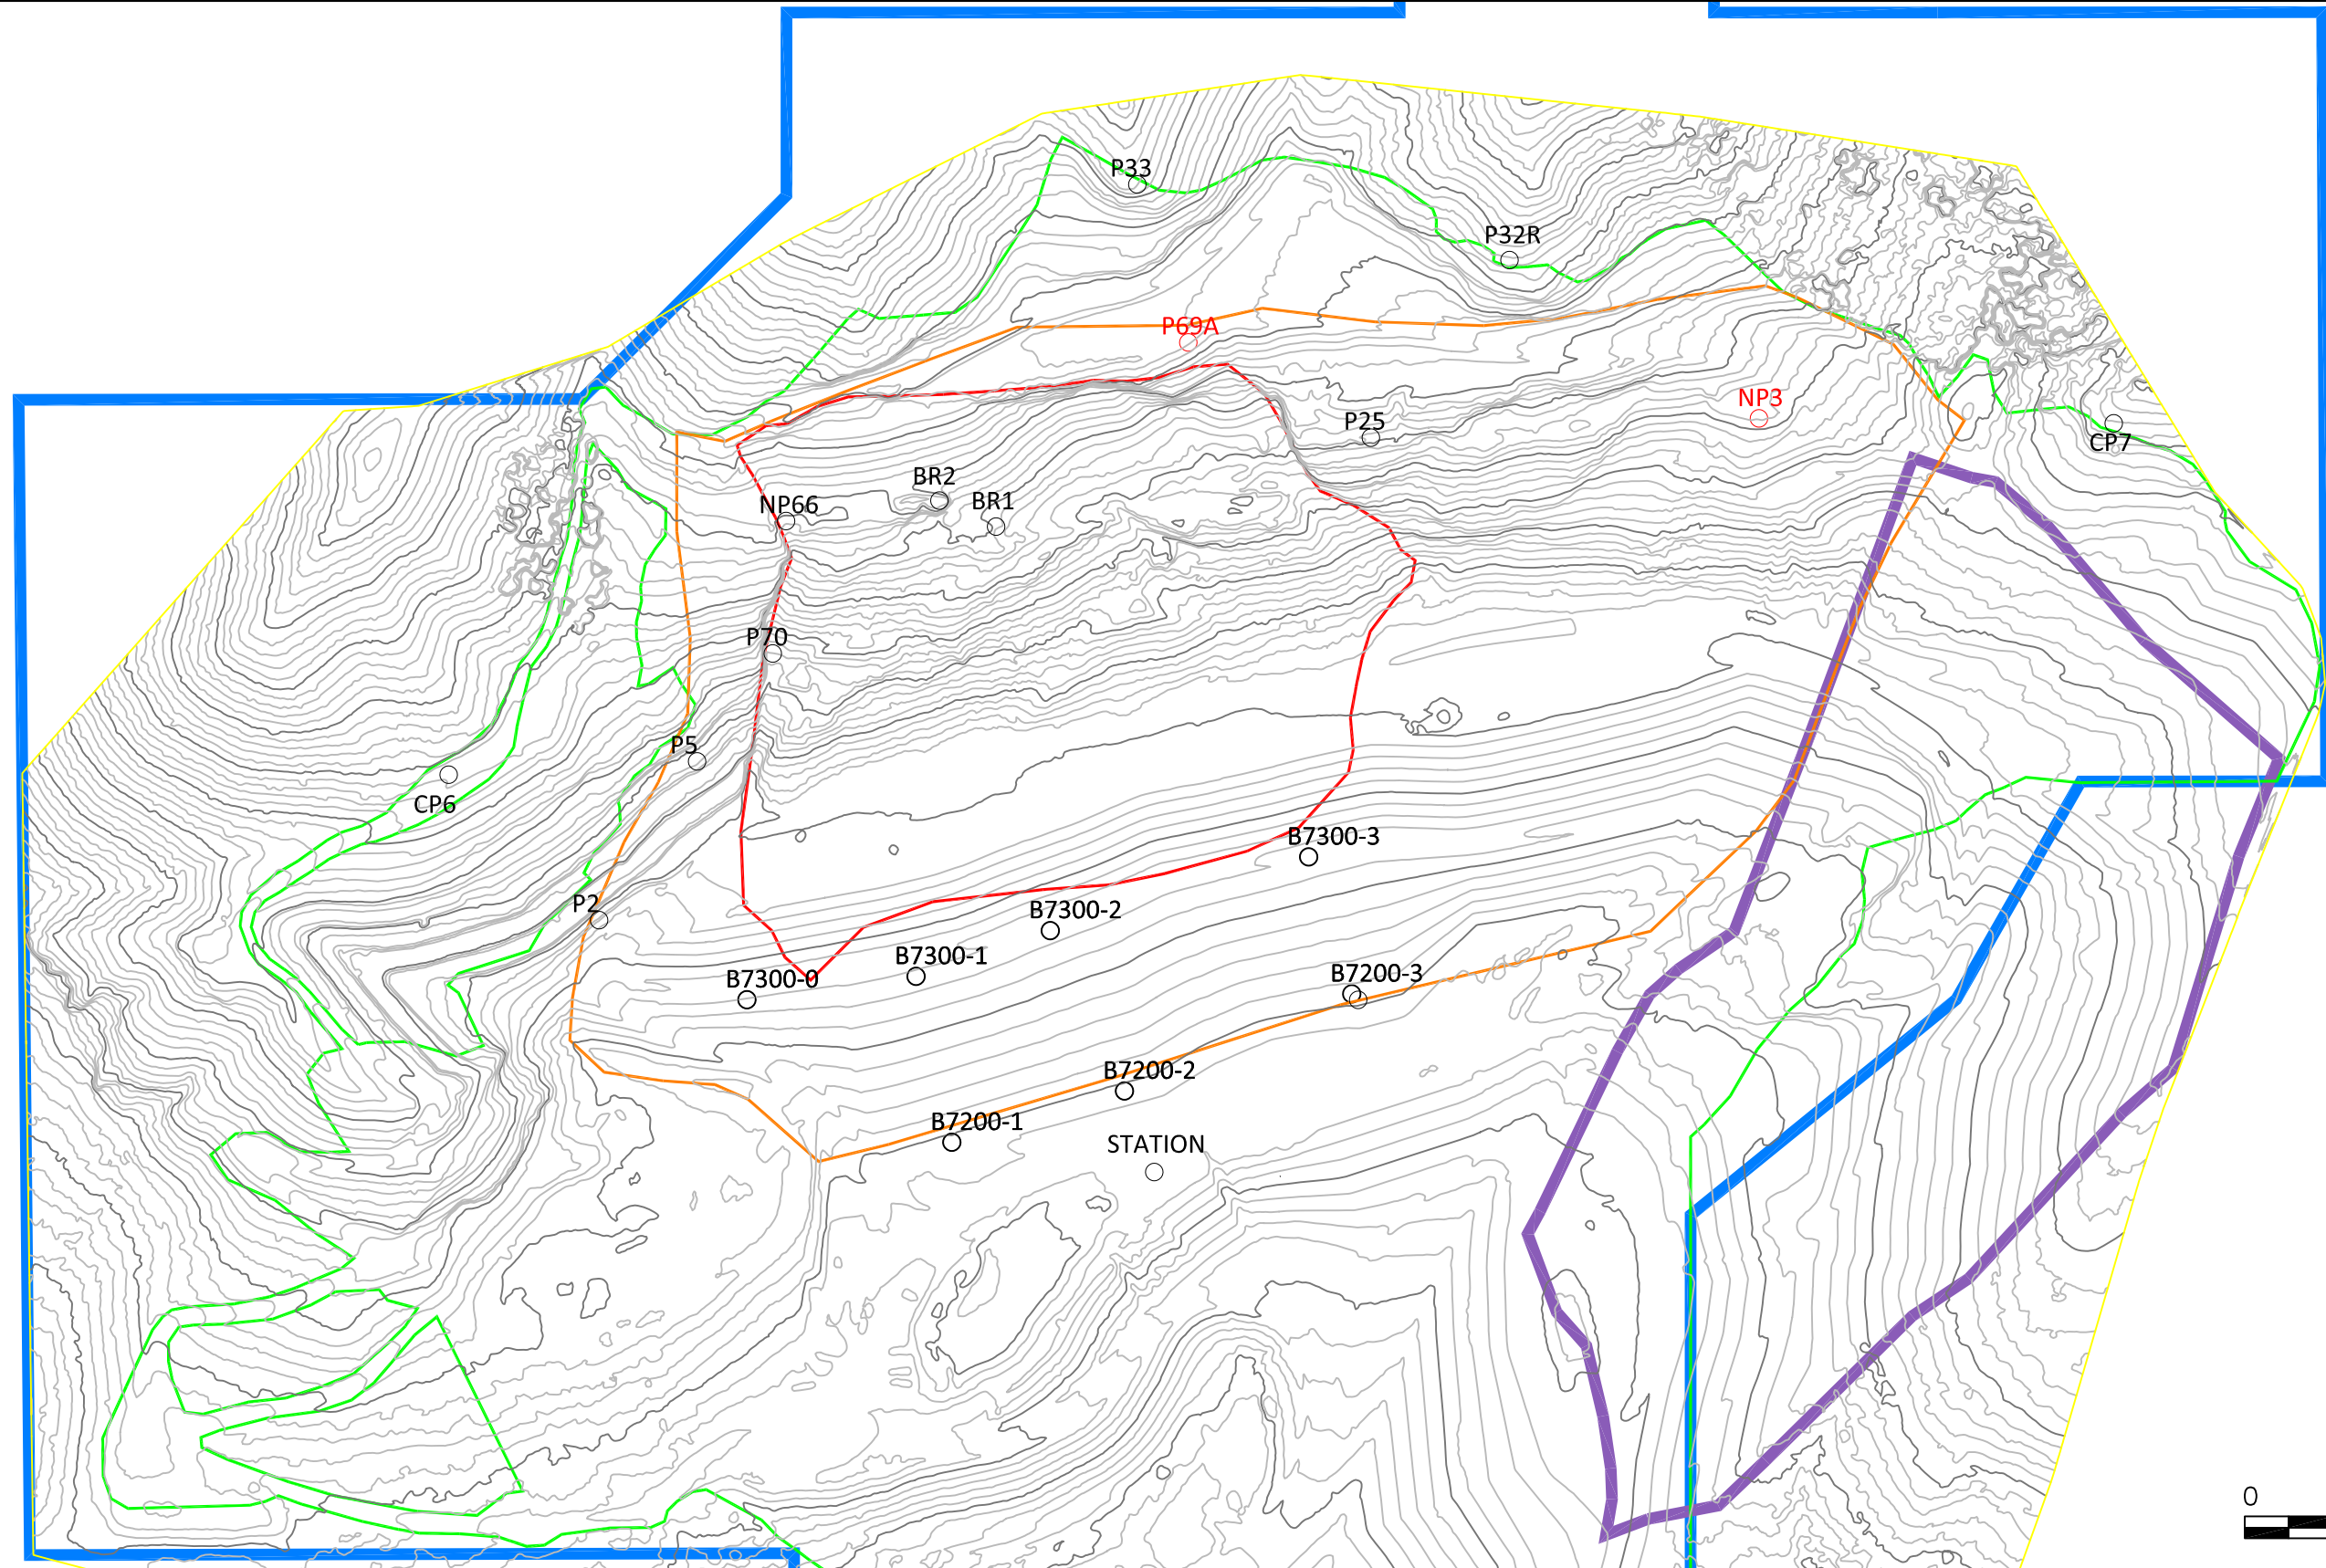
Title  
EXISTING PRISMS WITH  
CURRENT SURFACE  
Revision  
#  
Date  
2023.10.31  
Drawn By  
PK  
Figure No.  
3

The data show stable conditions with no movements at 15 of 20 prisms with recorded displacements limited to data scatter and not actual movements. Prisms BR1, BR2 P69A, NP3 and NP66 are located above the landslide, and these prisms recorded slope creep movements at slow velocity. This settlement was likely related to loose fill or landslide material consolidating under its own weight. These prisms were placed in areas where slope creep movements are likely to occur; therefore, movements being recorded is expected. Plots of the transverse and height displacements for each prism are included in Appendix B.

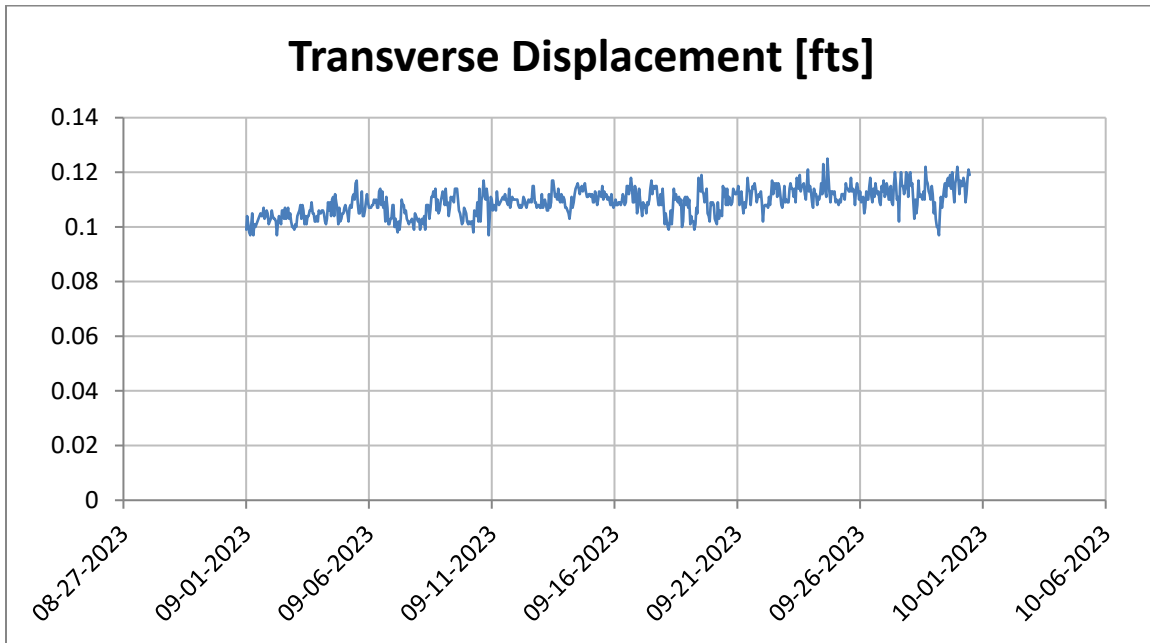
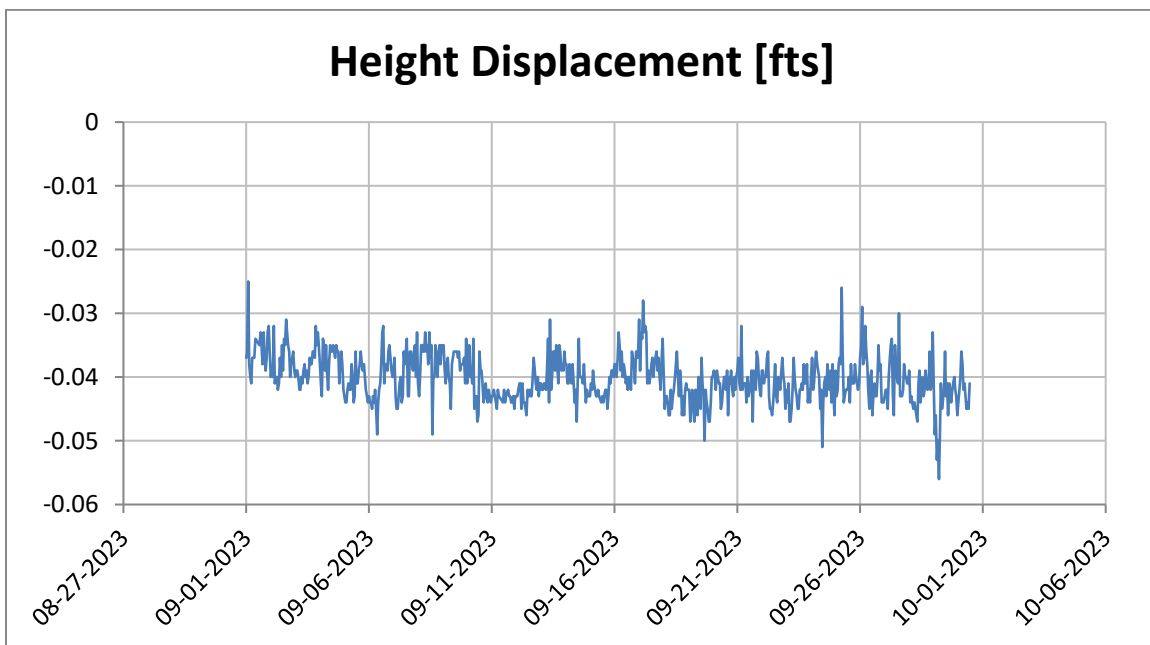
## Prism B7200-3

7. Hydromulched slope. Prism 7200-3 before cleaning.

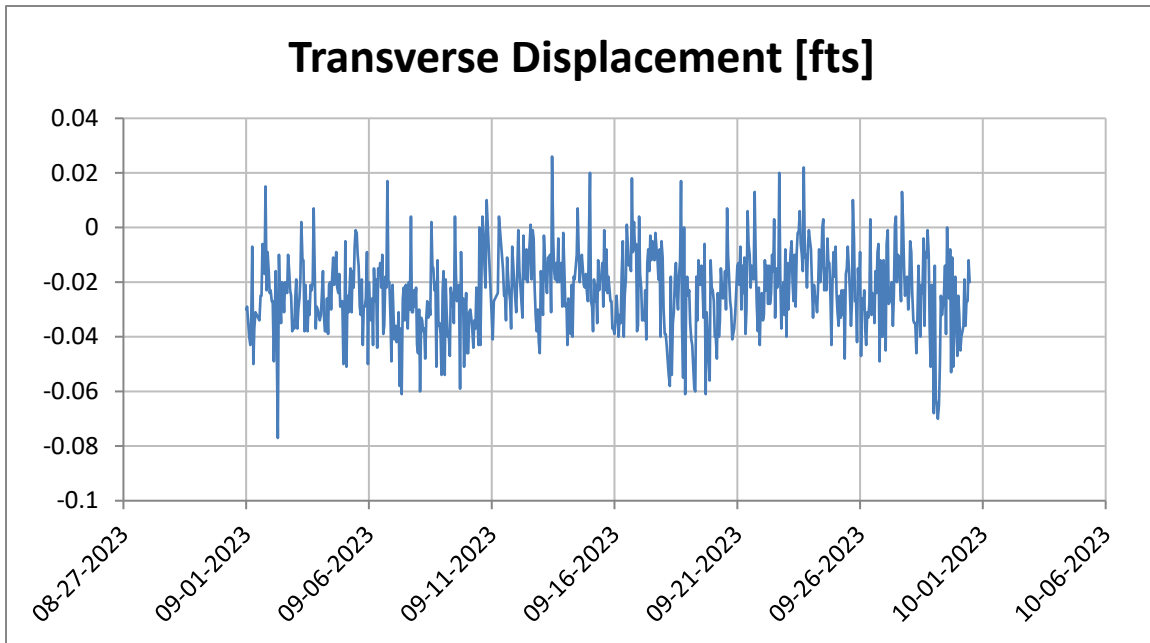
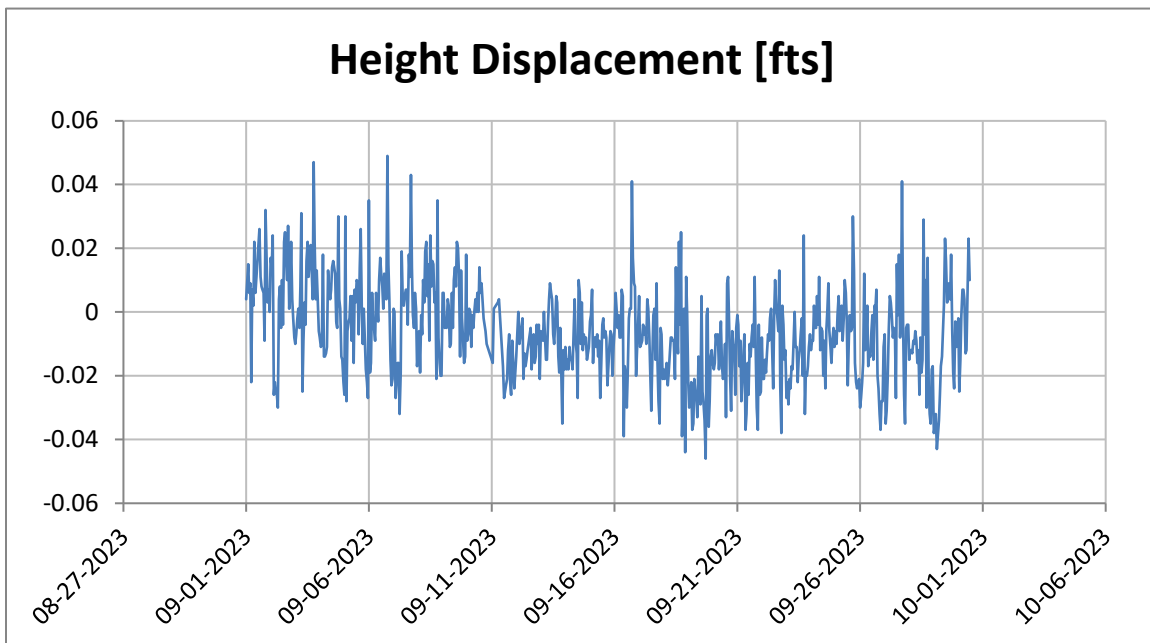
## Prism P32R

Prism	Date	Action	Comment
P32	1-Aug-23	Prism Removed	P32 was damaged by a falling rock. P32R was installed in the same location.
P32R	1-Aug-23	Prism Added	
P69A	28-Sep-23	Prism Removed	Reclamation grading to affect prism in near future
NP3	30-Sep-23	Prism Removed	Reclamation grading to affect prism in near future

1. P32R replaced P32 on August 1, 2023.
2. Survey accuracy is  $\pm 0.016$  feet.
3. Alert threshold is  $\pm 0.35$  feet.
4. Transverse displacement is in the horizontal direction. Positive direction means closer to the robotic station.
5. Height displacement is in the vertical direction. Positive direction means higher in elevation.
