RE: North River Gravel Pit Extension, Permit No. M-1999-007, Unresolved Problem(s) Noted in a Past Inspection Report

MINERALS PROGRAM INSPECTION REPORT
PHONE: (303) 866-3567

MINE NAME: North River Gravel Pit Extension	MINE/PROSPECTING ID#: M-1999-007	MINERAL: Gravel	COUNTY: Rio Blanco
INSPECTION TYPE: Surety Release Inspection	WEATHER: Clear	INSP. DATE: July 24, 2023	INSP. TIME: 12:30
OPERATOR: George T. Weldon Construction, LLC	OPERATOR REPRESENTATIVE: None	TYPE OF OPERATION: 110c - Construction Limited Impact	
REASON FOR INSPECTION: Surety Release Requested	BOND CALCULATION TYPE: None	BOND AMOUNT: \$11,750.00	
DATE OF COMPLAINT: NA	POST INSP. CONTACTS: None	JOINT INSP. AGENCY: None	
INSPECTOR(S): Amy Yeldell	INSPECTOR'S SIGNATURE:

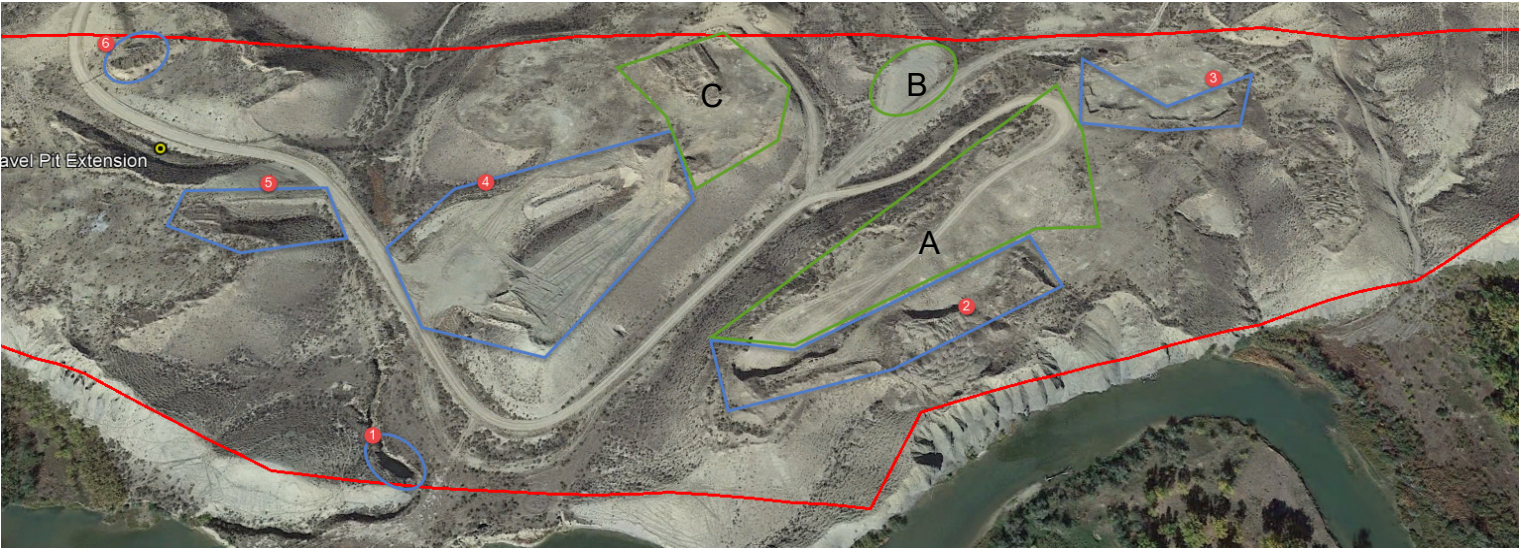
Vegetation on the southern west facing slope of area 4 is lush but unfortunately all non-desirable species. The northern west facing slope appears to be sufficiently graded and is far more arid. Only sparse Russian Thistle with very few shrubs or other desirable species were observed. One note is that the drill rows of the northern slope are going with the grade which will facilitate erosion in the event of precipitation (See Photo Ten). All disking and seeding should be done perpendicular to the grade to trap moisture and prevent erosion.

Photo 10: Southwest slope of Area 4. Drill rows wrong direction.
