## **Denver Field Branch Bond Release Evaluation Report**

Permittee:	Oxbow Mining, LLC
Operator:	Oxbow Mining, LLC
Site:	Elk Creek Mine
Permit No:	C-1981-022
Date of Inspection:	October 25, 2023
Inspection Type:	Partial Phase III bond release
Weather:	
Operator Representative:	Doug Smith
State Official:	Leigh Simmons
USFS Official:	Dan Gray
OSMRE Official:	Tom Medlin #562

This was a partial Phase III bond release inspection of reclaimed mine ventilation and coal exploration boreholes, drill pads, and associated road segments at the Elk Creek Mine in Delta and Gunnison counties, Colorado.

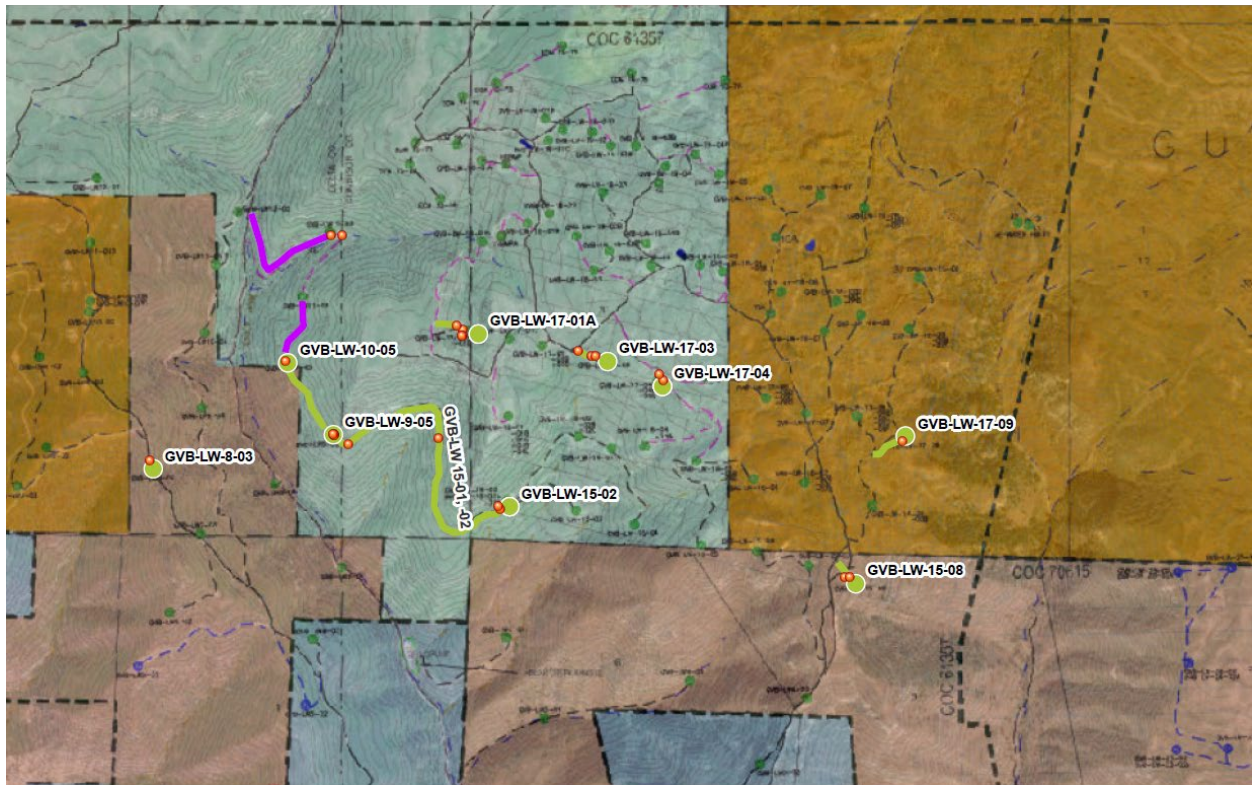
Reclaimed surfaces were stable, roughened, and well-blended with the native, often steep, topography. By private landowner request two road segments along the inspection route, shown in violet on Figure 1, were left in place.

Figure 1. Map of SL-8 reclaimed roads and pads. Violet road segments are permanently retained on landowner request.
