To: Jerald Schnabel  
Riverbend Industries Inc.  
File: October 2023 Monitoring Summary

**Reference: October 2023 Geotechnical Monitoring Summary Pikeview Quarry**

PIKEVIEW QUARRY SLOPE  
MONITORING

OBSERVATIONS FROM  
OCTOBER INSPECTION

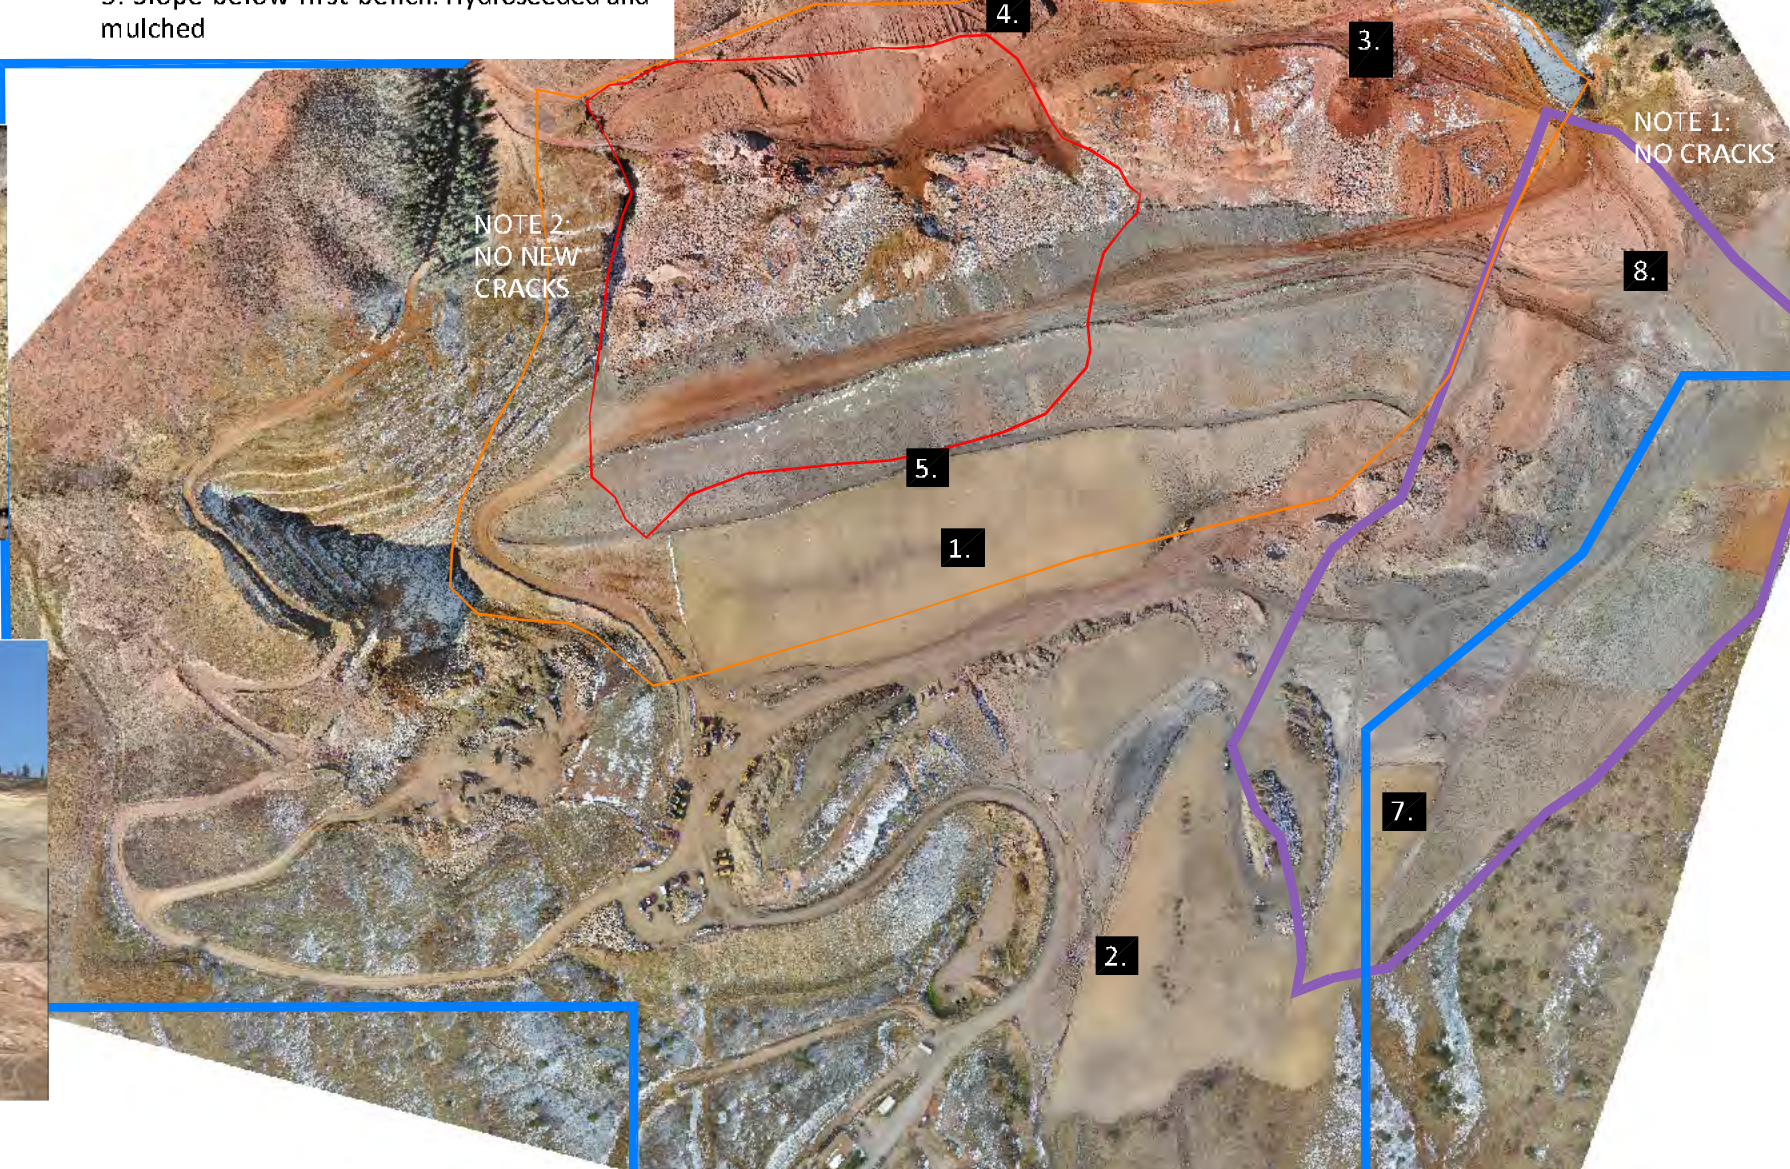
NOTE 2:  
NO NEW  
CRACKS

NOTE 1:  
NO CRACKS

- NO CRACKS OBSERVED IN THIS AREA.
- NO NEW CRACKS OBSERVED IN THIS AREA.
- PHOTOS TAKEN ON OCTOBER 25, 2023.

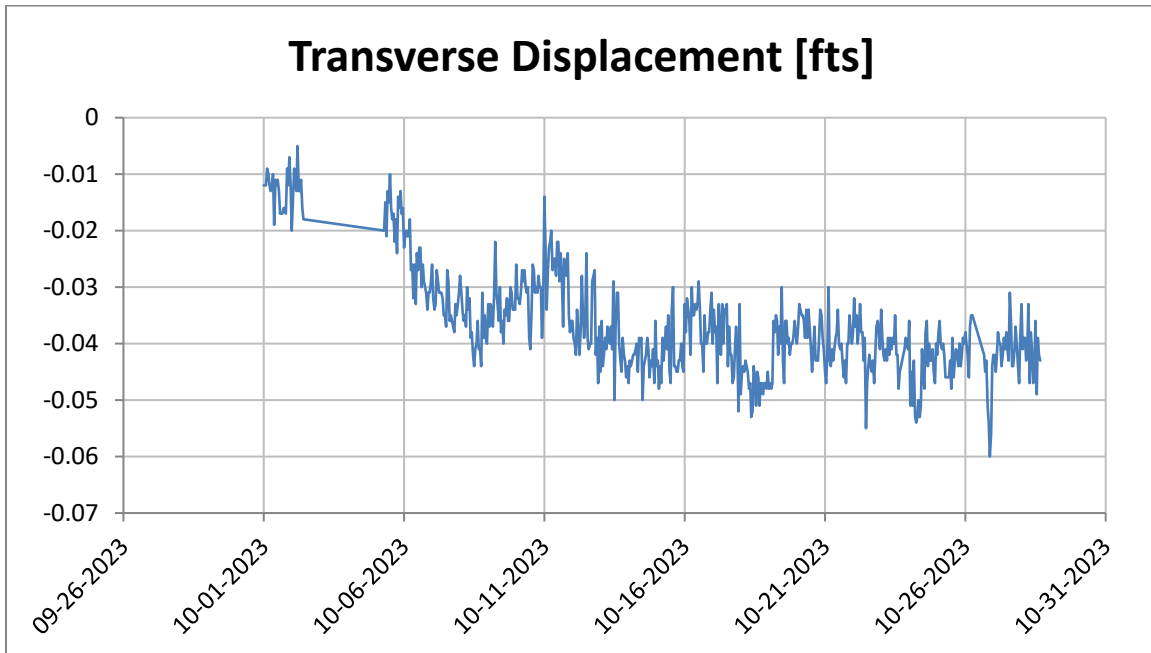
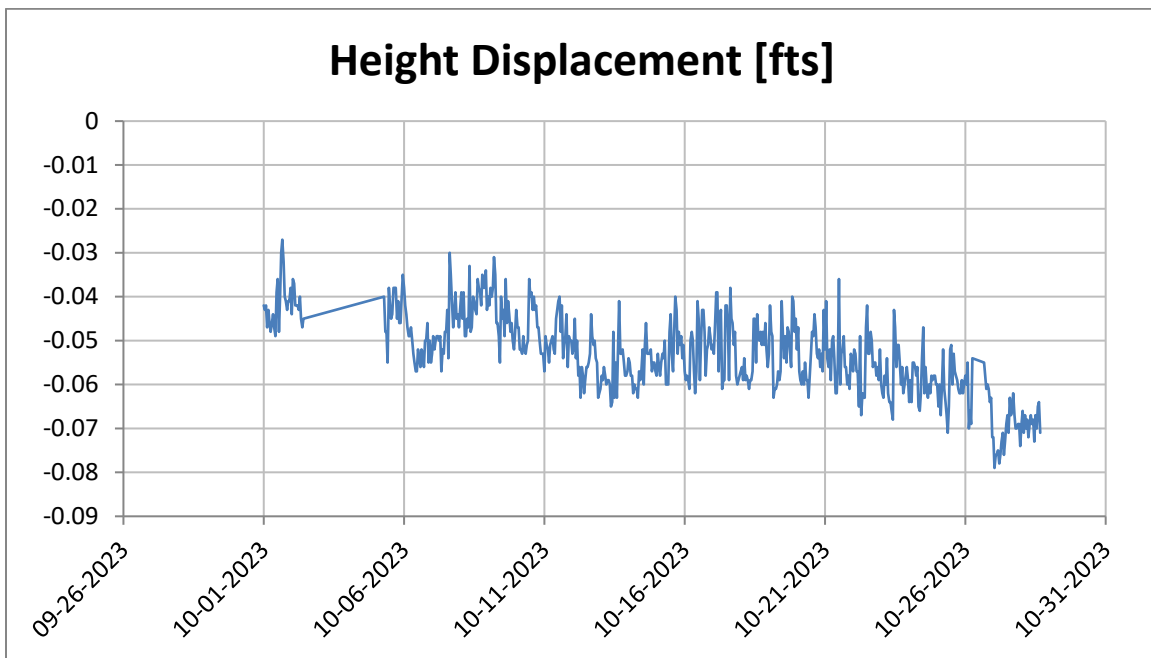
## Prism B7300-0

1. Survey accuracy is  $\pm 0.016$  feet.
2. Alert threshold is  $\pm 0.35$  feet.
3. Transverse displacement is in the horizontal direction. Positive direction means closer to the robotic station.
4. Height displacement is in the vertical direction. Positive direction means higher in elevation.
5. Apparent movements believed to be the result of topsoil placement around prism.

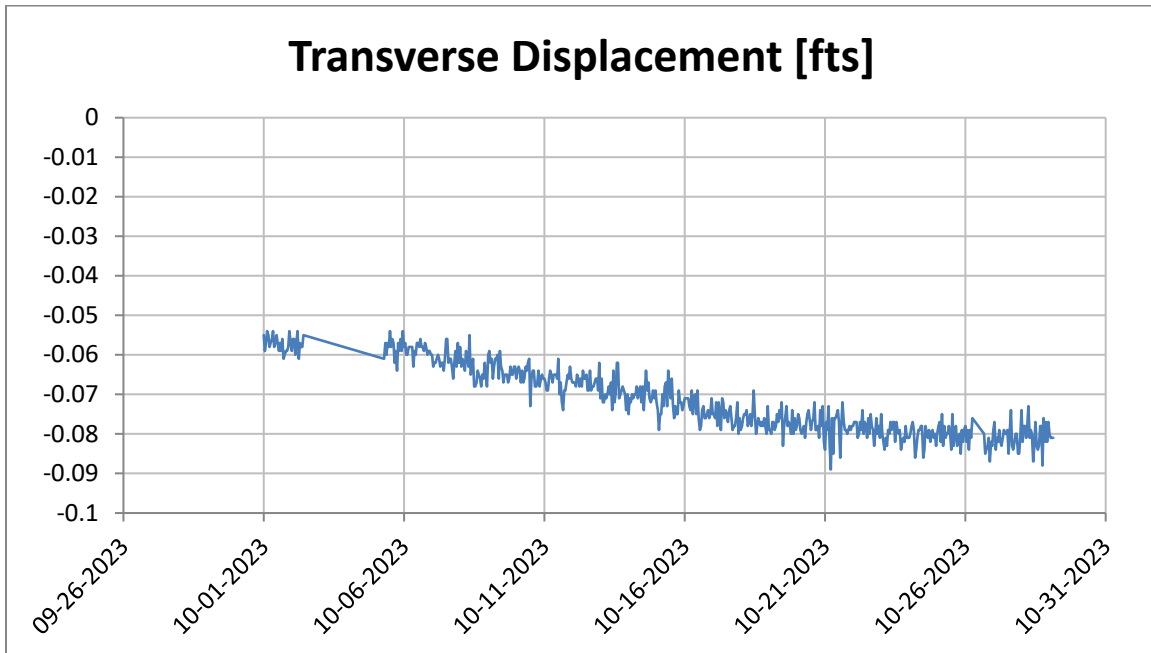
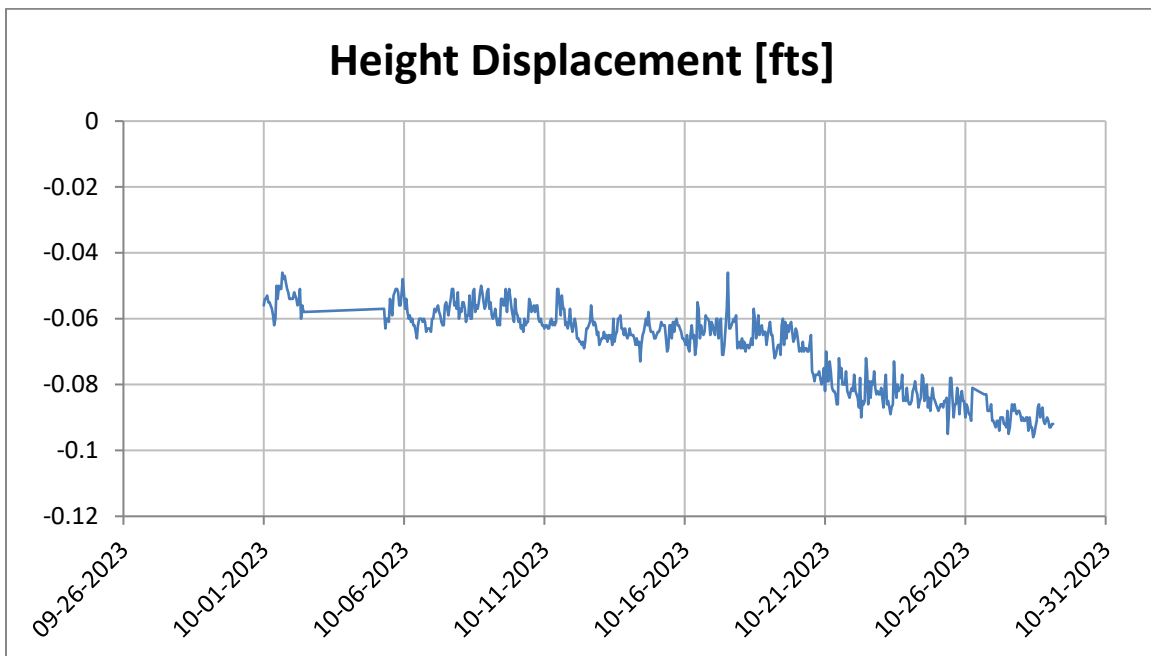
## Prism B7300-1

1. Survey accuracy is  $\pm 0.016$  feet.
2. Alert threshold is  $\pm 0.35$  feet.
3. Transverse displacement is in the horizontal direction. Positive direction means closer to the robotic station.
4. Height displacement is in the vertical direction. Positive direction means higher in elevation.
5. Apparent movements believed to be the result of topsoil placement around prism.

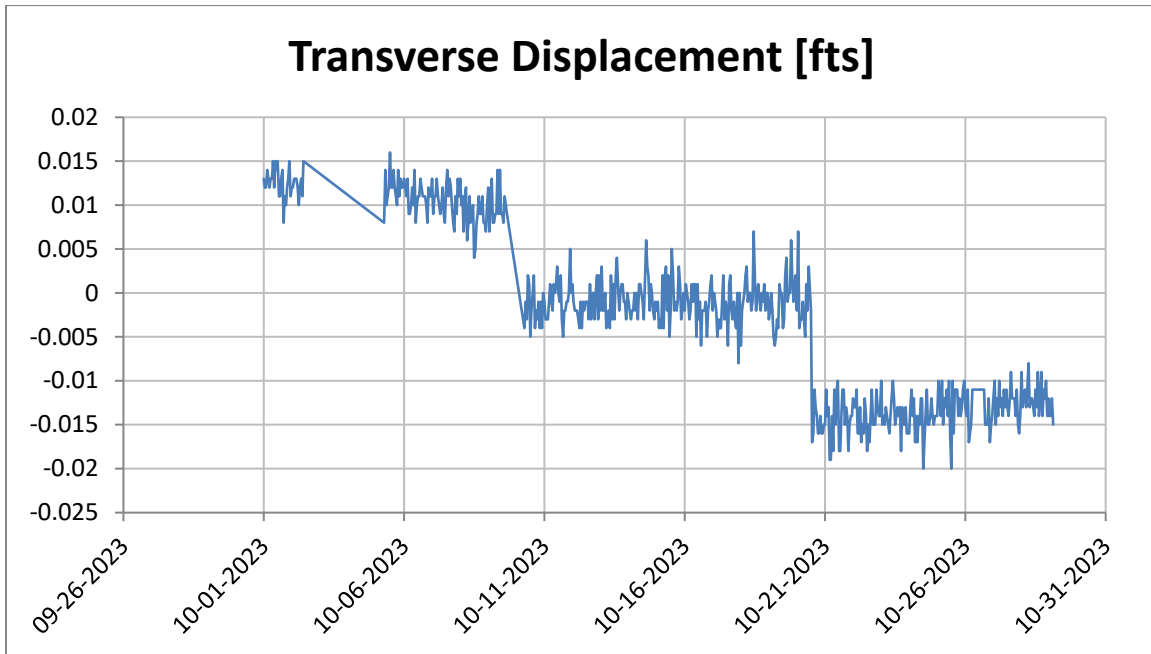
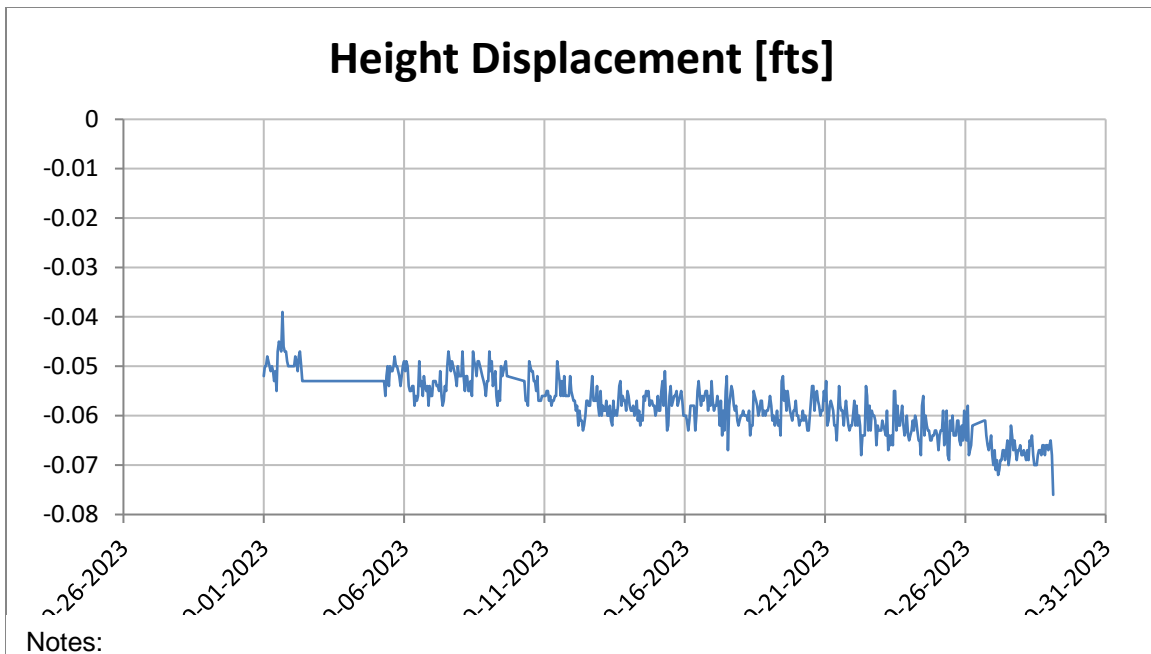
## Prism B7300-2

1. Survey accuracy is +/-0.016 feet.
2. Alert threshold is +/-0.35 feet.
3. Transverse displacement is in the horizontal direction. Positive direction means closer to the robotic station.
4. Height displacement is in the vertical direction. Positive direction means higher in elevation.
5. Apparent movements believed to be the result of topsoil placement around prism.

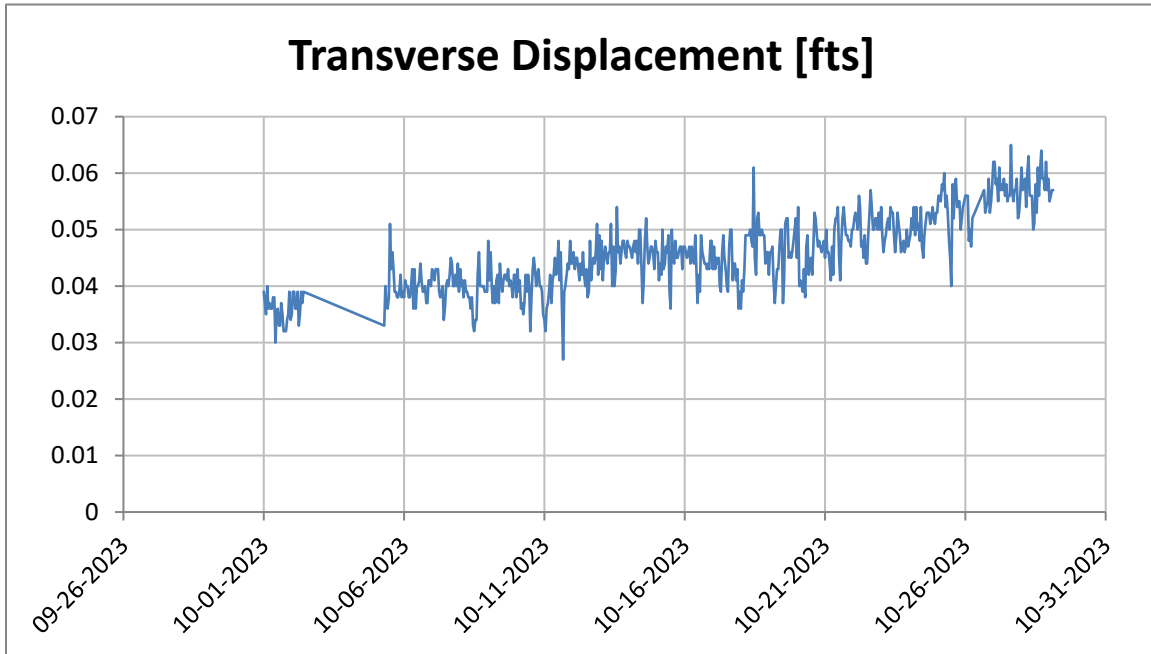
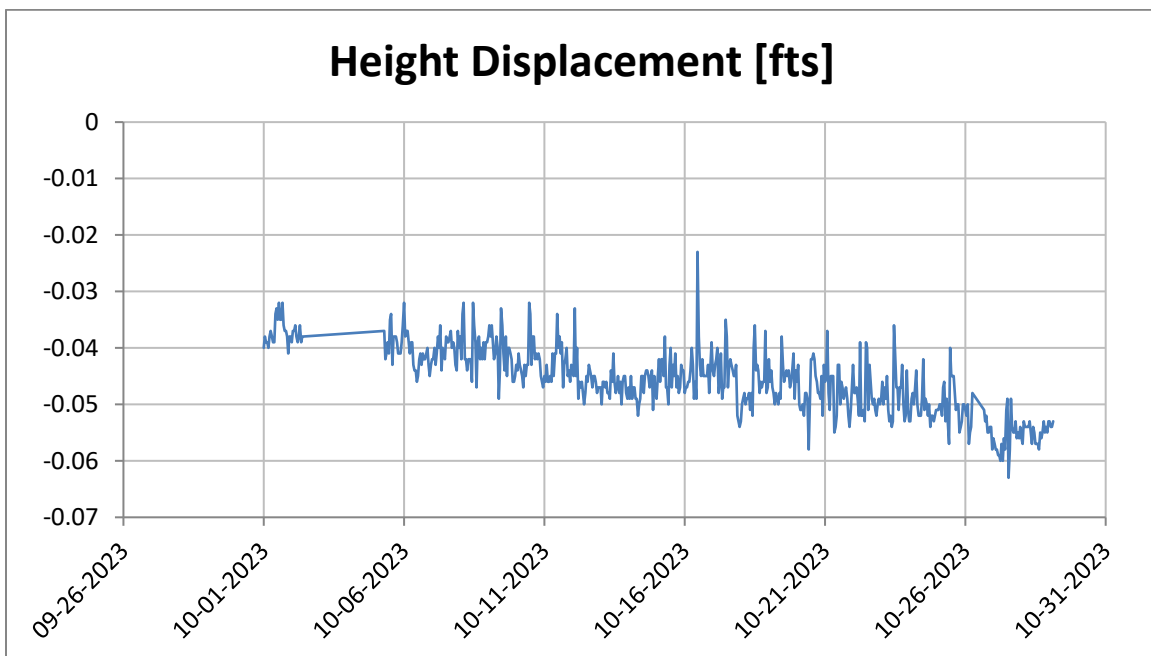
## Prism B7300-3

1. Survey accuracy is  $\pm 0.016$  feet.
2. Alert threshold is  $\pm 0.35$  feet.
3. Transverse displacement is in the horizontal direction. Positive direction means closer to the robotic station.
4. Height displacement is in the vertical direction. Positive direction means higher in elevation.
5. Apparent movements believed to be the result of topsoil placement around prism.

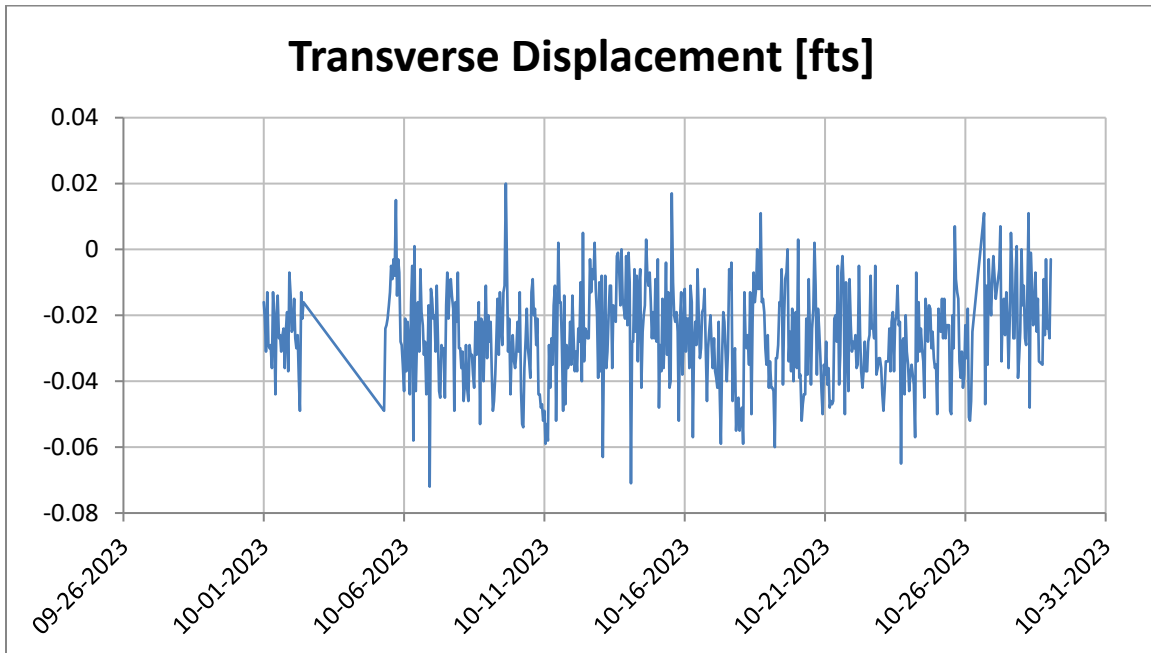
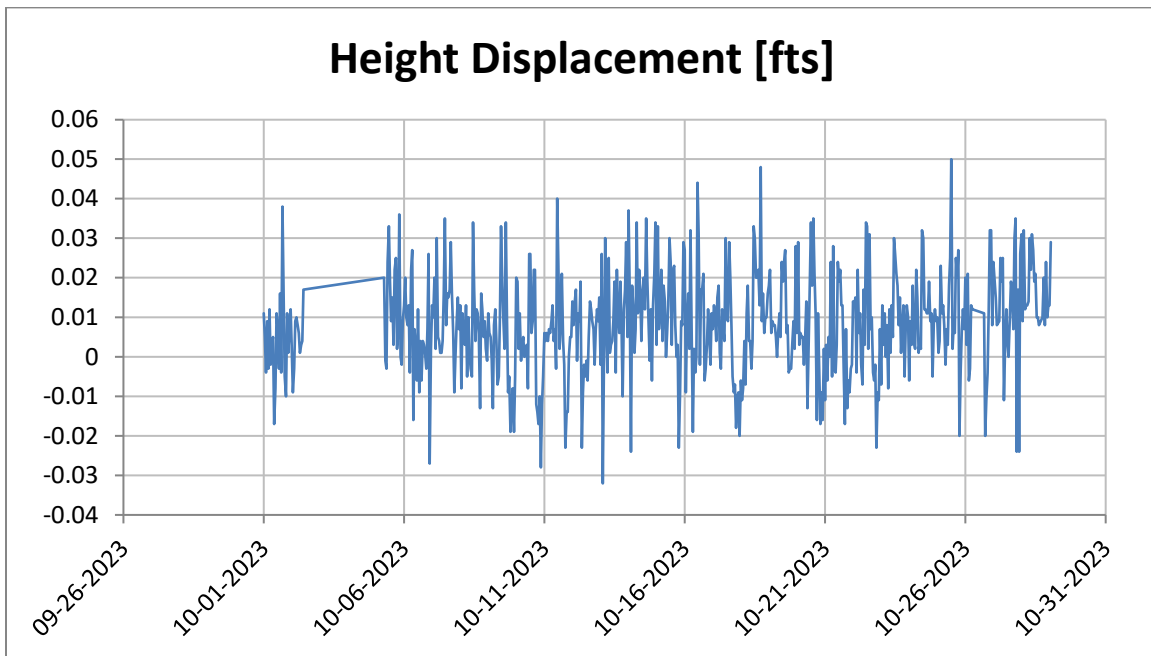
## Prism P32R

Prism	Date	Action	Comment
P32	1-Aug-23	Prism Removed	P32 was damaged by a falling rock. P32R was installed in the same location.
P32R	1-Aug-23	Prism Added	
P69A	28-Sep-23	Prism Removed	Reclamation grading to affect prism in near future
NP3	30-Sep-23	Prism Removed	Reclamation grading to affect prism in near future

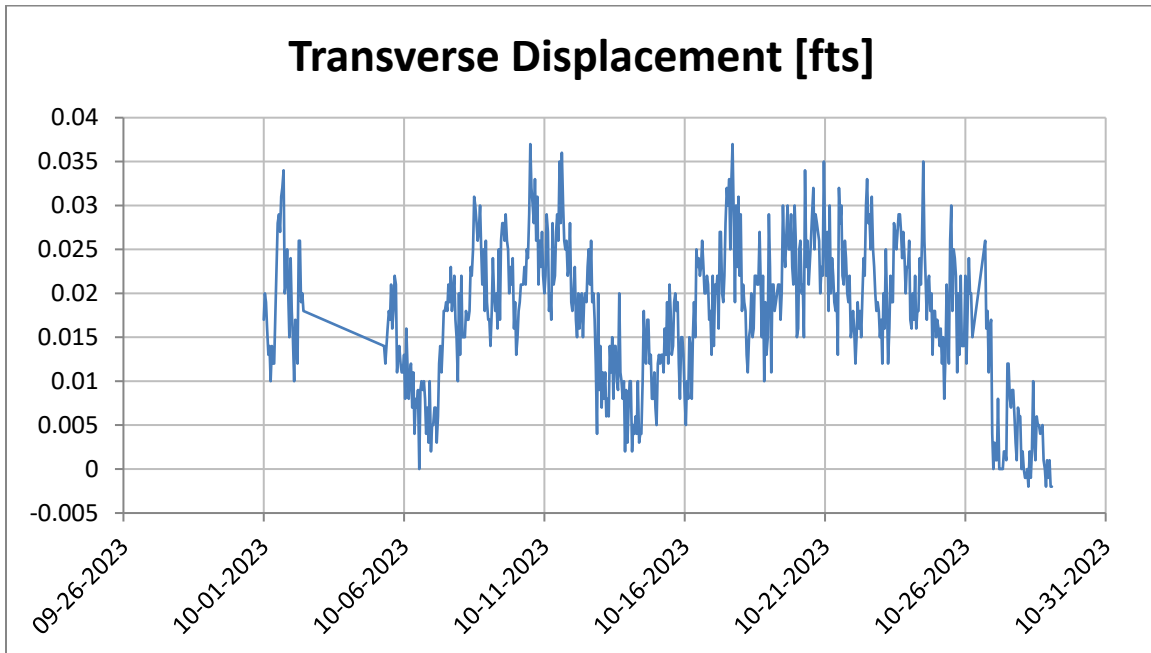
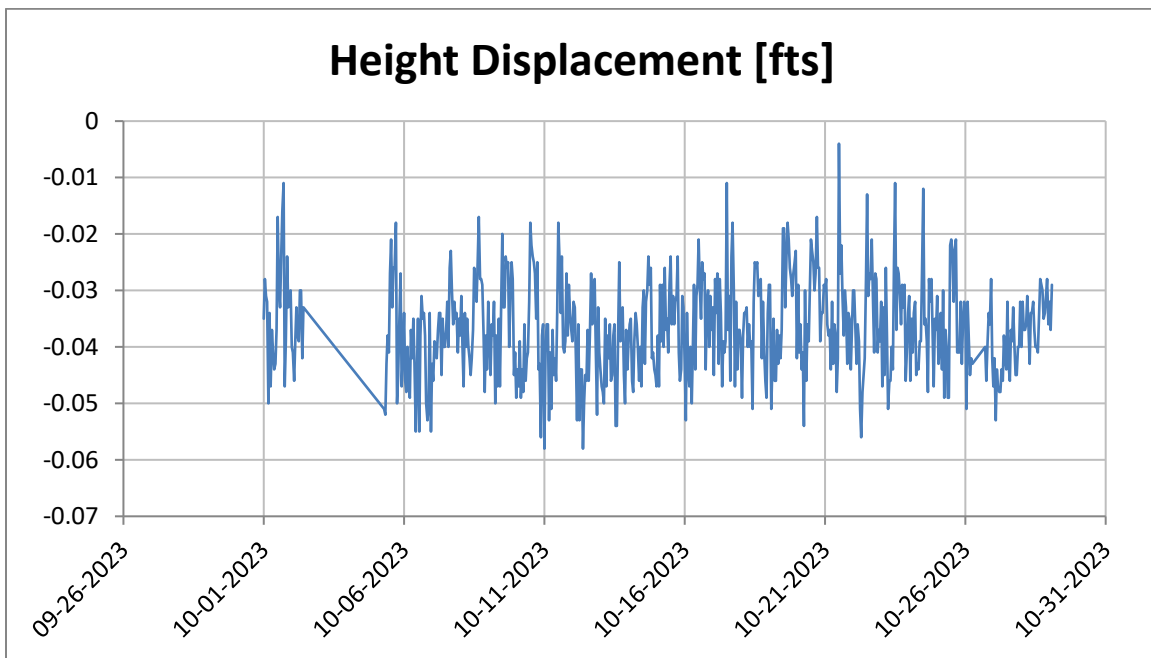
## Prism P70

26-Oct	P70 not found	Single event. Likely blocked by equipment operations.	26-Oct
27-Oct	Points P32R and P33 not found	Fog. No work being performed at time of alerts.	27-Oct
28-Oct to 29-Oct	Points not found	Snow and fog. No work being performed at time of alerts.	30-Oct
29-Oct to 2-Nov	Leica system offline. No alerts received, but no readings taken	Leica software issues. A spotter was used to monitor the slopes during construction activities	2-Nov
