MINERALS PROGRAM INSPECTION REPORT
PHONE: (303) 866-3567

MINE NAME: Shot Rock Pit	MINE/PROSPECTING ID#: M-2012-023	MINERAL: Crushed stone material	COUNTY: Las Animas
INSPECTION TYPE: Monitoring	WEATHER: Clear	INSP. DATE: November 28, 2023	INSP. TIME: 01:00
OPERATOR: Tamrock Gravel LLC	OPERATOR REPRESENTATIVE: Brent and Tami Tamburelli	TYPE OF OPERATION: 112c - Construction Regular Operation	
REASON FOR INSPECTION: Normal I&E Program	BOND CALCULATION TYPE: Complete Bond	BOND AMOUNT: \$22,800.00	
DATE OF COMPLAINT: NA	POST INSP. CONTACTS: None	JOINT INSP. AGENCY: None	
INSPECTOR(S): Amber Gibson	INSPECTOR'S SIGNATURE:

INSPECTION TOPIC: Slides & Other Damage

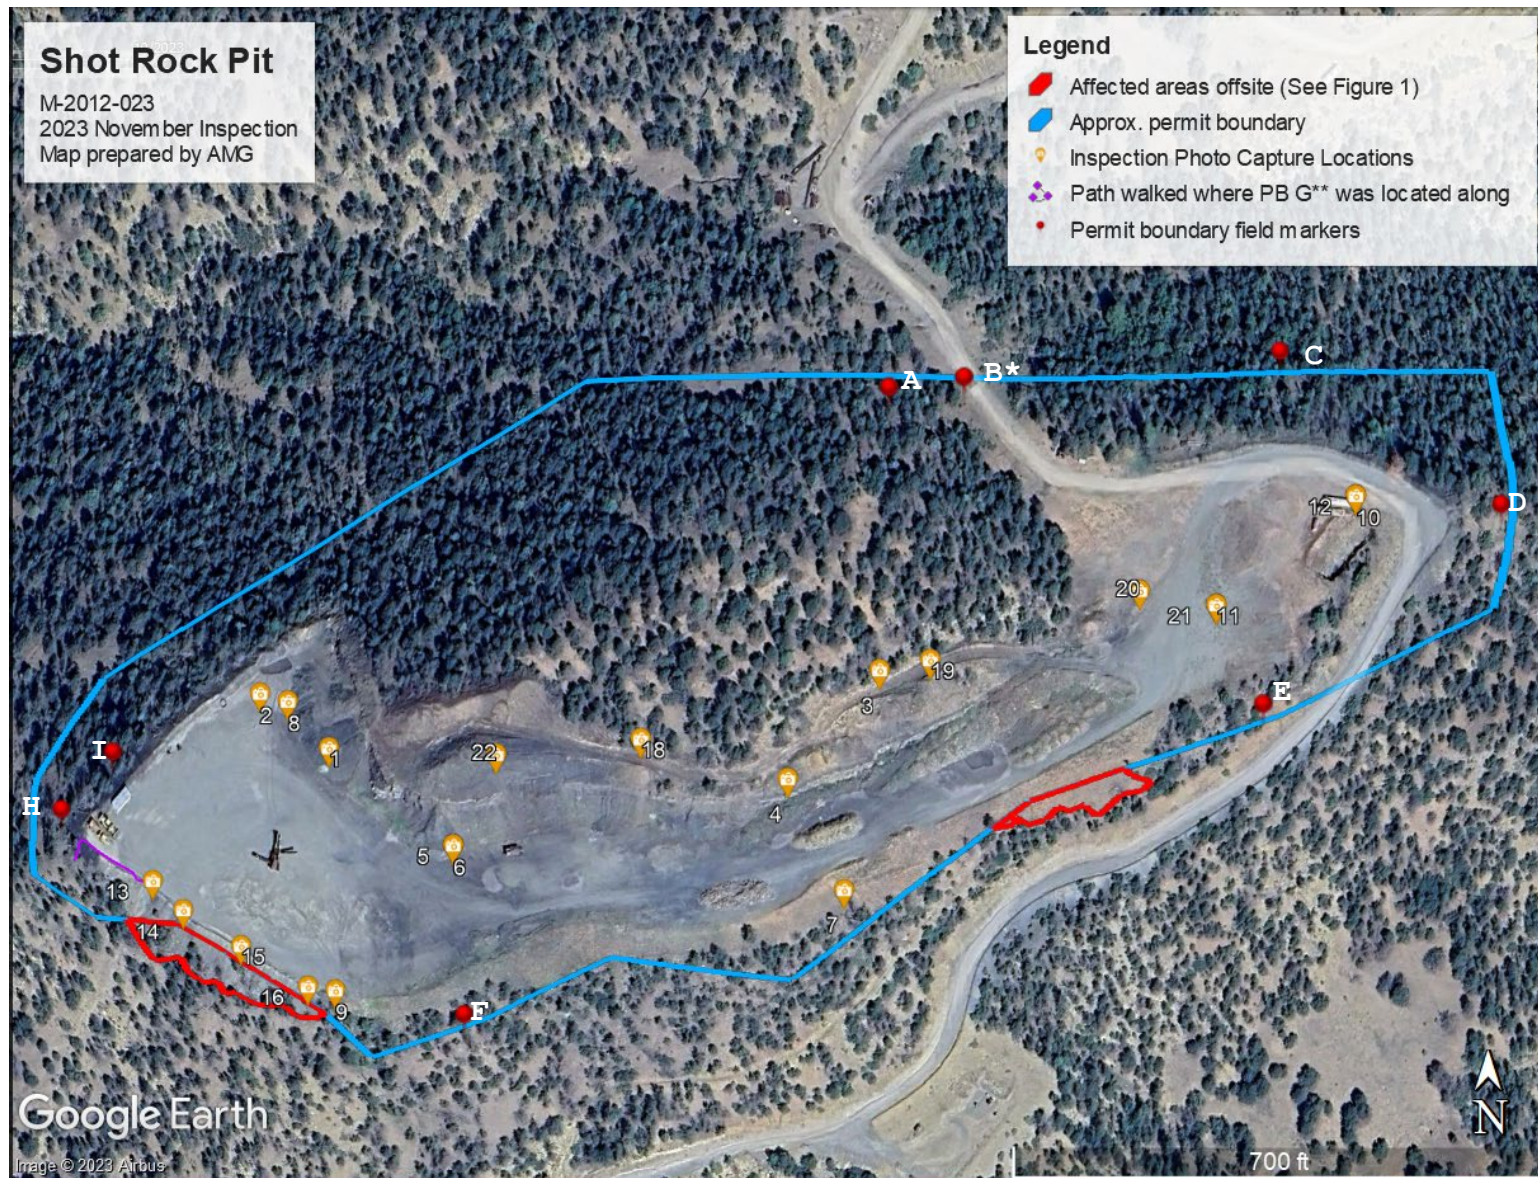
The Operator stated that the area leading down from the equipment storage area on the east side of the permit, had been blasted and backfilled. Further cut and fill work will be conducted in this area, and the Operator also plans to install armored ditches to facilitate controlled drainage. However, upon further review of recent Google Earth Pro aerial images, it appears that an approximately 0.11 acre area outside of the permit boundary has been affected. The Operator had excavated this area and it has since backfilled with material. This backfilled area is downslope of the permit boundary (see Map 1 and Figure 1).

Additionally, along the south-west portion of the permit, where the Operator stated that they were required by MSHA to build higher safety berms, approximately 0.23 acres contain material that appears to have slid down-slope and off-site (see Map 1 and Figure 1).

Map 1: Map prepared in Google Earth Pro. The aerial imagery sourced for this map was dated October 2023. Photographs in the report correspond to this map. The polygons in Figure 1 below also correspond with this map.
