Division of Reclamation,  
Mining and Safety

### MINERALS PROGRAM INSPECTION REPORT

<b>MINE NAME:</b> Lopez Quarry No. 2	<b>MINE/PROSPECTING ID#:</b> M-2007-034	<b>MINERAL:</b> Sand and gravel	<b>COUNTY:</b> Las Animas
<b>INSPECTION TYPE:</b> Monitoring	<b>WEATHER:</b> Clear	<b>INSP. DATE:</b> November 29, 2023	<b>INSP. TIME:</b> 08:15
<b>OPERATOR:</b> S & S Services	<b>OPERATOR REPRESENTATIVE:</b> Lonnie Lopez	<b>TYPE OF OPERATION:</b> 110c - Construction Limited Impact

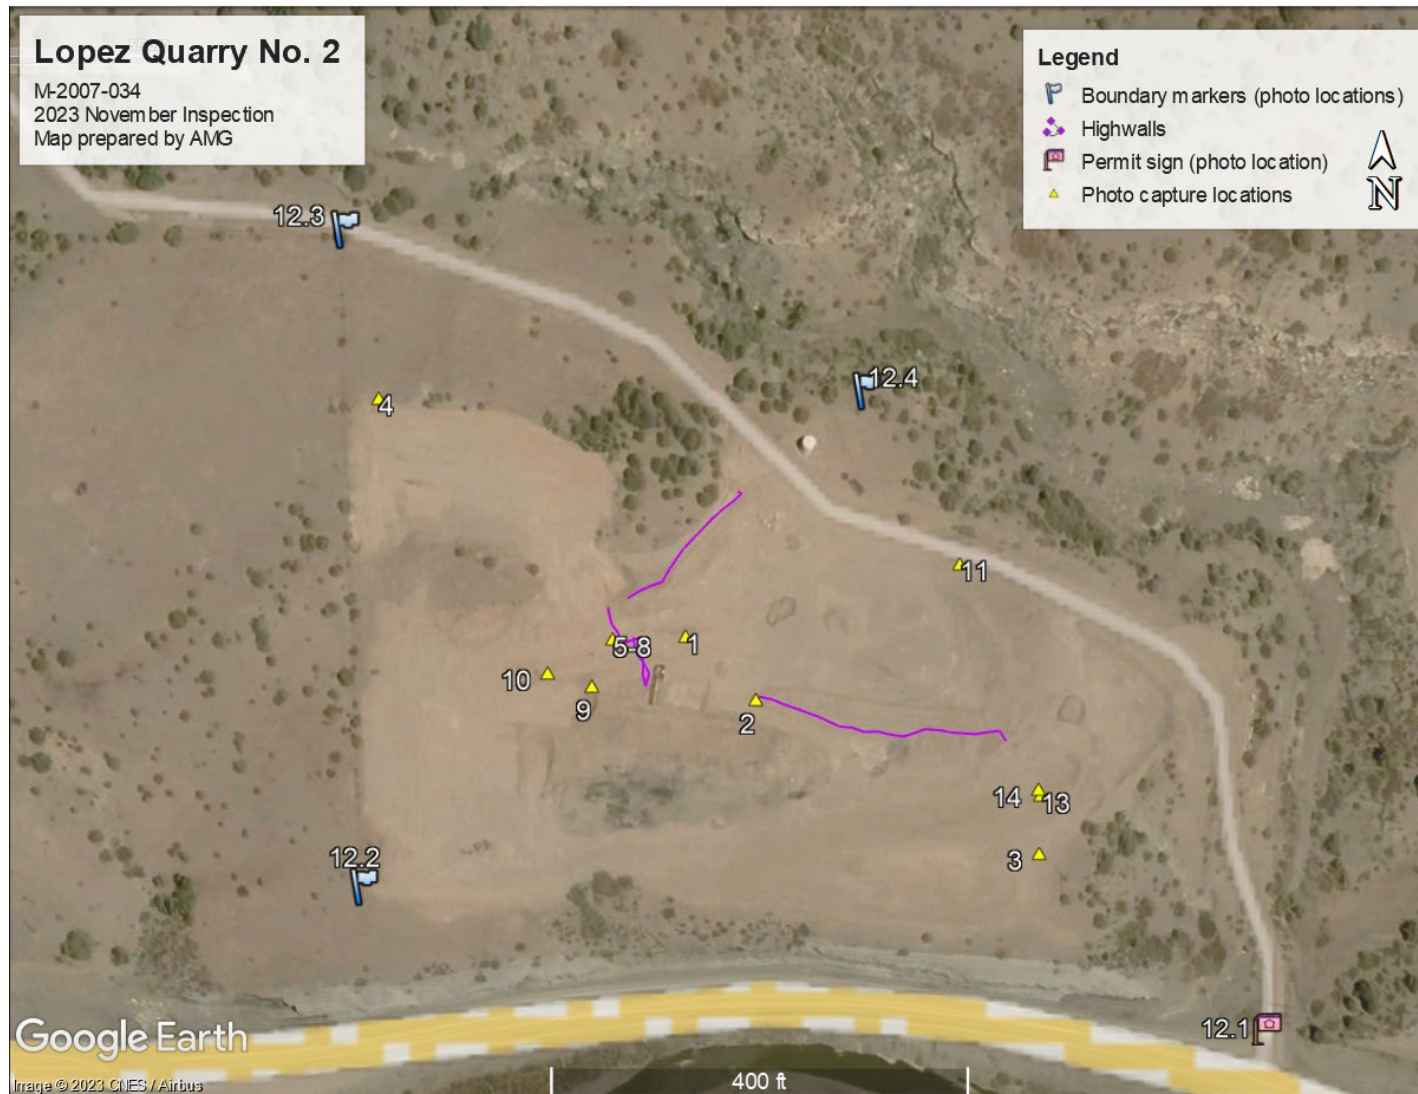
A few highwalls currently exist at the site (Photos 1-3, and purple path lines on Map 1). The northernmost highwall on Map 1 used to extend westward to the western boundary. There also used to be a pit extending eastward from the location of Photo 4, indicating the observed disturbance boundary (Photo 4; Map 1). These areas have since been backfilled by the Operator. The area at the disturbance boundary has been graded (Photo 4; Map 1), but the south-western area where the highwall had extended has not. Erosion in the form of ruts and gullies was observed in this area (Photos 5-9; Map 1). However, the Operator has placed and maintained a berm along the south boundary of the permit to ensure that excess sediment has not left the site (Photos 10 & 11; Map 1). The excess erosion in this area has been **cited as a problem** above. The Operator shall grade and stabilize this area to prevent further erosion. Once this area has been stabilized, the Operator shall submit photo evidence as proof by the corrective action date.

Equipment onsite included a loader, a grizzly screener, and a water tank (Photo 3; Map 1). There is also a white tank acquired from the gas company that is currently being stored onsite, but will likely be converted to scrap (Photo 3; Map 1). Overall, the site is operating according to the approved mine plan, the affected acres are within the permit boundary, and no off-site damage was observed.

A permit sign, posted in compliance with Rule 3.1.12(1) was observed at the entrance to the site (Photo 12.1; Map 1). The corners of the active pit area were marked with signs on the fence line (Photos 12.2-12.4; Map 1). At the inspection, the Division brought the Operator's September 2023 annual report map. On the map, there is a boundary drawn as the 'pit boundary'. The pit is within the approved permit boundary. However, the way that the boundary is illustrated on the map, gives the impression that there is mining disturbance outside of the approved affected area. This has been **cited as a problem** above, pursuant to Rule 3.1.12(2) which states that the affected area must be marked by boundaries. As a 110c operation, the entire permitted area is approved to be affected. The Operator stated during the inspection that they do not intend to mine north of what has already been affected. Because of this, the Operator was instructed during the inspection to move their north-east corner boundary more to the east, but within the permit boundary, to encompass the entire on-site disturbance.

**Map 1:** Map of the permit area during the November 29, 2023 DRMS inspection. This map was generated using Google Earth Pro, with the most recent aerial imagery being from May 2020.
